SOMERSAULT

JANUARY 2000

Vol 23, No 1

SIGNALLING RECORD SOCIETY OF VICTORIA INC

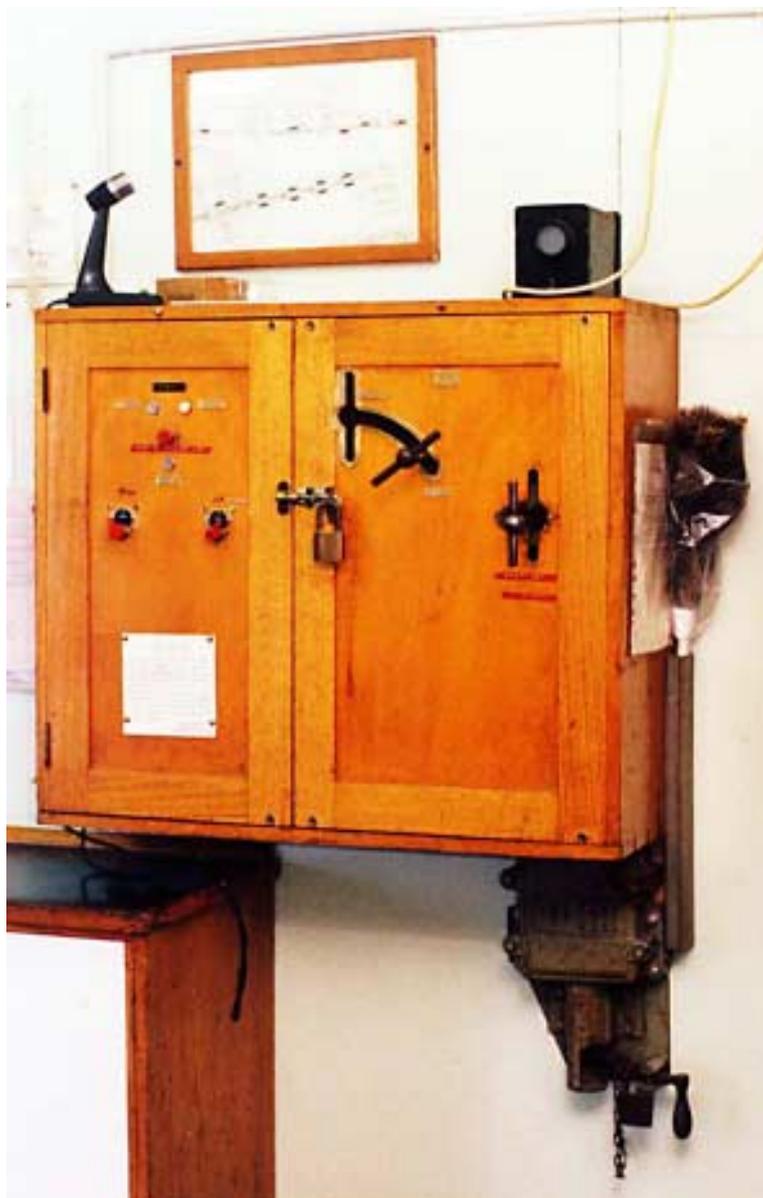
The unique panel at Gowrie with the route set up for an Up train to depart from the Back Platform. On the right hand door can be seen the curved slot and the handle that controlled Crossover F to the Back Platform Road. The handle is in the reverse position. To the right of the point handle is the Annett key in its lock. At the top of the left hand door are the Normal and Reverse indications for the points. Under these is a push button to release the lock on the point handle, and below that a 'Points free' indication. Finally there are two thumb switches; the Down Home is on the left, the Up Home from the Back platform on the right. Each has switch Normal and Reverse indications. Above the panel on the right is the Down Approach indicator, while below the panel on the right is the emergency point crank. The crank allowed the point motors on Crossover F to be manually operated. Note that no official diagram of the points and signals was provided; the framed diagram above the panel actually showed the overhead switching arrangements. The staff had produced their own unofficial version (not shown in this photo). The photo was taken on the SRS Tour on 26 July 1990.

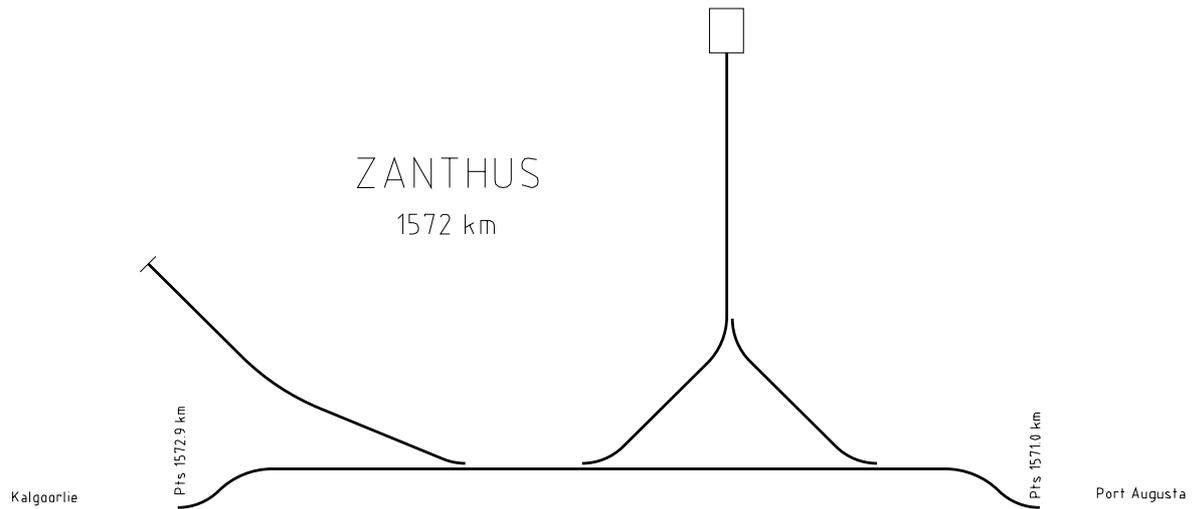
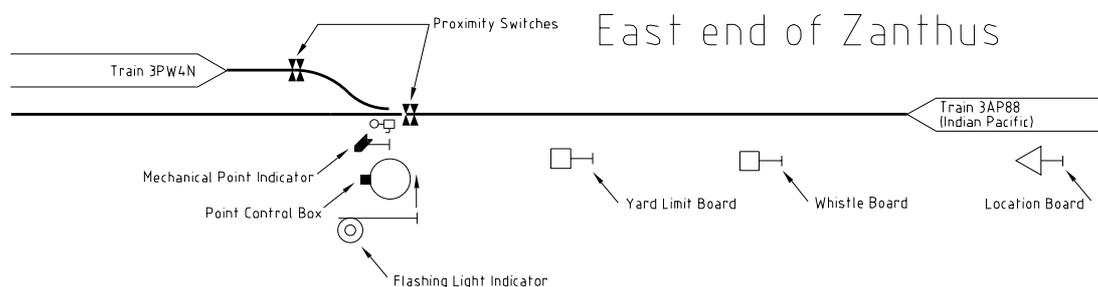
No track circuits are provided. Four proximity switches are fitted; two near the toe of the points and two in the crossing loop. These detect the passage of wheels and the points restore to normal when the same number of axles counted in have been counted out.

Trains Crossing at Unattended Locations on Train Order Territory with Flashing Light Indicators and Self Restoring Points First Train is to take the Crossing Loop.

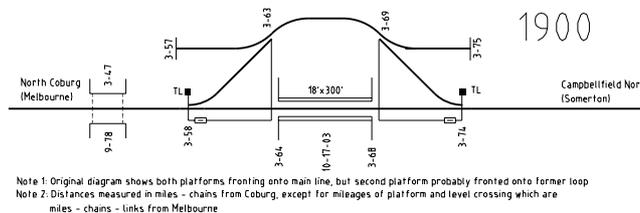
Note 1: Original diagram shows both platforms fronting onto main line, but second platform probably fronted onto former loop
Note 2: Distances measured in miles - chains from Coburg, except for mileages of platform and level crossing which are miles - chains - links from Melbourne

A diagram from around the turn of the century shows an unusual layout, with two timber faced earth platforms - one on each side of the main line - with a siding looping behind the platform. One explanation for this odd layout is that the diagram is not quite accurate; with the Down side platform actually situated further from the main line on a lifted loop.

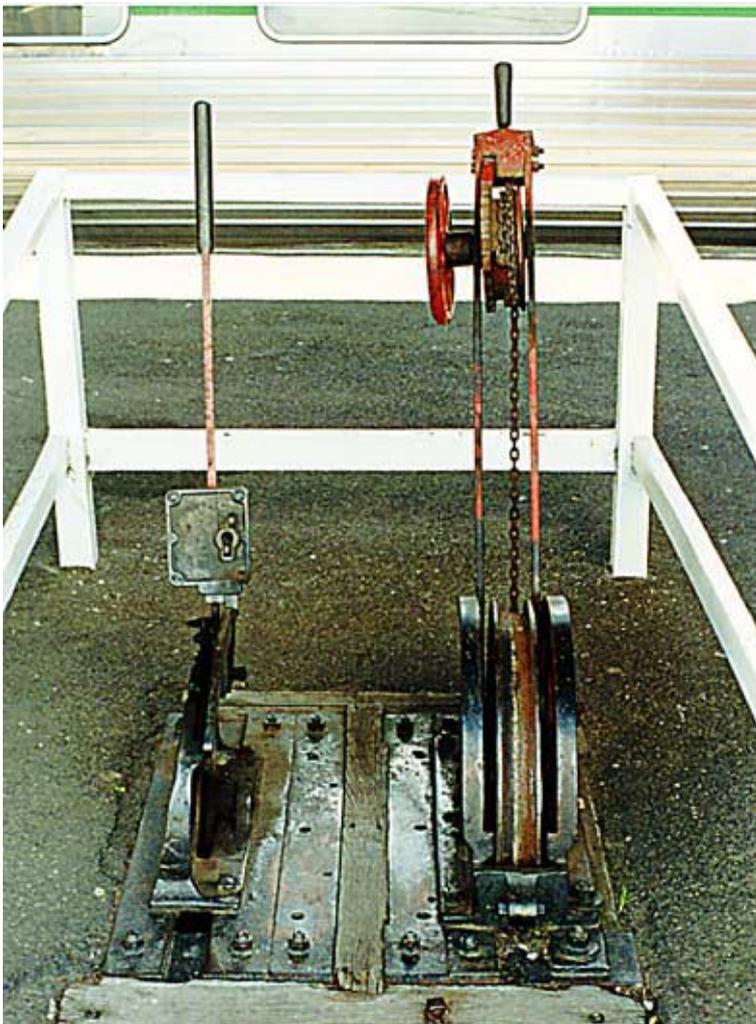
The two mechanical signal levers that were on the platform at Gowrie prior to its abolition as a Staff and Ticket station in 1998. The lever on the left works Up Home B and the Annett Lock that secures the lever normal can be clearly seen. The lever on the right works Up Home C protecting the flashing lights at Box Forest Road. The left hand lever is of the type known as a 'Tail Quadrant' as the signal wire is directly connected to the tail of the lever below ground level. This type of lever is used where the distance between the signal and the lever is small enough that it is not necessary to regularly alter the length of the signal wire due to temperature changes. The righthand lever is a 'Ratchet Quadrant' which is used where it is necessary to regularly take in or let out the signal wire. The signal chain passes round a large drum at the base of the lever and then around the small drum at the top of the lever. This small drum can be wound up (tightening the wire) by means of the small handwheel on the left of the lever. The ratchet, of course, holds the small drum in place once the adjustment has been made. In the middle can be seen the mounting plates where the third lever, another ratchet quadrant, was mounted before provision of the panel.

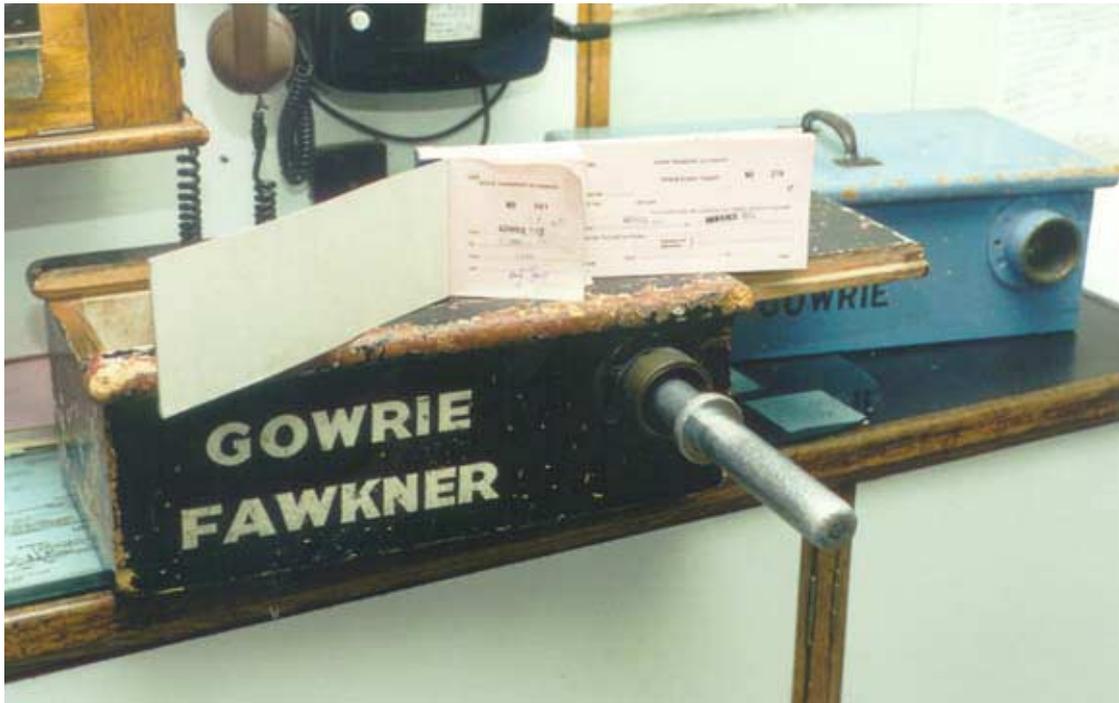
The Staff and Ticket Boxes at Gowrie in 1997. The top photo shows the Gowrie - Fawkner Ticket box (black with white lettering). The Staff is in the lock and the Ticket Box is open with the Ticket Book open on top of the box. The Upfield - Gowrie can be seen behind the Fawkner box, and another photo is shown below. The Upfield - Gowrie Ticket Box was Blue with Black lettering. The Gowrie - Fawkner Staff is a modern Duraluminium Staff, while the Upfield - Gowrie is a very battered Steel Staff with Brass rings. In front of the Upfield - Gowrie box can be seen the A Pattern Annett Key used to unlock the Up Home signal.
