SOMERSAULT

MARCH 2007
Vol 30, No 2

SIGNALLING RECORD SOCIETY OF VICTORIA INC

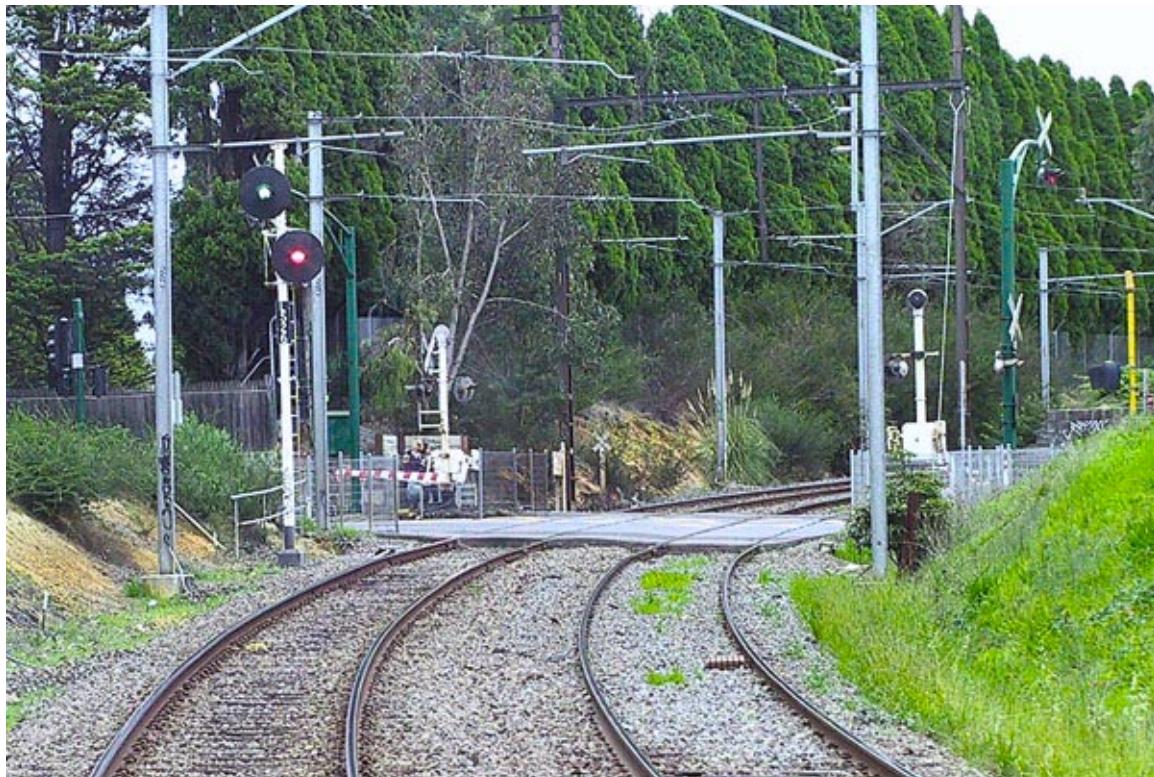
The major work reported in this issue is the abolition of the level crossing at Middleborough Road between Box Hill and Laburnum, seen here from the Down side. The level crossing was closed on 1 January 2007 when the line between Box Hill and Blackburn was taken out of use to allow construction of the grade separation. The boom barriers were provided on 13 July 1958 when the hand operated gates were abolished in conjunction with the provision of three position signalling between Box Hill and Blackburn. The signalling between Box Hill and Blackburn was altered on 19 October 1980 to improve the headways when Blackburn replaced Box Hill as a terminating point during reconstruction of Box Hill station. Like many Melbourne level crossings, the signalling associated with the boom barriers at Middleborough Road was complex to reduce the time the crossing was closed to road traffic while not reducing safety. The conditions under which the booms will (or will not operate) are shown in a diagram on page 26.

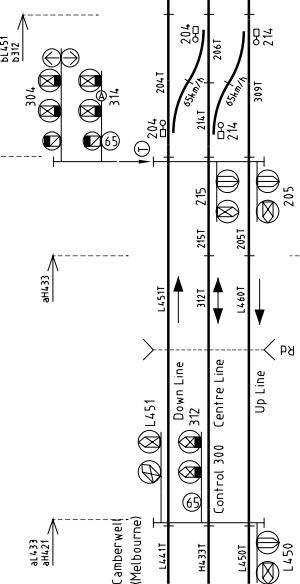
Based on Signalling Arrangement S25688/83 amended to 25/5/04

Box 312 approach operated to medium warning when 316T occupied with Points 226 reverse or 326T occupied with Points 226 normal and 312T occupied for 20 seconds or 312/25T occupied for 33 seconds

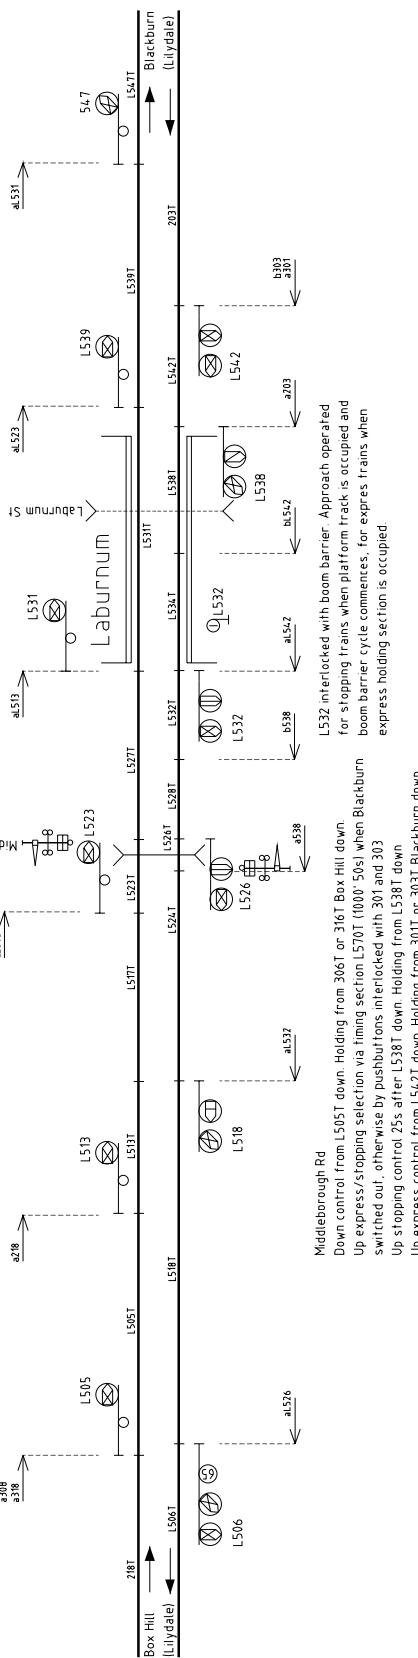
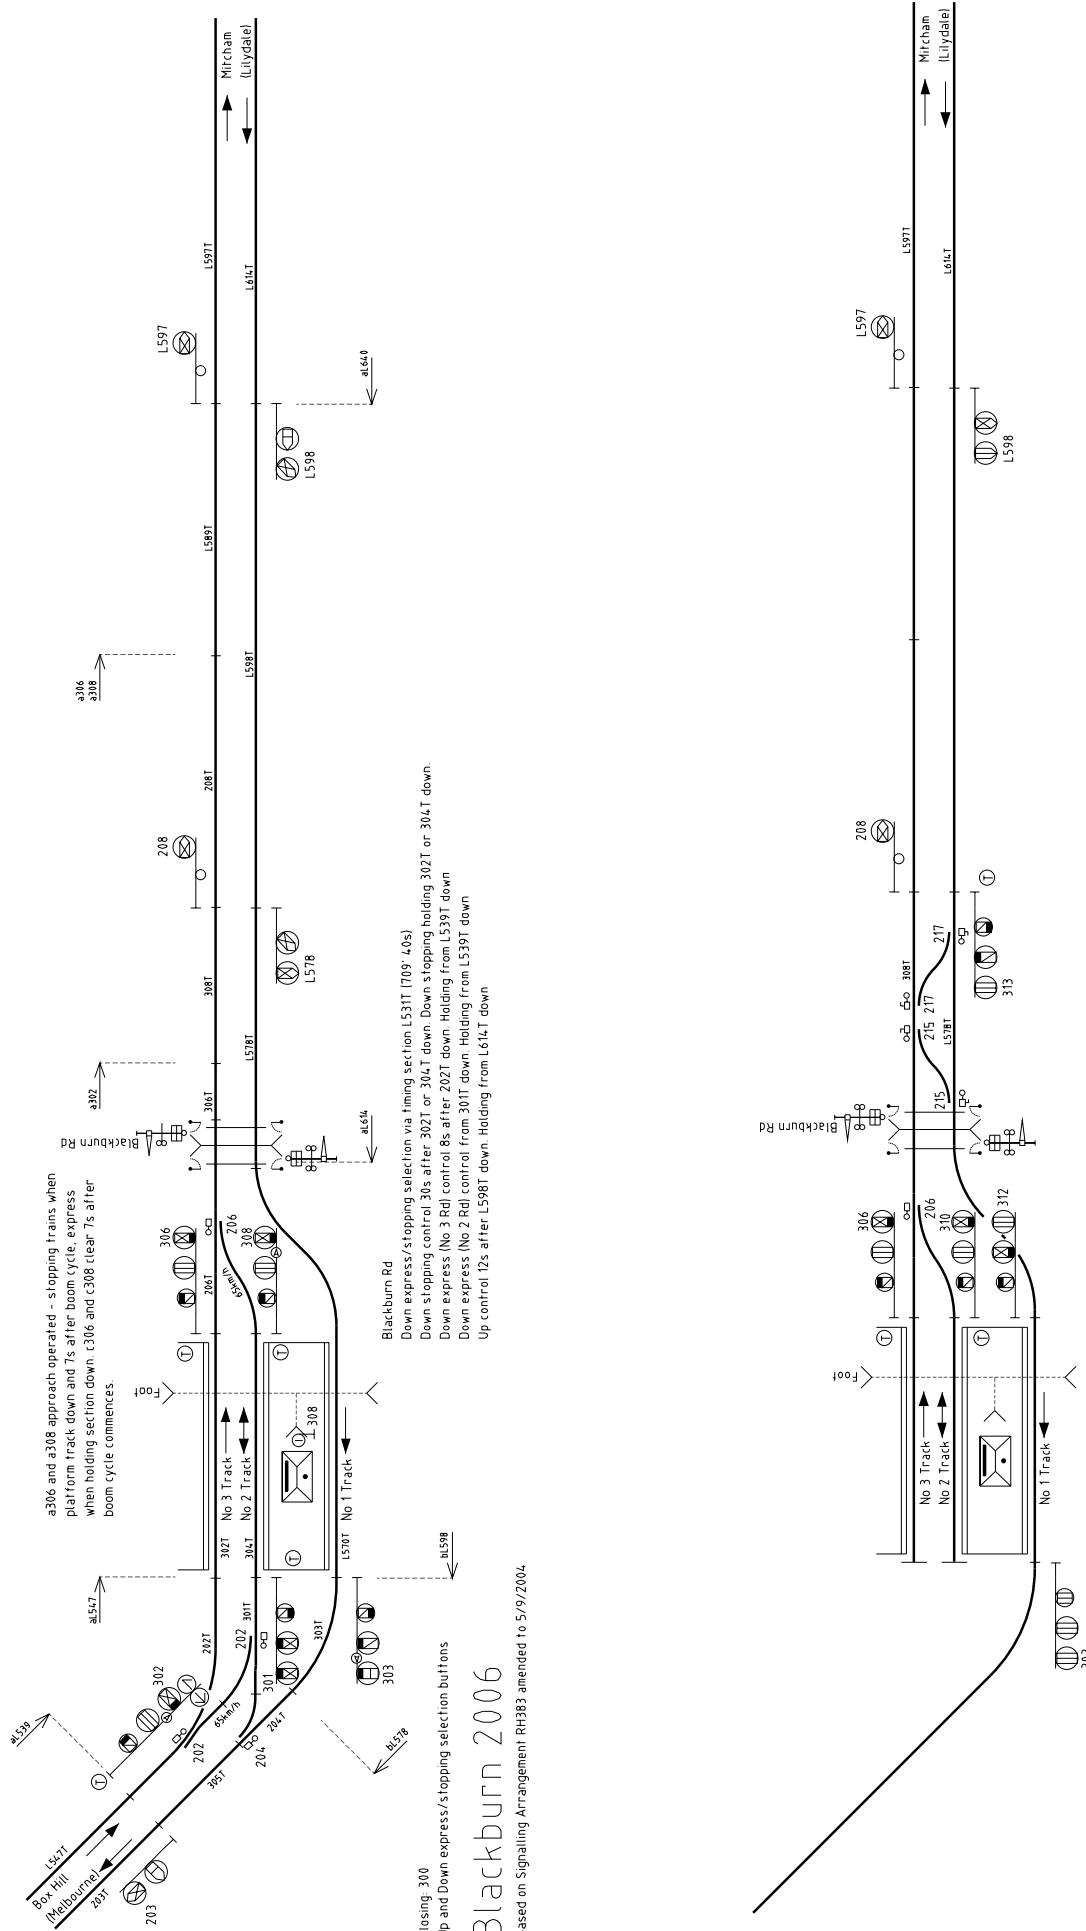
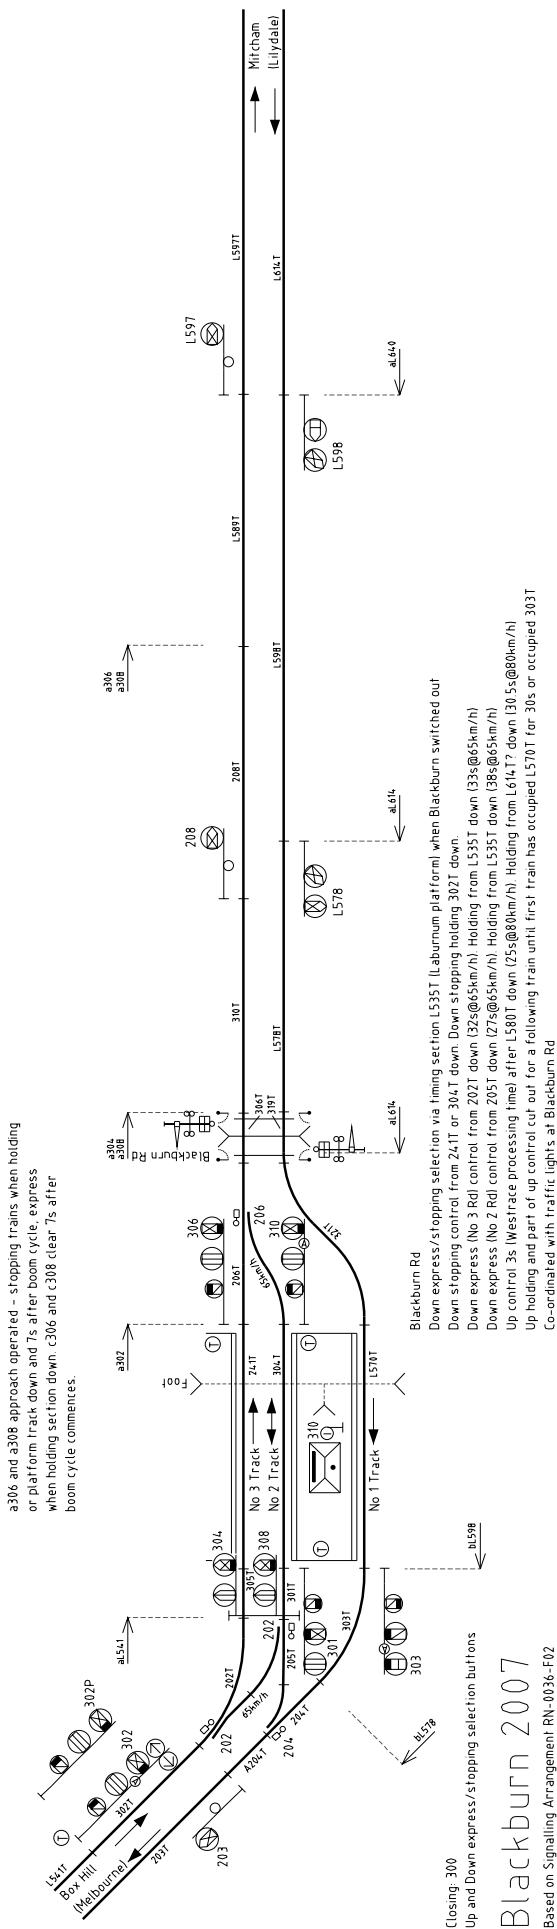
Laburnum 2007

Middleborough Rd
Down control from L505T down. Holding from 306T or 316T Box Hill down.
Up express/stopping selection via timing section L570T (1000' 50s) when Blatburn switched out otherwise by pushbuttons interlocked with 301 and 303 Up stopping control 25s after L538T down. Holding from L538T down

L532 interlocked with boom barrier. Approach operated for stopping trains when platform track is occupied and boom barrier cycle commences, for express trains when express holding section is occupied.

Based on Signalling Arrangement RN-0036-F02

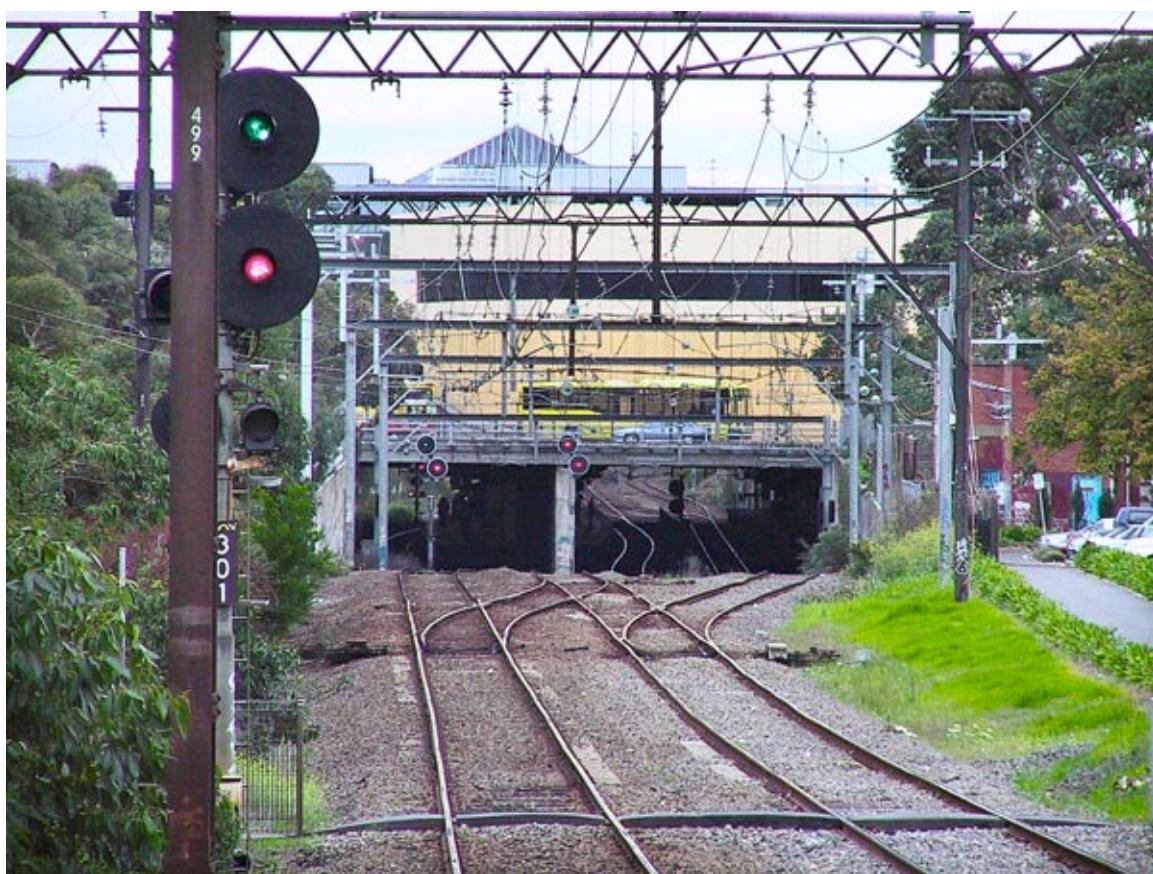
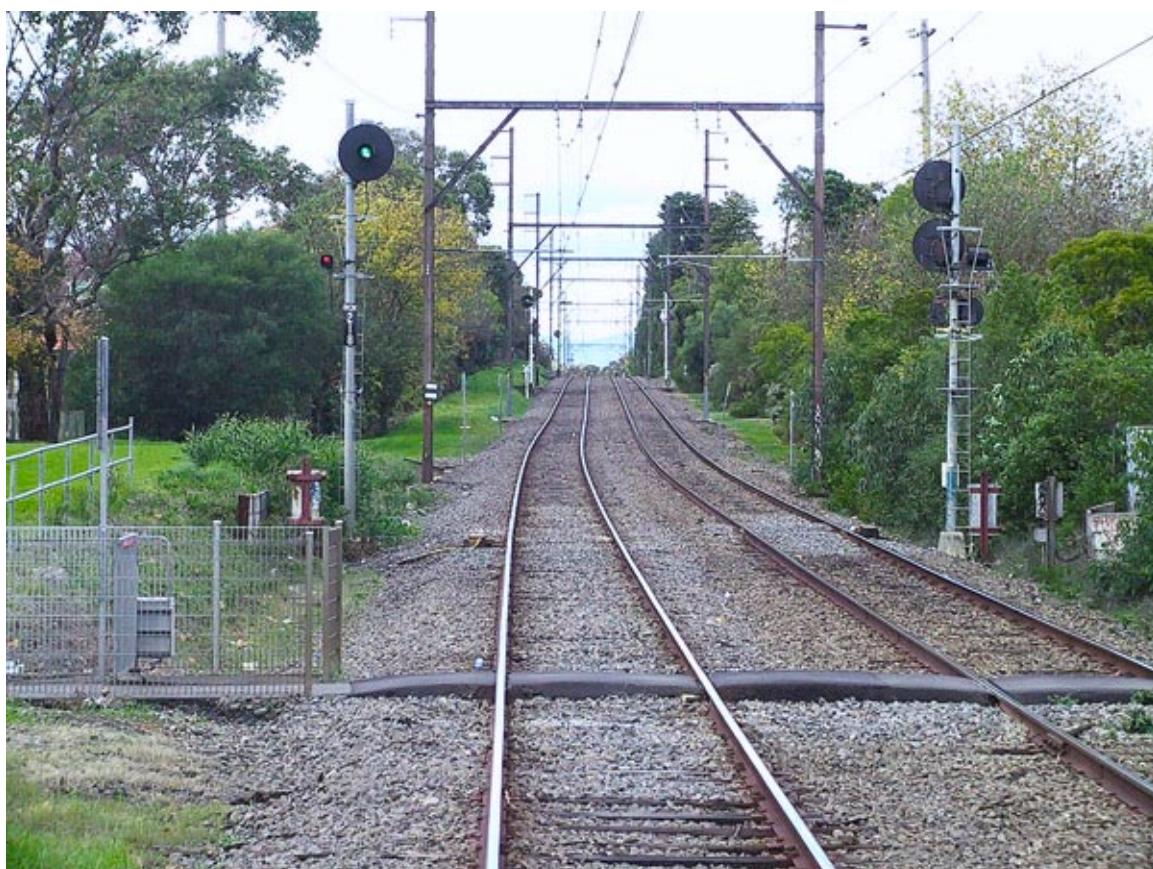
BOX HILL - BLACKBURN BEFORE RESIGNALLING

(Above) Looking in the Up direction towards Box Hill station which is underneath a shopping centre. Home BOX301 is almost hidden behind the overhead stanchion at left with the William St pedestrian gates are immediately behind. In the distance, just before the Station St overbridge can be seen Automatics BOX 303 and BOX 313. (Below) Looking in the opposite direction away from Box Hill with the Williams St crossing in the foreground, with BOX301 on the right and Down Automatic BOX218 on the left. Both photos Rod Williams

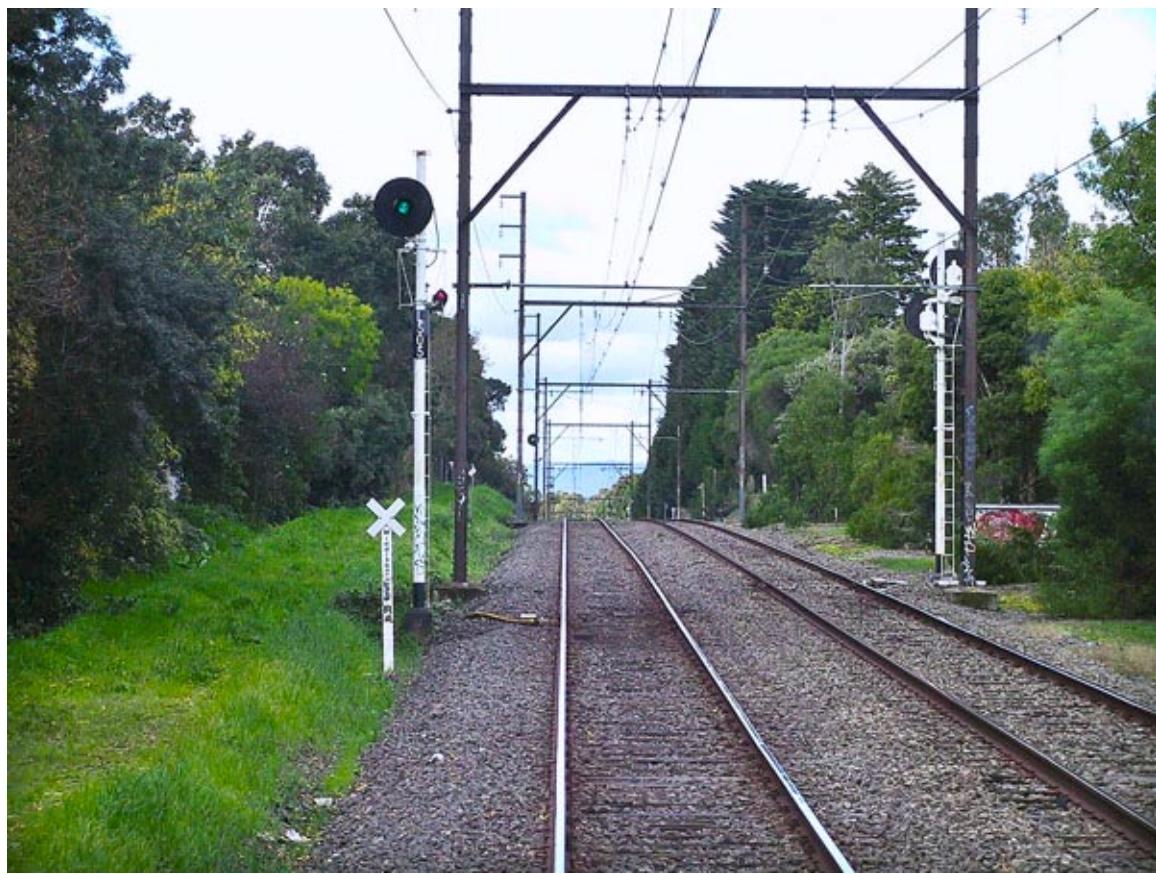
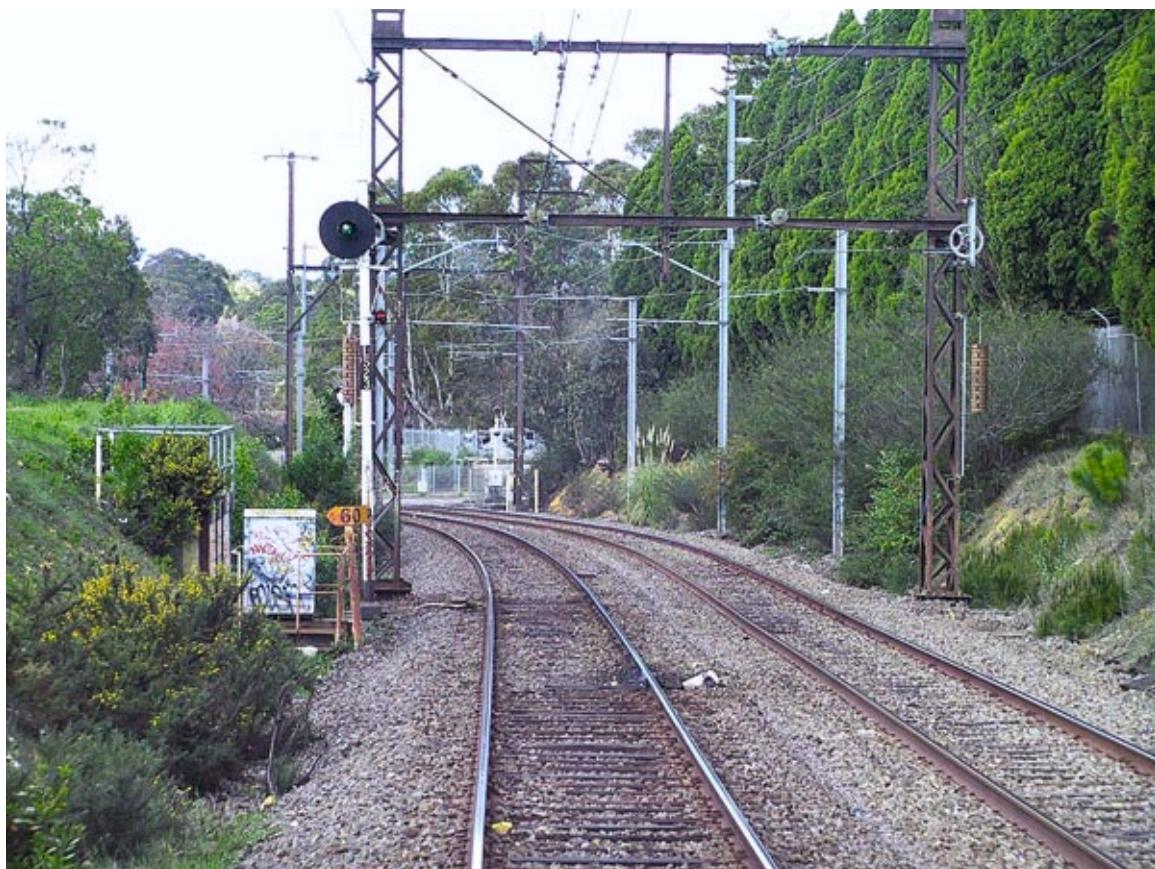
(Above) Looking in the Down direction between Box Hill and Blackburn past Automatic L505 with the top of the grade just beyond the signal. The grade leading to this summit was 1 in 40, that beyond was initially 1 in 45, easing to 1 in 96 for a short distance before steepening to 1 in 40. Up automatic L506 is on the right. The whistle post for Middleborough Road is immediately in front of the signal. (Below) Down Automatic L523 was located on a 1 in 40 falling grade at the start of a 20 chain righthand curve. The Middleborough Road level crossing can just be seen around the curve. The sighting of trains at Middleborough Road was very bad. Both photos Rod Williams.

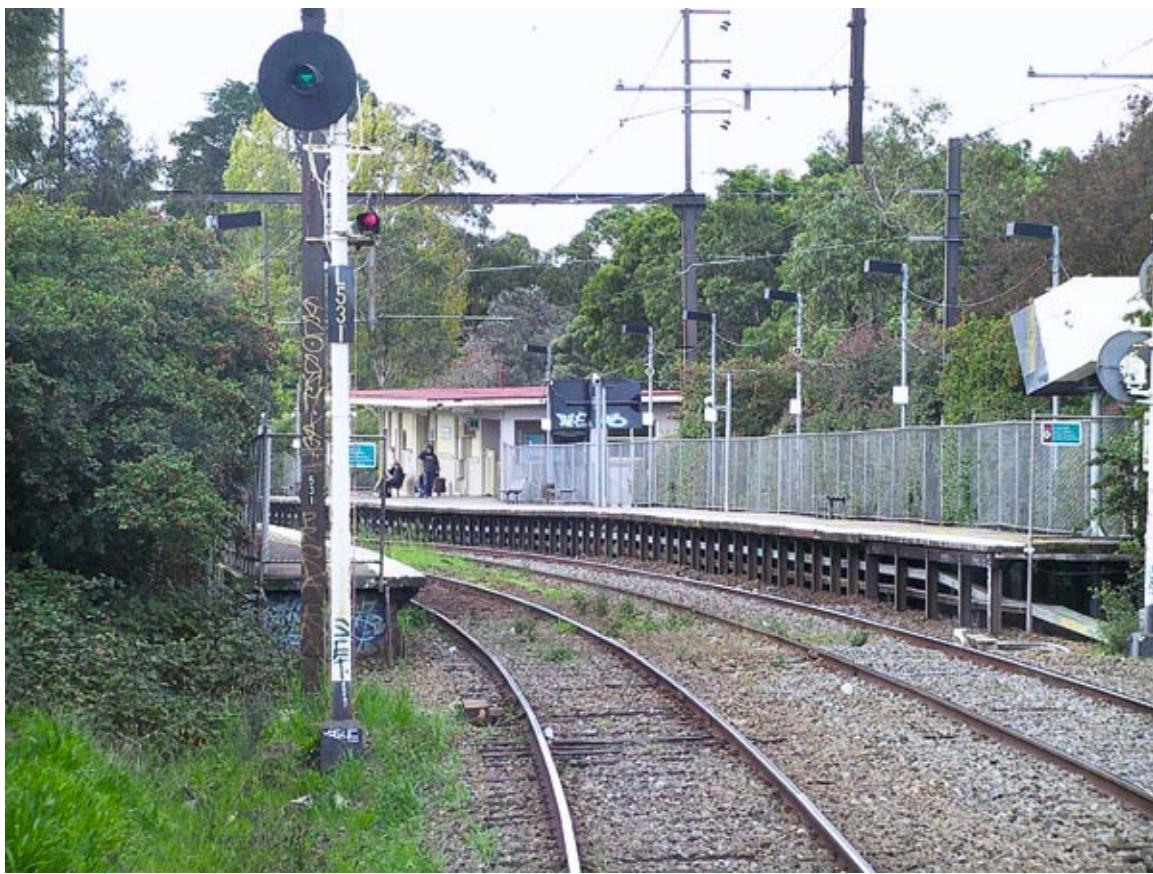
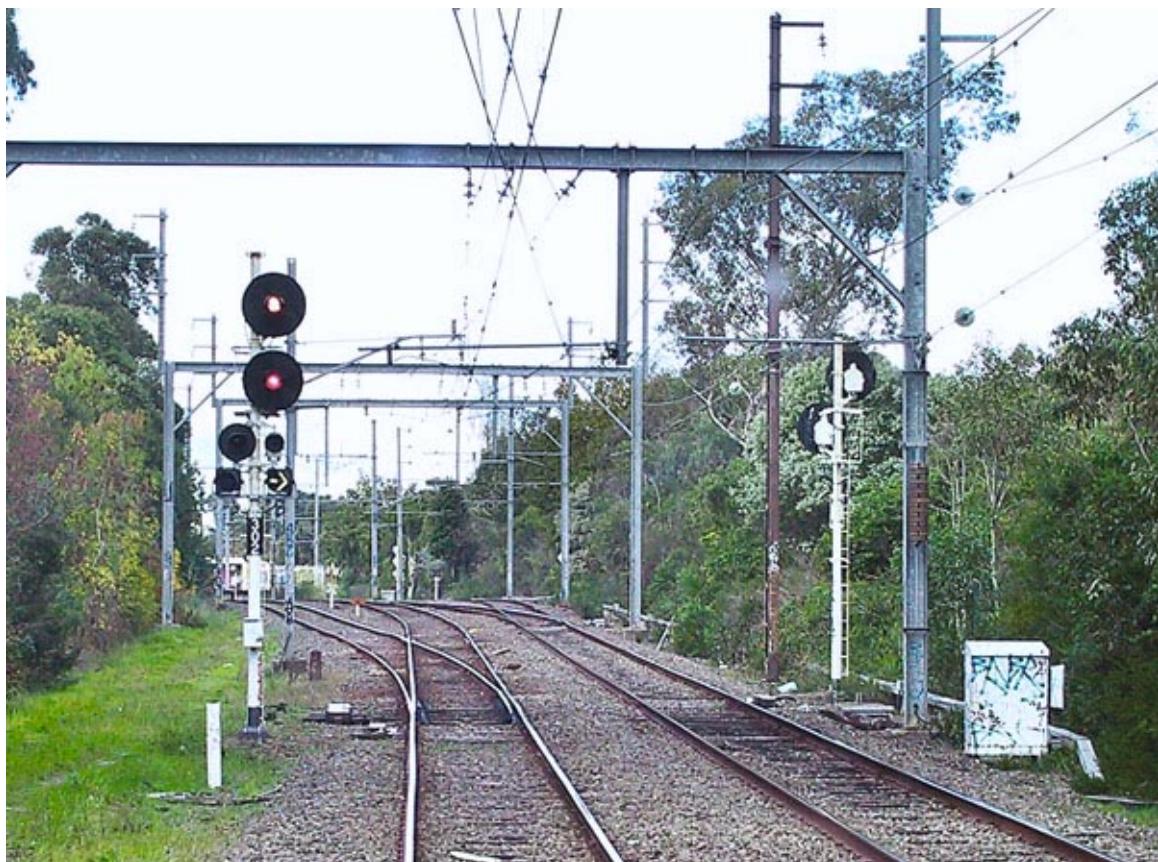
(Above) The old Laburnum station was located on a 1 in 40 grade and a reverse curve. The first half of the platform was located on a 20 chain left hand curve, then followed a short straight, before a 20 chain right hand curve commenced. Down Automatic L531 was located at the start of the platforms. (Below) The Up end of Blackburn. The route is set for the train to arrive into No 2 Platform, as can be seen from the illuminated arrow below homes. On the right is Up Automatic 203. Both photos Rod Williams.

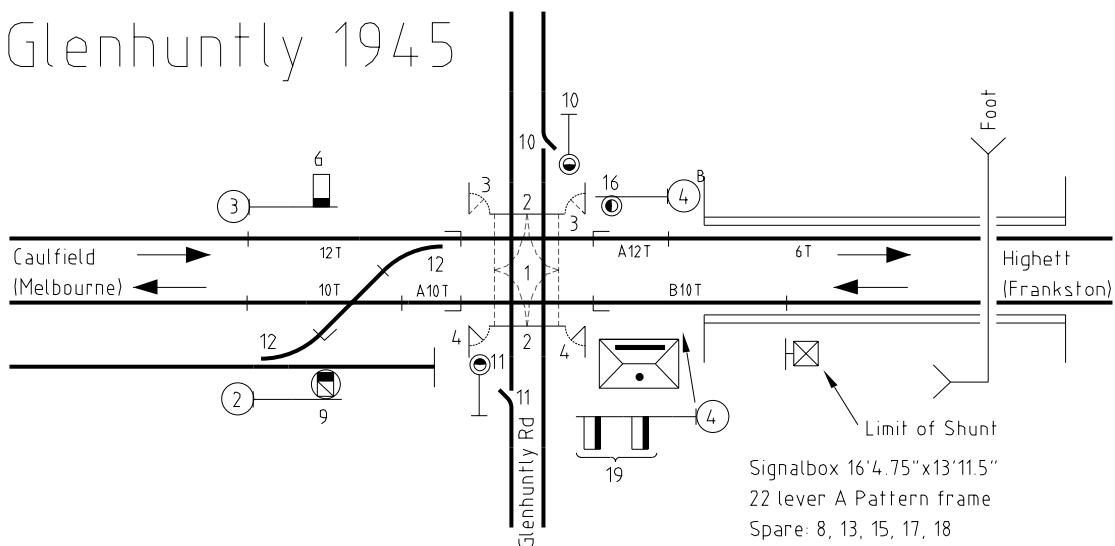
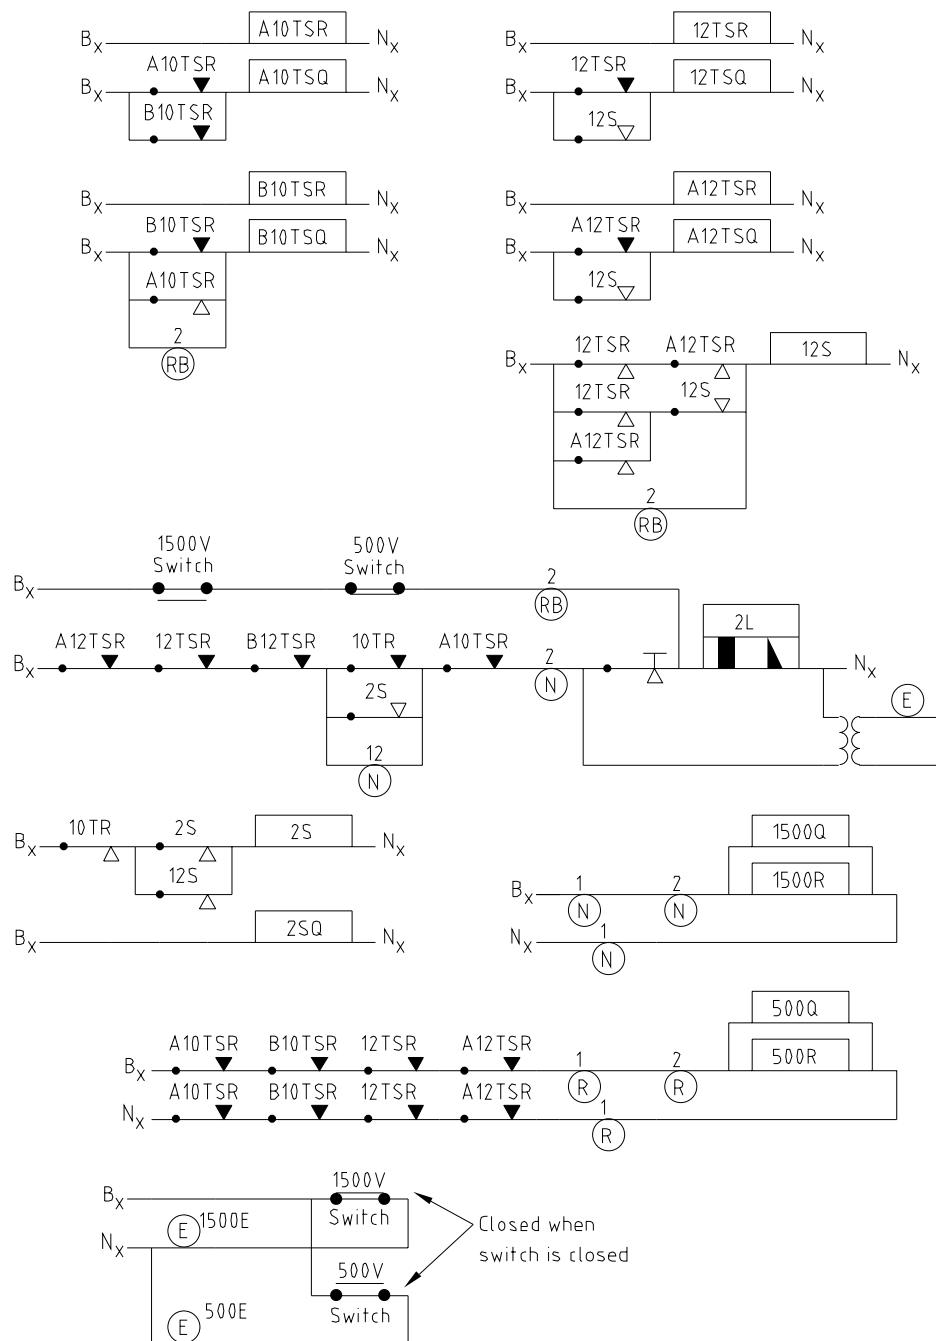
Glenhuntly 1945

Colin Rutledge has very kindly forwarded a portion of RB174 which details the circuits at Glenhuntly as at 19 December 1945. This answers the questions about the purpose of the limit of shunt board on the Up line in the rear of Post 4. I visited Glenhuntly just before it was resignalled and took a photograph of the board, hanging underneath the verandah of the Up platform. However, it was only when I commenced to write up the signalling history of Glenhuntly that it occurred to me to wonder why it was provided. The board prevents shunting trains, travelling in the right direction on the Up line, from approaching Post 4 at the Up end of the platform. It was speculated that it had to do with the tramway crossing.

Relay B10TSR would drop when a train occupies track circuit B10T and short circuited the line coil B10TSR. This cut power to the local coil B10TSQ as the front contact B10TSR opened. The relay will now stay down even if the train moved off track circuit B10T. The relay will remain down until the train occupied track circuit A10T on the departure side of the level crossing. This caused A10TSR to drop which fed power to B10TSQ over the back contact of A10TSR. With B10TSQ energised, the relay would pick up again as soon as track circuit B10T was unoccupied.

The RB lever contact on gate stop lever 2 in the circuit for B10TSQ is provided to ensure that a momentary dropping of B10T track will not lock up the level crossing. The contact cut out the stick feature unless it was actually needed for a train movement. When the gatestop lever was reverse, or on the back stop (or anywhere between), current was continuously fed to B10TSQ irrespective of whether track B10T was occupied or not. This cut out the stick function. If B10TSR dropped in this situation it would consequently pick up im-

mediately the track circuit cleared. No similar contact is required on A10TSQ as A10TSR will pick up immediately whenever B10TSR is up.

The equivalent circuits for the Down line are similar, but required an extra relay, 12 S (Stick), because there were signalled moves over the level crossing in both directions and the circuits consequently had to be symmetrical.

The contact for 10TR was included in the circuit to prevent the signalman from reversing gatestop lever 2 when a train was travelling from the siding, past Dwarf 9, to the Down line. The contact was cut out of the circuit whenever 2S was up or crossover 12 was normal. These conditions would hold when 10T was occupied by an Up movement, either along the Up line, or a shunt move from the Down line to the siding. When crossover 12 was normal, 10T track must have been occupied by a movement along the Up line, and hence could be ignored in the control of 2L. Relay 2S was normally down. It was energised when 12S was up (i.e. a move across the level crossing on the Down line was in progress) and 10T was occupied. It would then stick up after the movement cleared the level crossing, cutting out the 10TR contact in the 2L circuit until 10T was cleared. Note that 2S would also pick up for moves from the siding to the Down line, but would not do so until 12S had picked up. This would not occur until both 12T and A12T had been occupied, in which case 2L could not be energised.
