SOMERSAULT

NOVEMBER 2013

SIGNALLING RECORD SOCIETY OF VICTORIA INC

BLOODSTOCK AND LIVESTOCK THE FLEMINGTON RACECOURSE LINE, PART 2

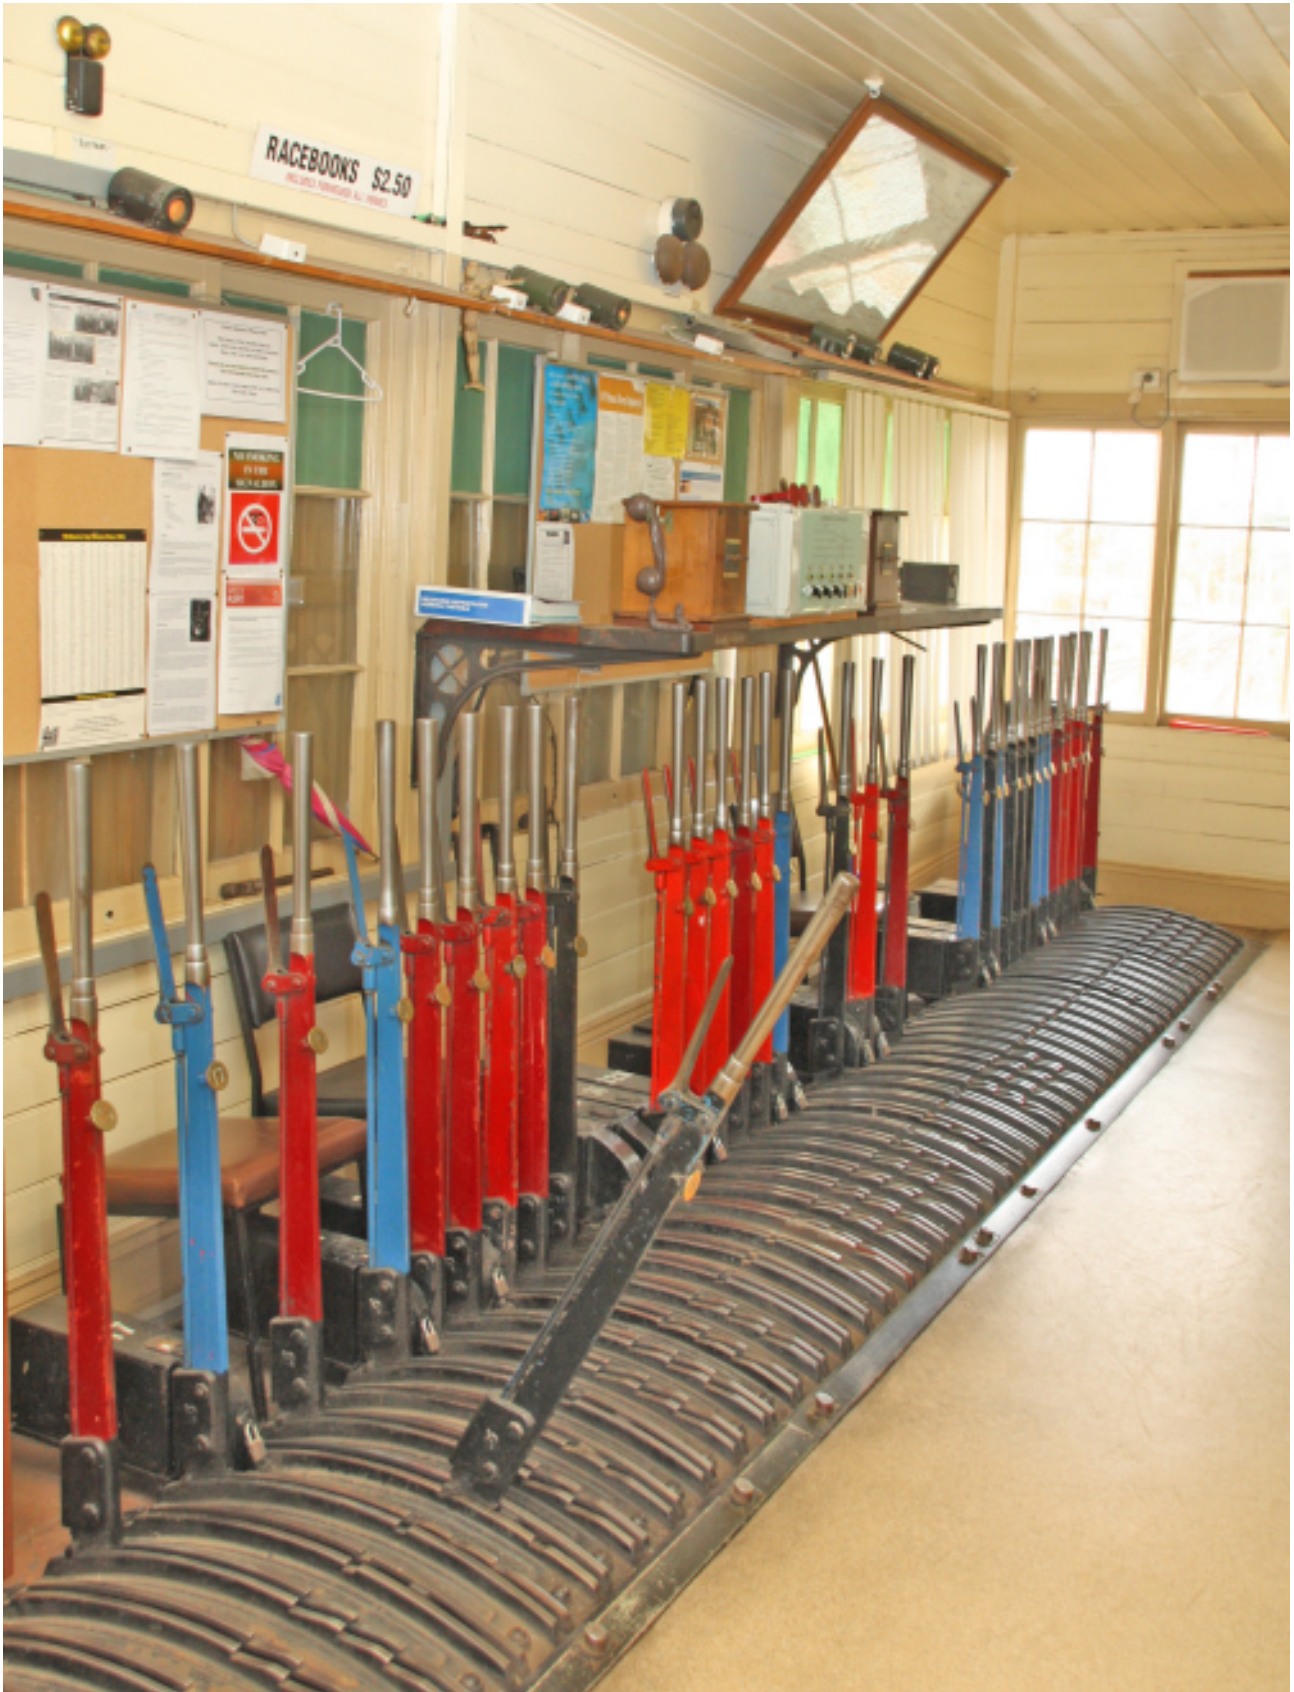
(Front cover) Flemington Racecourse signal box was opened on 31 October 1885 - just prior to the Spring Racing Carnival - as part of an expansion of facilities for race traffic. One hundred and twenty eight years later it is the oldest operational signal box in Victoria (and, indeed, Australia). However, it has probably worked its last Melbourne Cup as the new computerised signalling should be commissioned in 2014. In view of the impending resignalling, the society visited all the boxes on the Flemington Racecourse line during our 2013 Showday tour. Flemington Showgrounds box contains a 61 lever McKenzie and Holland Rocker frame - probably the original frame extended by 2 levers in 1888. The yard layout remained largely unchanged for 100 years, however it was simplified in 1985 to allow for wider track centres. A significant number of levers, particularly at the left hand end of the frame, were removed at this time. A small panel can be seen on the block shelf. This was provided in 2006 to work motorised derails. Curiously, Flemington Racecourse box is busier now than it has ever been before. Over the past decade Flemington Racecourse yard has been used to stable EMUs, requiring the box to be staffed every weekday. (Photo Andrew Waugh)

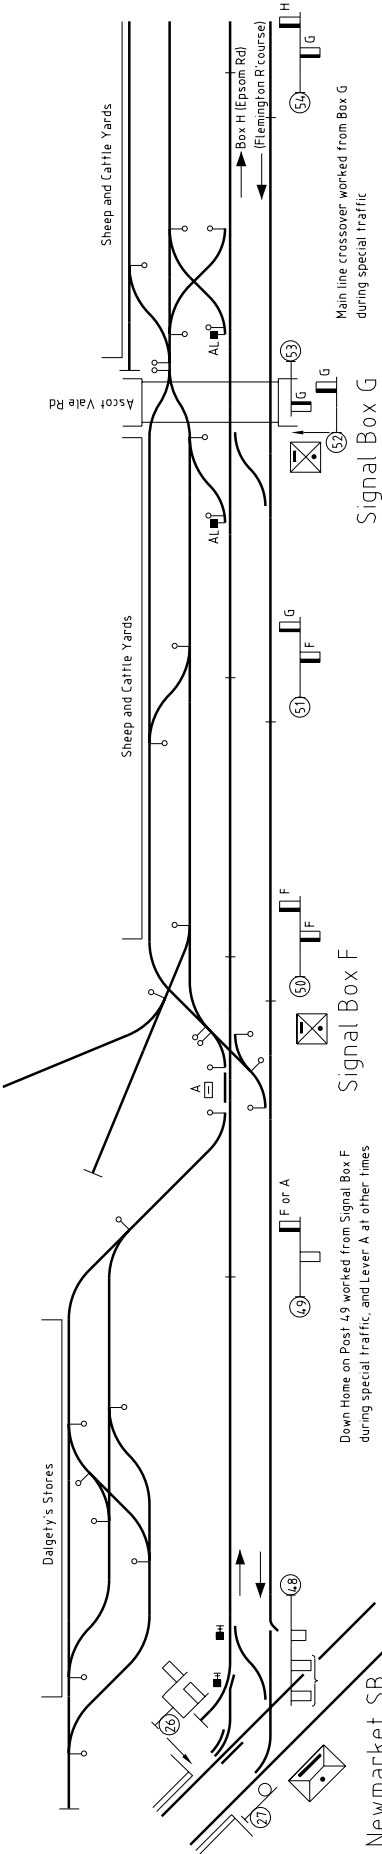
Newmarket Area 1912

Based on Diagram 46/12

By the issue of Diagram 35/15 the straight masts between Newmarket and Showgrounds, each carrying an Up and a Down Home signal, had been replaced by bracket posts. This, of course, brought the Down Homes closer to the Down track. It is not known when this alteration occurred, although it was after 1912, but it is possible that the altera-

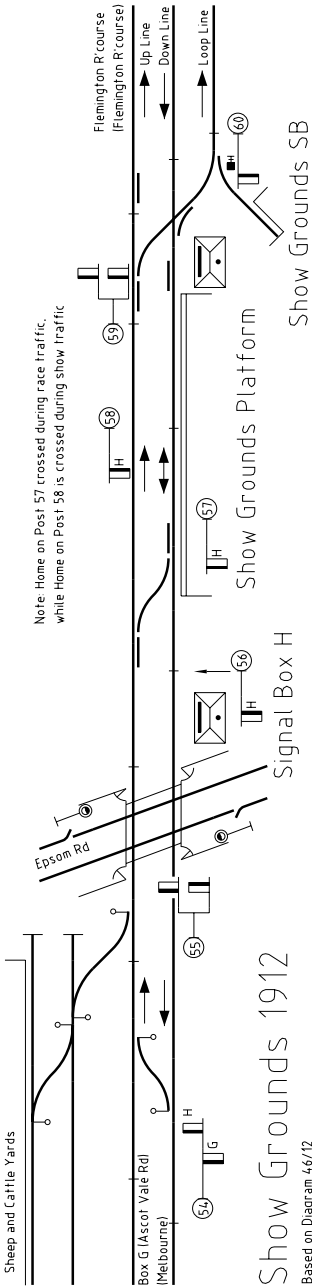
Show Grounds 1912

Based on Diagram 46/12

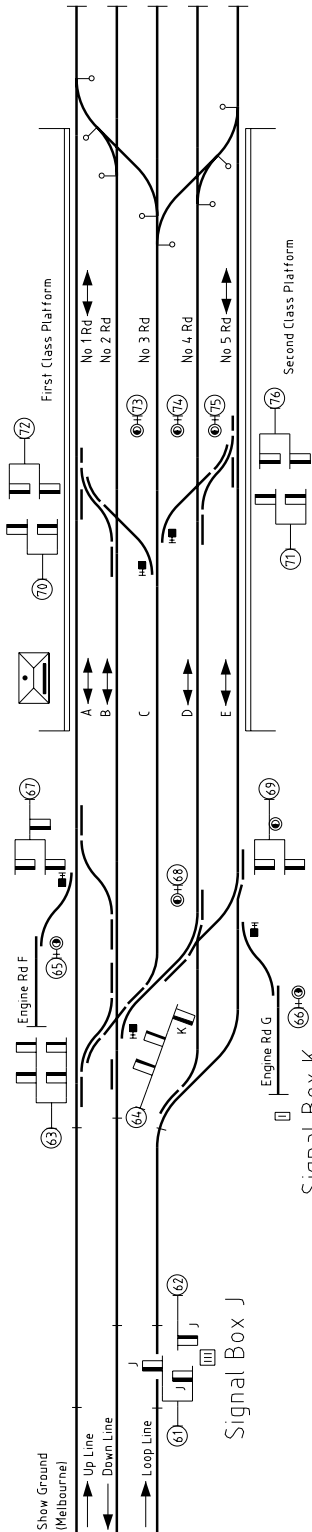
Flemington Racecourse 1912

Based on Diagram 46/12

On 1 November 1915, Ground Disc 69A (lever 14) was provided to control moves from 'C' to Nos 1 or 5 Roads. The interlocking register suggests a number of other alterations were made at this time to the frame. An additional control lever was provided - probably No 61 control with Showgrounds Junction. Two point levers were removed, and one lockbar lever added. There were now no spaces in the frame.

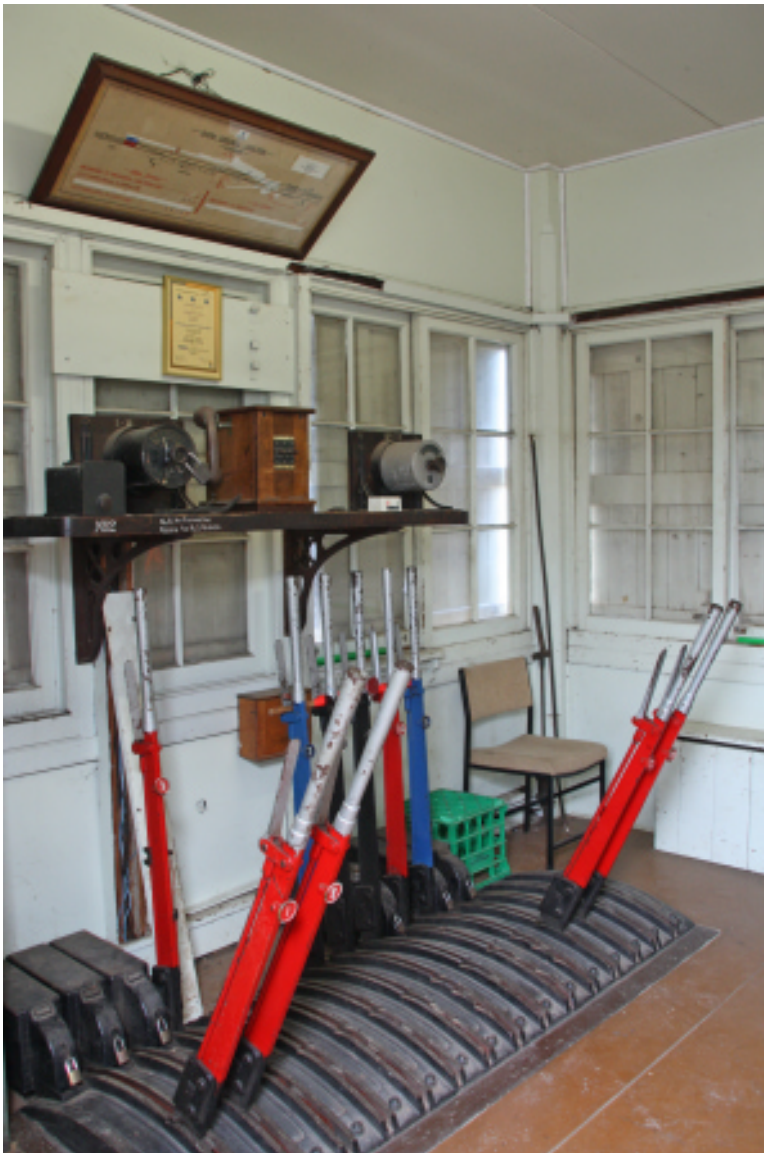
Show Grounds Junction signal box (right) contains a 15 lever A pattern cam and tappet frame. It was installed on 5 July 1919 in conjunction with the provision of power signalling on the Flemington Racecourse line. Above the frame is a short block shelf with two time releases (for Up and Down signals) and a telephone concentrator. Like all the boxes on this line, the 'block' shelf has never hosted block instruments. Safeworking on this line was originally by means of flagmen that showed a green hand signal if the line was clear to the next flagman. In 1899 the hand signals were largely replaced by fixed signals, but otherwise the working remained the same. In 1910 the line was track locked, and each home signal was controlled by a track circuit to prove the line was clear. The mechanical signalling was replaced on 5 July 1919 by two position automatic signalling (using light signal heads). Show Grounds Junction spends most of its time unstaffed. Interestingly, no closing switch or lever is provided. Instead the running signals will work automatically so long as the controlling lever is left reverse. This is a very unusual provision in Victoria, normally home signals are 'stick' signals - that is when passed by a train they return to stop and stay at stop until the controlling signal lever is restored to normal and reversed again.

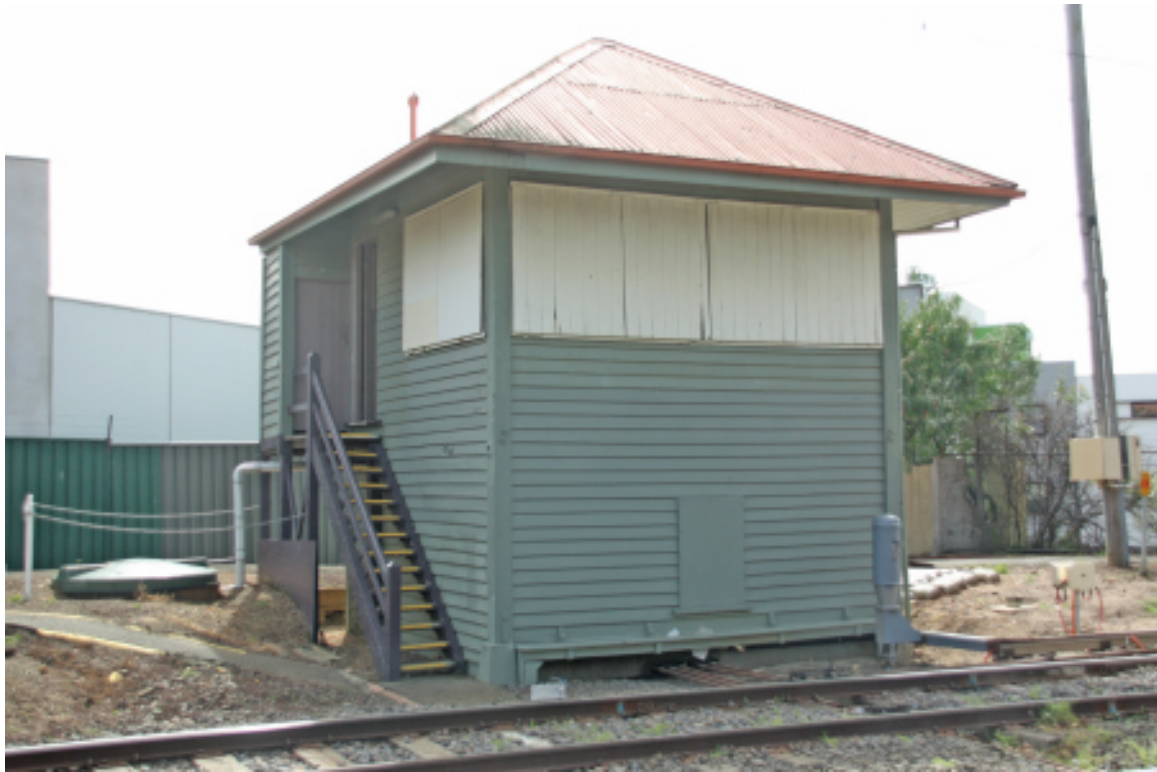
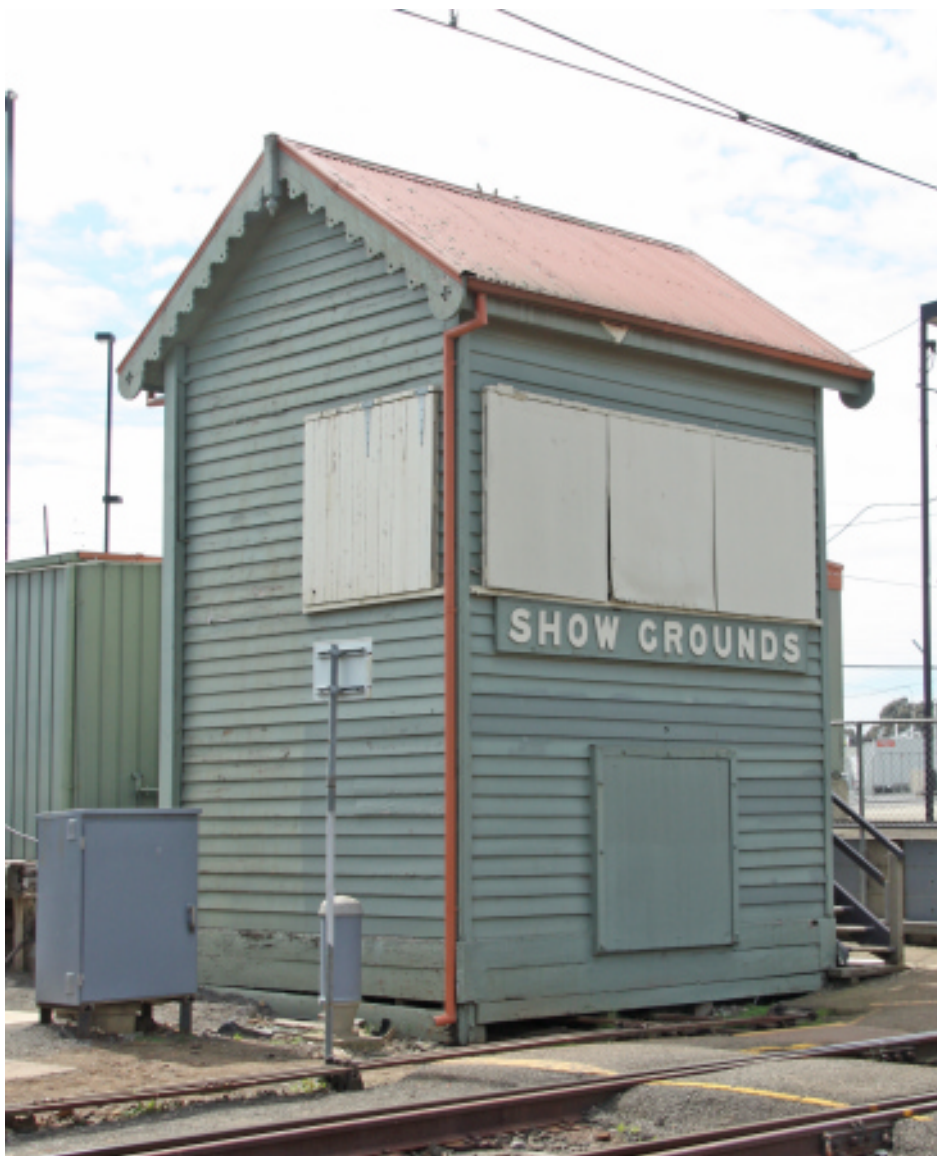
Showgrounds is worked from two signal boxes. The box at the Melbourne end of the platform is Epsom Road, and that at the Flemington Racecourse end is 'Show Grounds Junction'. (These are the current names on the box diagrams.) Show Grounds Junction box (left) is the older, and dates from 2 November 1888. It is possible that the box is second hand from elsewhere, as this style of box (with the scalloped bargeboards) had ceased being constructed around 1886. Epsom Road (above) was provided on 5 June 1925, at the same time as the adjacent level crossing was being replaced by an underpass. Epsom Road is a far more suitable design for the Australian climate than Show Grounds Junction - the deep eaves on four sides provide shade for the box and make it much cooler. Note the provision of an inground water tank fed from the down pipes - a reversion to a very old idea as in ground tanks was common on the VR in the 1880s. The large shutters on the windows of both boxes were provided - a long time ago - to reduce vandalism as the boxes have spent most of their life unstaffed.

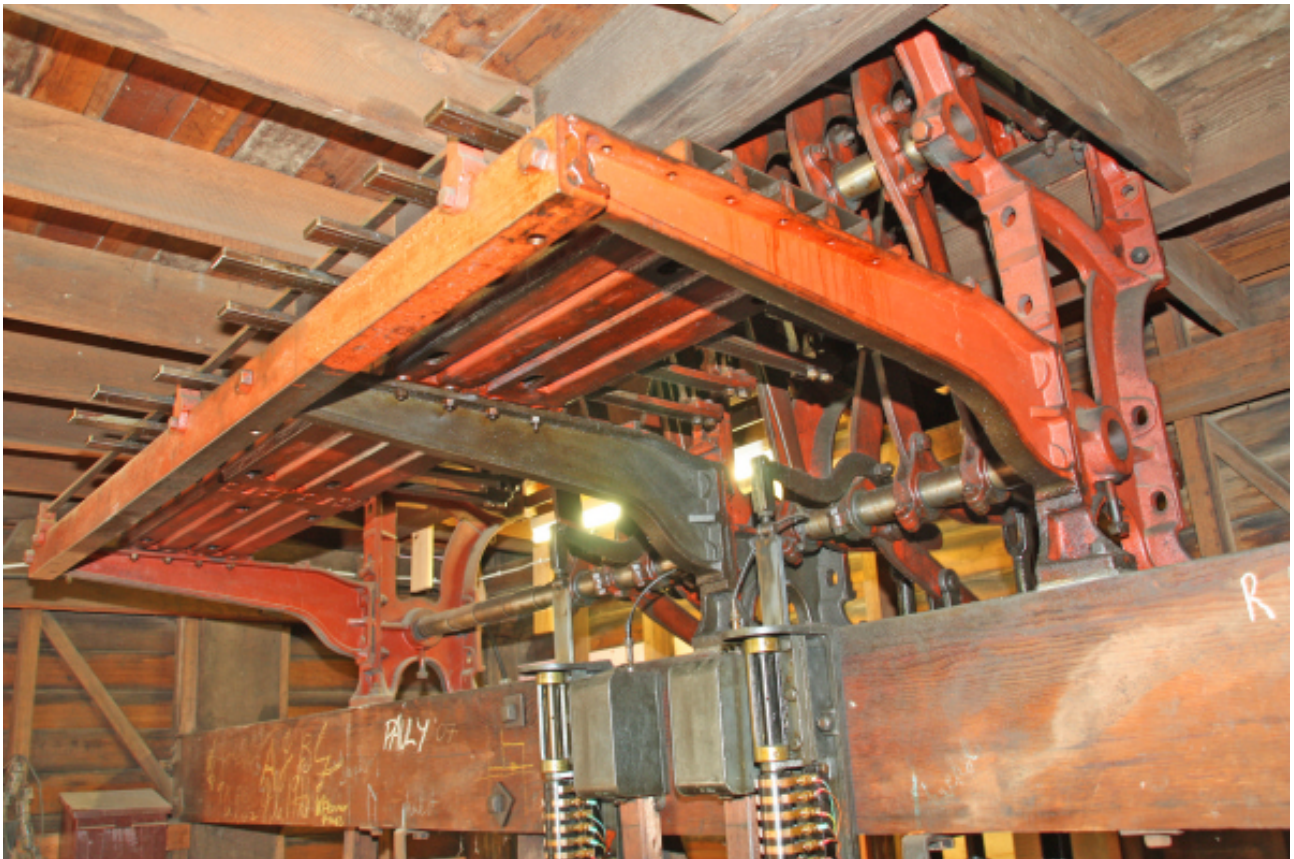
Epsom Road box (above) contains a 15 lever Type A Cam and Tappet frame dating from June 1925 when the underline bridge was provided. Interestingly, levers 1 to 5 have never been used and were originally intended to work the tramway crossing and wickets at Epsom Road. Mounted on the back of the machine timbers are two D2 circuit controllers (with the covers off) and two J3 latch contact boxes. By way of contrast, Flemington Racecourse (below) contains a 61 lever frame McKenzie and Holland No 6 Pattern Rocker frame dating from 1888. The much greater metal content in a Rocker frame is very apparent!
