SOMERSAULT

SEPTEMBER 2016

SIGNALLING RECORD SOCIETY OF VICTORIA

VR WOODEN SEMAPHORE MASTS

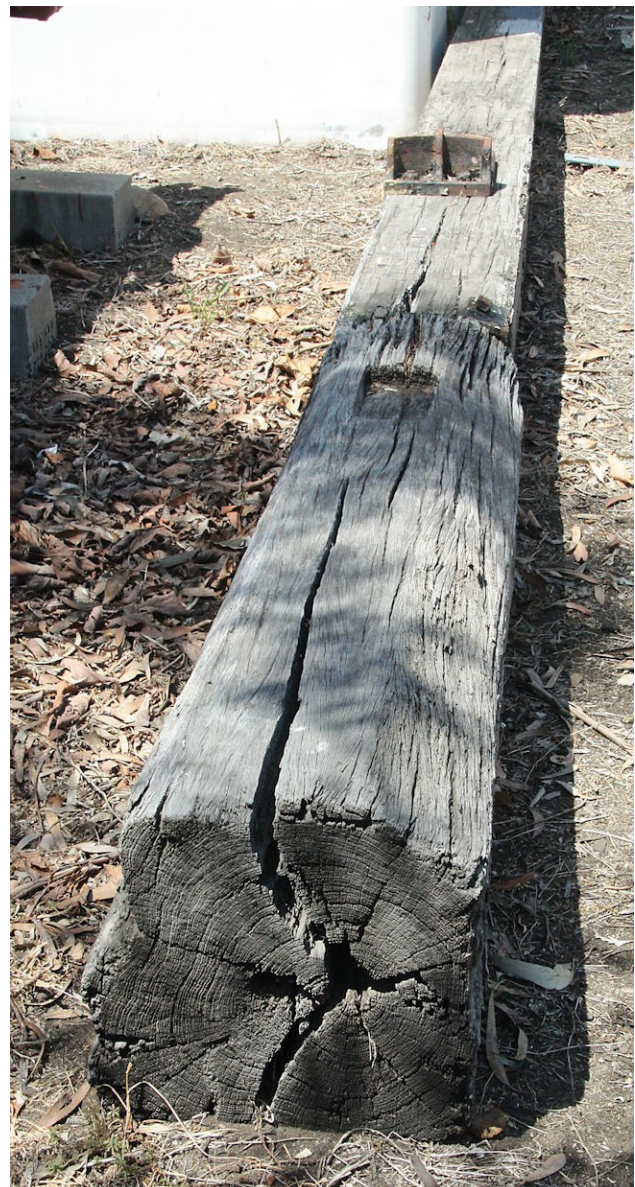
(Below) Looking up the ARHS mast from the base of the butt. The change from the roughly squared butt to the squared mast is clearly visible. Also visible are the housings cut into the butt to take the underground braces. The metal casting is the remains of the lever plate.

The butt has evidence of below ground bracing. Each of the visible sides has a housing for a brace. Each housing is 10" long by 5" wide and is roughly 1¼" deep at the top. The bottom of the housing is 47" (3'11") from the bottom of the butt. The braces would have rested on a foundation, probably two timber sills under the base of the mast.

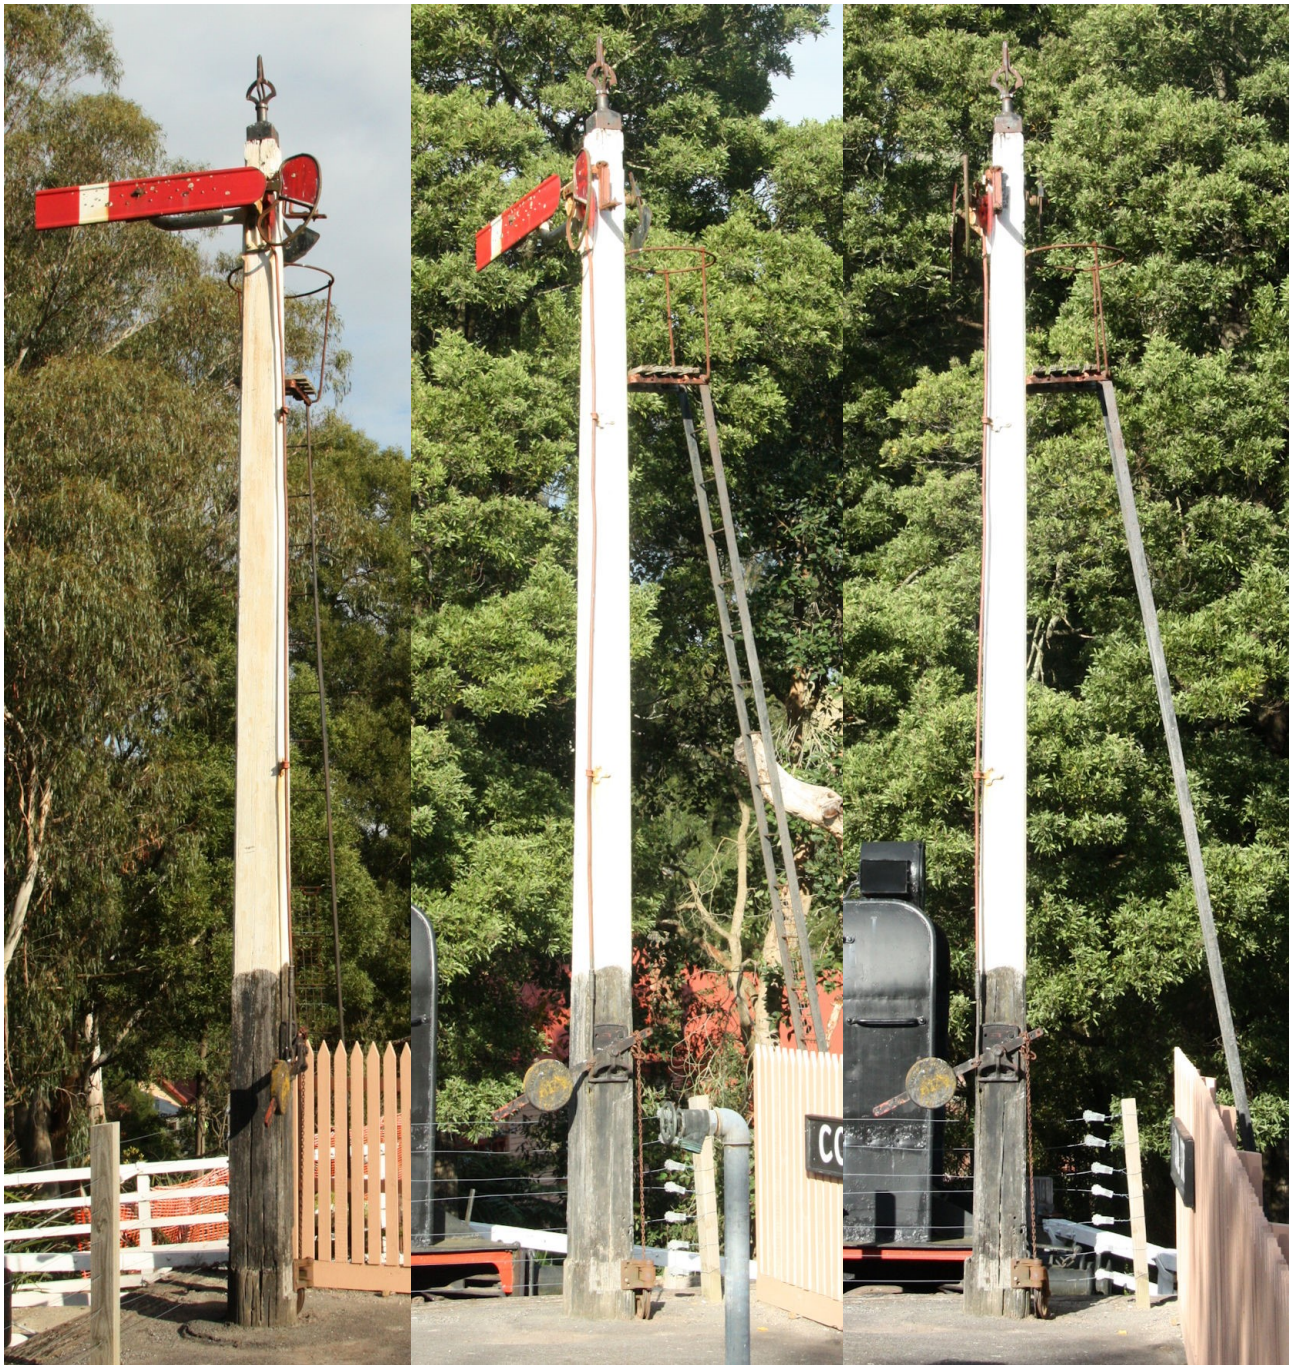
Three views of the wooden semaphore mast at Coal Creek, Korumburra. The durability of the Victorian hardwoods can be judged by the fact that this mast would be over 100 years old.

Starting from ground level, the first point to note is that the butt of the mast protrudes about 10" above ground level – although this might be further than originally intended due to a relocation of the swivel wheel.

The lever plate is mounted with its edge adjacent to the front of the mast. This allows a straight drive of the down rod, as can be seen in the rightmost photo. One or more down rod guides are fitted to ensure that the rod doesn't buckle when the signal is cleared. This mast has two rod guides, while the mast at the ARHS museum has only one.

The bottom portion of the mast, to five feet from the top of the base, is painted black with the remainder painted white. As seen here, it was common for the top of the black portion to be curved.

The ARHS mast had lost all of its paint, but it is interesting that the Coal Creek mast conformed to these instructions. The division between the black and white portions of the mast was rounded off, but the lowest portion of the division was five feet above the base.

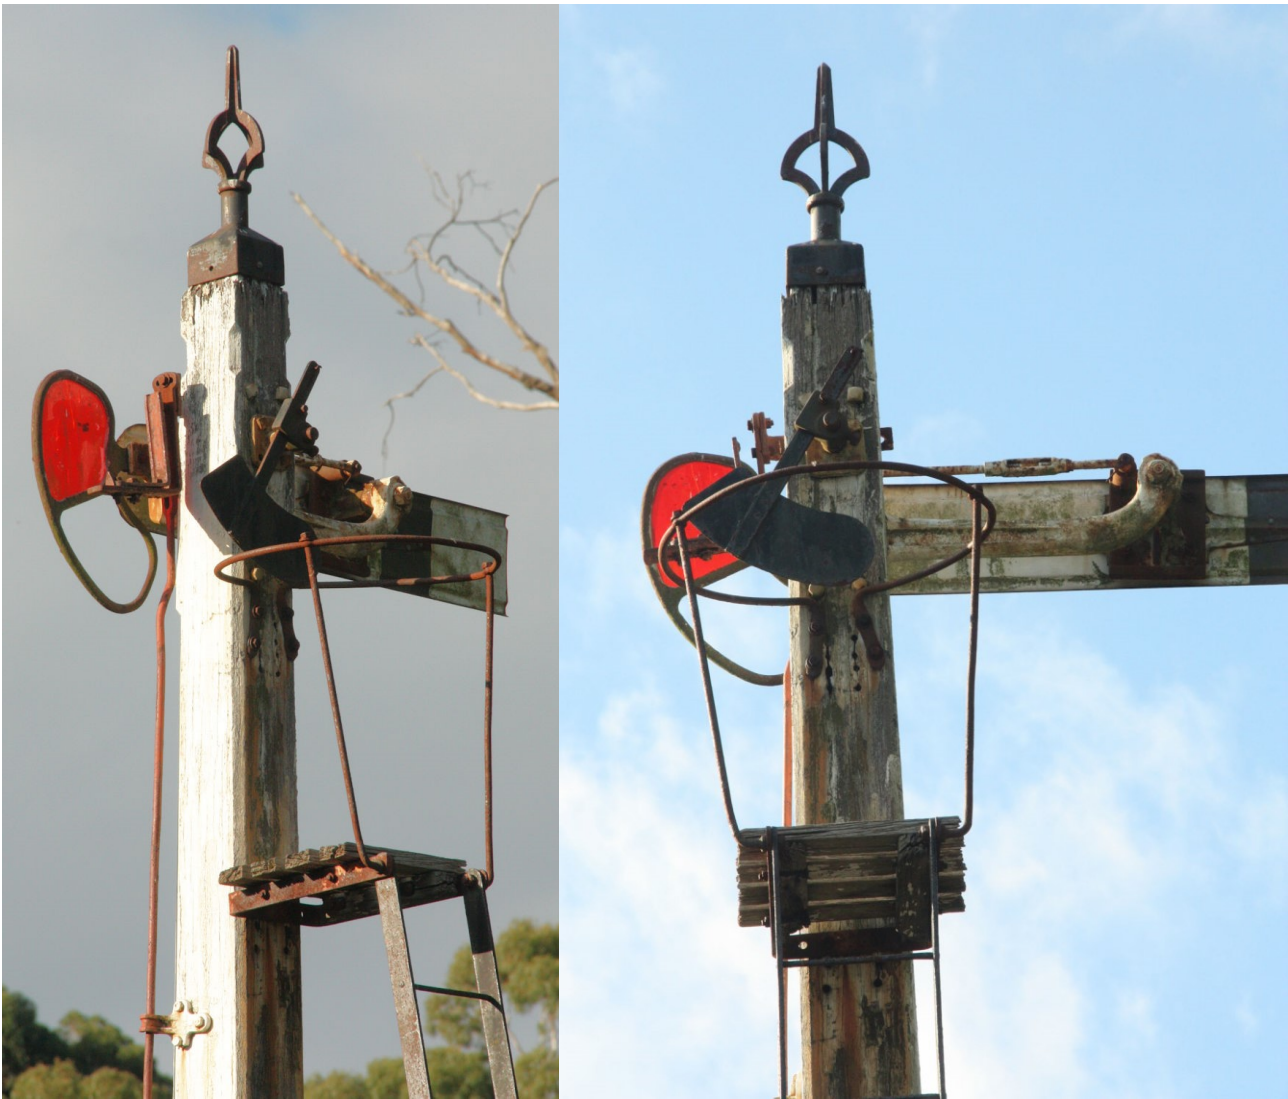
Two views of the top of the mast at Coal Creek.

The finial is the type more usually used on lattice masts (2B615). This type of finial was not uncommon on wooden masts, possibly this type of finial was used on those wooden masts provided towards the end of the use of wooden masts. Notice how the base of the finial is slightly smaller than the top of the wooden mast.

The finial served an important function on a wooden post as it prevented water getting into the end of the post and causing it to rot. The fancy design of finials simply reflected the design aesthetics of the period; the roofs of buildings, telegraph poles, and even fence posts were all finished off with a finial.

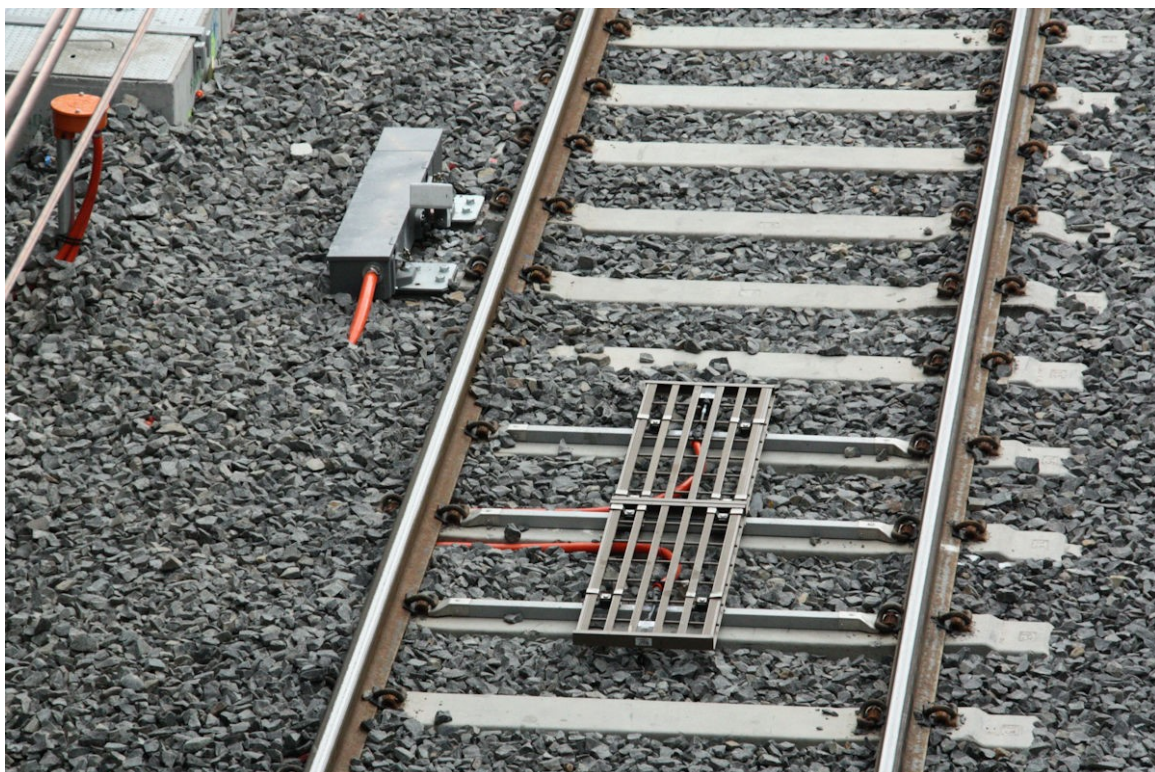
(Below) One of the interesting features of the new grade separation between Ormond and Bentleigh is that all of the new signals are fitted with both train stops and TPWS(TSS), as shown here at Up Automatic FM466 at McKinnon. The complete provision of TPWS(TSS), including at Automatic signals, is understood to be the new standard wherever both V/Line and MTM rolling stock runs. A train stop TPWS installation consists of two loops mounted next to each other. When the adjacent signal is at stop, both loops are energised. A TPWS equipped train passing over the first loop detects it and starts a counter running. The brakes are applied if the train detects the second loop before the counter runs out. Since the two loops are located next to each other in a TPWS(TSS) location, the second loop will always be detected before the counter runs out and the brakes applied.
