SIGNALLING RECORD SOCIETY (VICTORIA)

SIGNALLING ALTERATIONS

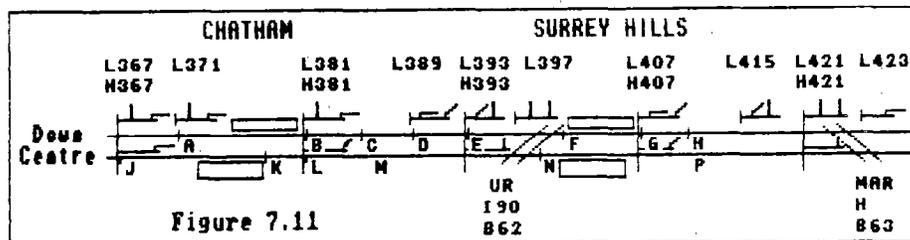
SOMERSAULT vol 5 no 4, July 1982) but the intermediate Automatics, although normally at Stop, are shown in Figure 7.11 displaying the aspects which apply after a Down train has left Camberwell and is ready to pass signal H367 on the extreme left.

Down trains are timed through Canterbury to set the controls for Union Road (UR) for an express or a stopper. In Figure 7.11, an express on the Down line on passing point A causes signal L397 to clear to G/R, and L393 and L389 follow suit. The booms at UR start when the express passes C. A stopper causes L397 to clear when it passes B, and the booms start when it passes D. On the faster Centre line an express causes H393 to clear when it passes J, and the booms at UR start when it passes L. A stopper causes H393 to clear when it passes K, and the booms start when it passes M. There are no insulated joints at this point which is determined by timing; it occurs about 10 to 12 seconds after a suburban electric passes L.

Considering now the booms at Mont Albert Road (MAR), an express on the Down line causes L421 to clear when it passes E, and the booms start when it passes G. A stopper causes the signal to clear 40 seconds after it passes F, and the booms start when it passes H. On the Centre line an express causes H421 to clear when it passes M and the booms start when it passes N or a few seconds later. A stopper causes the signal to clear 40 seconds after it passes N, and the signal clears when it passes P; this also is without insulated joints.

The stopping approach tracks on both lines for both crossings (starting from D, H, M, and P) seem to be made as short as safely practicable. The 40 seconds delay at Surrey Hills might be imposed for two reasons, to ensure that the train really was a stopper - if it beat the timing then L421 would remain at Stop until the train had passed H and the booms had come down - and as a method of shortening the stopping outer approach track. Section FH would be much longer than 35 seconds having in mind the station stop, and GH would be too short; the delay enabled the starting point to be effectively between F and G.

The controls for the new booms at Centre Road beyond Clayton were somewhat similar to those for Mont Albert Road on the Centre line (Figure 7.11), with signals D607, D625, and D645, corresponding respectively to H393, H407, and H421. Trains were timed through Huntingdale and D645 cleared when an express passed D607. For a stopper it cleared about 35 seconds after the platform was entered, i.e. about when the train was ready to depart.

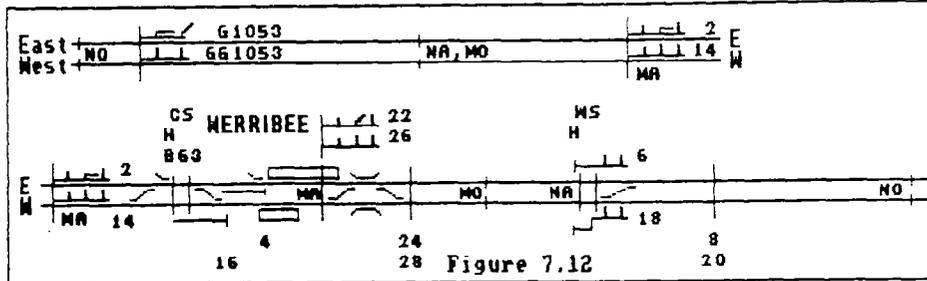
In 1973 (28 Oct) the existing booms at Cherry Street (CS), Werribee (Figure 7.12), were converted from manual to automatic control in conjunction with completion of three-position signalling through the station; the two-way East and West lines on each side were already worked under the Automatic and Track Control system. The points were also now converted to power operation and the mechanical interlocking frame replaced by a Control Panel.

A new idea was adopted here for speed control of the booms approaches. Whether the train was to stop or not, if the signal protecting the booms showed a Normal Speed aspect then an approach calculated for 112 km/h applied, but if it showed Medium Speed then an approach for 40 km/h applied. The diagram is to be read from the top left, signals 2 and 14 being repeated on the bottom left. The beginnings of the Normal Speed and Medium Speed outers and approaches for both directions are marked on the diagram as NO, NA, MO and MA. Only the posts or bridges carrying the Up signals are shown, but the numbers are given along the bottom of the diagram. For movements through the high speed crossover at the Down end near the Werribee Street (WS) hand gates signals 26 and 18, or 8 and the preceding Auto G1178, showed an illuminated '40' with the Y/G and R/G or R/Y aspects; this meant that the crossover could be taken at 64 km/h (40 mph).

In Figure 7.12 it is assumed that levers 2, 22, and 6, which work signals on the East line, are operated but that the Gatekeeper's control at WS is applied to 6. A Down train thus passes signal G901 (off the diagram to the left) at G/R, and then as shown passes G1033 at Y/G, 2 at R/G, and 22 at R/Y unless by this time the gates have been opened and the control released. An explanation with comments follows on this unusual "aspect sequence" for a straight route G/R-Y/G-R/G-R/Y-R/R, but it is a diversion from the topic of Boom Barriers. The same sequence is thought to apply when Up signal 1/16 at Deer Park is at Stop.

The distance from signal 2 to 22 is 2145 ft (647 m) and from 22 to 6 is 1921 ft (572 m), so that the total from 2 to 6 is greater than that from G1033 to 2. A deficiency with the existing system was that where a train needed two signal sections to stop, there was no way that it could pass the intermediate signal for a straight-ahead route at a speed greater than 40 km/h. Braking distance is proportional to the square of the speed V , and it is easy to prove that if the intermediate signal is at the half-way point then it would need to be passed at a speed v equal to $V/\sqrt{2}$ which approximates to $0.7V$. Thus in the particular case of Werribee if a train passed 2 at 70 mph (112 km/h) then with uniform deceleration to stop at 6 it would pass 22 at around 50 mph (80 km/h).

An unfortunate effect of the Werribee system, which was experienced more than once by the writer, was that a Down train had to slow at G1033, unreasonably early for passengers, but also too early for the hand gates to block the road. The position was relieved in 1976 (24 Oct) when the gates at Werribee Street were replaced by automatic booms, and signal 6 could be cleared well in advance.

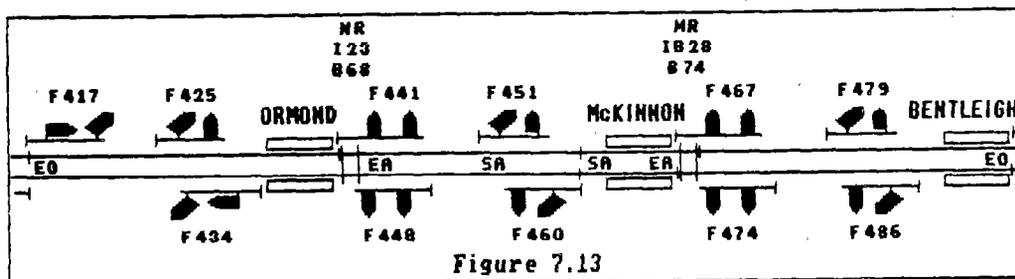
In Figure 7.13, North Road (NR), McKinnon Road (MR), and Centre Road (just outside to the right) were evidently surveyed to be at half-mile (800 m) intervals. With four three-aspect signals between Ormond and Bentleigh the spacing would be suitable for 50 mph (80 km/h) running (minimum required spacing about 1250 ft (380 m)). But the Railways did better than this and provided four-aspect signals at the same spacing showing the sequence G/R-Y/G'40'-R/Y'40'-R/R. It took a long time to realise that this signalling was suitable for 60 mph (96 km/h) running, the four aspects being necessitated by the closeness of the stations. Elsewhere on the Frankston line, three-aspect signalling can be used for 96 km/h because the minimum spacing of about 1800 ft (546 m) is achievable.

To avoid congestion in the Figure, the booms controls are shown in the Down direction only for McKinnon Road and in the Up direction only for North Road. A delay of 12 seconds occurred after a Down stopper passed SA before the booms started, and a similar delay applied at the other stations. Signal F474 changed to Y/G and F486 to G/R, about 30 seconds after an Up entered Bentleigh platform or about 10 seconds after it stopped; similar behaviour occurred at McKinnon. This would be for the same reason as the 40 second delay at Surrey Hills. The booms started about 15 seconds after the train passed F486 or F460. The SO would start when the signal changed. Class of train is selected by PB at at Glenhuntly (Down) or Cheltenham (Up), the latter using a progression system.

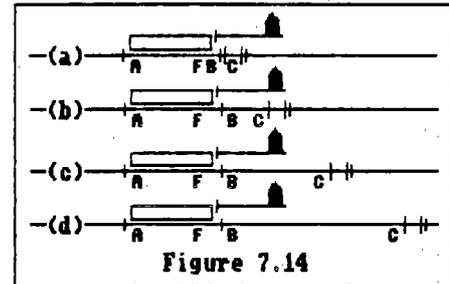
Figure 7.14

In Figure 7.14, it is assumed that a train stops with the front at F 20 seconds after passing joints A at the entrance to the platform. It stands for 12 seconds and then re-starts from F, passing joints at B 8 seconds later. The crossing C is a variable distance ahead of B. A minimum of 25 seconds warning should be given at the crossing; the actual period should not be much greater.

In (d) C is at least 25 seconds ahead of B. The booms now do not need to start until the train passes B; the signal however is still delayed to clear 5 seconds or more after the train stops, to ensure that it does stop. The distance BC corresponding to a time of 25 seconds is $1197-70=1127$ ft (344 m). At this distance there could be two signals between the platform and the crossing.

In (b) or (c) the delay of 25 seconds or more which occurs after the train passes A before the booms start, counts as part of the outer approach section, as does the delay in (d) before the signal starts.

Examples of (b), with signal numbers in brackets, have been observed for stopping trains at Seaholme (WR579), Glenroy (E516)*, Regent (T394)*, Reservoir (T445), Thomastown (T576), Mont Albert (L428), Nunawading (L640), Croydon (H971), Bayswater (309, 306), Boronia (L1053)*, Darling (18), Cheltenham (12), Windsor (B190)*, and North Port (P95); (* signal near crossing C, not B).

Examples of (c) for stopping trains have been observed at Seaholme (WR574), Ginifer (M578, not M568), Fawkner (Post 61), Croxton (T266, T271), Laburnum (L532), Blackburn (308), Ringwood East (H858), Westall (4), Noble Park (D846), and Highett (F600). The initial delay may be less than 12 seconds, e.g. on T271, but this could mean excessive delay at the crossing.

Examples of (d) with one signal have been observed for stopping trains at Batman (Post 56), Macleod (i11), Tooronga (DG248)*, Yarraman (D882)*, and Edithvale (F986), and with two signals at Northcote (T240), Thornbury (T305), Bell (107), Ruthven (T470), Nunawading (L665)*, Mitcham (L672)*, Kooyong (DG243)*, Carnegie (D397), Clayton (D645)*, Sandown Park (D793), Noble Park (D863), McKinnon (F448)*, Bentleigh (F474)*, Patterson (F498)*, Mentone (F769)*, Parkdale (F780)*, some others on the Frankston line, and Prahran (B187)*; (* signal near C).
