SIGNALLING RECORD SOCIETY (VICTORIA)

In one of the many boxes in the J.C.M. Rolland collection in the Latrobe Library is a packet of "Items of Information" issued between 1930 and 1936, about 45 pages of them and I am delighted to know that they have been preserved.

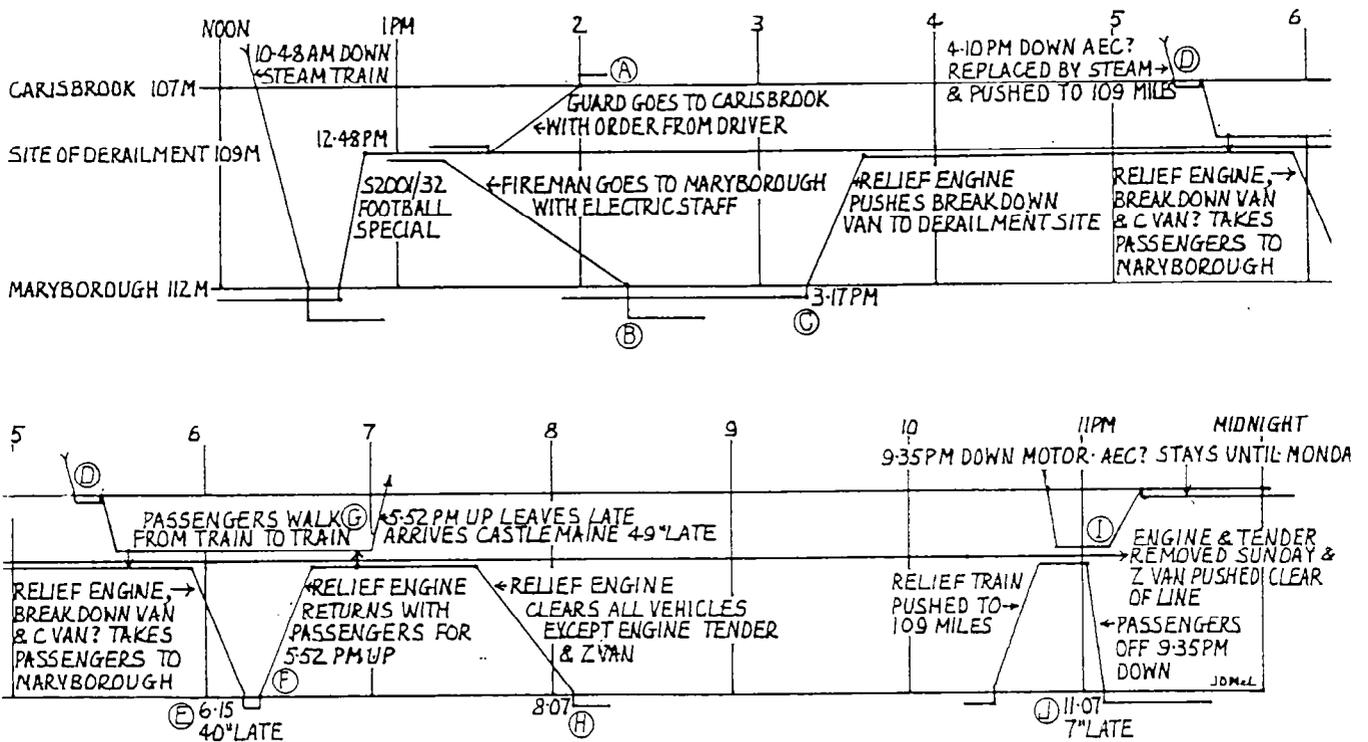
4. Graph showing probable movements of trains.

From the Item and also from newspaper paragraphs, and using working time tables I have, I have drawn a graph which is shown here, and will be referred to from time to time. I will also include extracts from the Rule, where they apply.

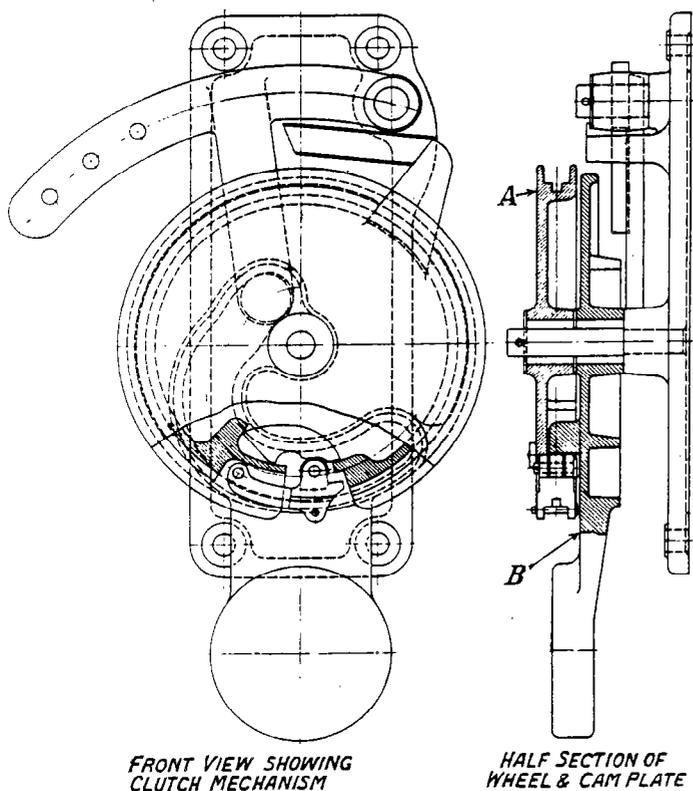
Fig. 1a

wheel *A* (Fig. 1, *a*, *b*, and *c*) and a circular cam plate *B*; these are capable of independent rotation about a common axis *C*, but can be coupled together by a releasable clutch mechanism *D* and *E*. They rotate in unison during normal operation, but are automatically uncoupled should the return wire break. The clutch arm *D*, located in the rim of the pulley *A* and pivoted at *F*, carries a roller *G* engaging under tension with a projection *E* on cam plate *B*.

The pull wire is connected to the clutch arm *D* at *H* and passes round the pulley; *A* and *B* are mounted on base plate *I*, movement being imparted to the signal

of the return wire breaking. The new mechanism was designed to overcome this by the use of a disengaging clutch mechanism illustrated in Fig. 1. The new type of point machine simplified the layout of the equipment and increased the efficiency of operation, maintenance being considerably facilitated; new improved methods of mechanical detection were also adopted, the designs being suitable for both double- and single-wire working and having distinct advantages over the hatchet and slide types now widely used. These improvements, which have been patented, were designed by Mr. F. W. Harvey, Assistant Engineer, Signal & Telegraph Division.

The signal mechanism is of the cam plate type and consists essentially of two elements, a grooved pulley

through the crank *K*, one arm of which is connected to the signal down rod, while the other engages with the cam path on *B*. The crank *K* is also mounted on the base plate. If a wire breakage causes the pulley to rotate, disengagement of the clutch arm *D* with the projection *E* occurs owing to release of tension in the wire. If the signal is at "danger," the cam plate remains normal and maintains it so, but if the signal is at "clear" the balance weight *L* returns it to danger. The clutch arm *D* is kept in training on its pivot by a limited degree of radial movement each time the signal is operated. Roller *G* is normally set out of engagement with the notch *R*, as shown at *M*; the projection *Q* on the wheel holds the cam plate projection *N* against the stop *O* on the base plate. In normal operation idle movement of the pulley occurs until roller *G* engages in notch *R*, but on the signal being returned to danger it lifts out of the notch and assumes its normal setting.

In the event of the wheel becoming uncoupled from the cam through any cause other than a broken wire, the clutch is re-engaged by operating the hand lever from reverse to normal when the roller *G* rides over the ramp *P* to assume its normal setting.

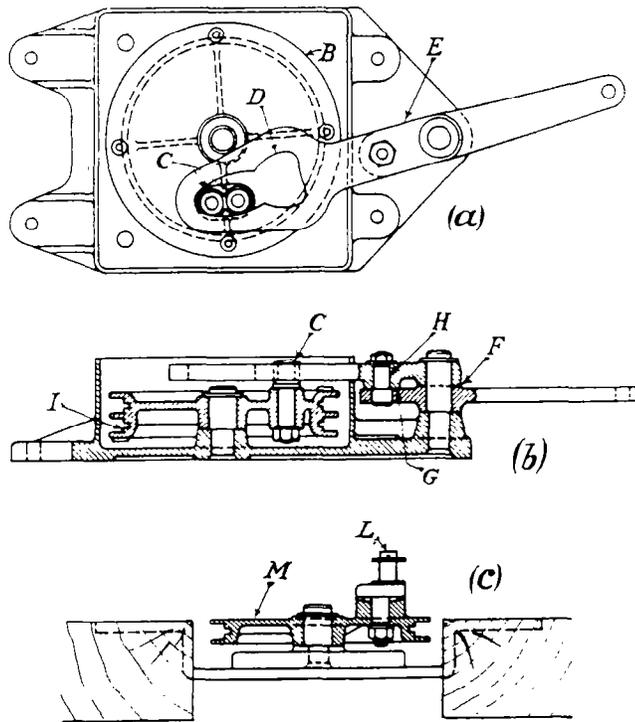
Fig. 2

Figs. 2a and b give a plan view with cover removed, and a central transverse section of the motion wheel,

shown in its central position with operating rollers engaged with the cam. The case is of cast iron, fitted with a sheet steel cover. Motion wheel B carries on its upper face a pair of concentrically-aligned rollers C, which engage with the cam slot D in one end of the crank arm E, itself divided as shown at F, its two sections being connected at G by a shear pin H to avoid damage to the mechanism should the points be run through. Inspection and maintenance are readily effected without removing the motion

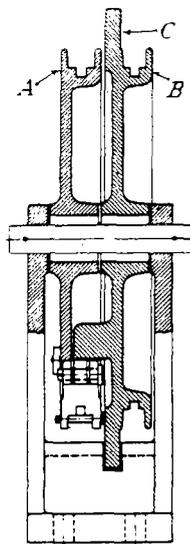
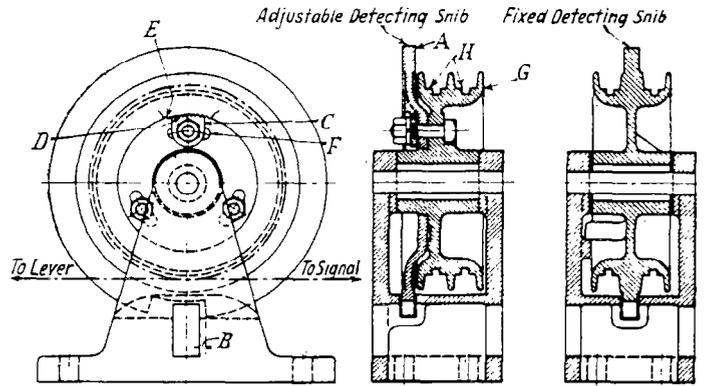
Fig. 4b

TYPE 2.

Type 2 (Fig. 4b) consists of a pulley wheel G having two grooves H, carrying a detecting snib A, capable of adjustment around the wheel for varying clearance B. The snib is held in position by plate C, which has serrations D engaging with others, E, on the snib face. Slotted holes F allow of circular movement on the wheel.
