SOMERSAULT

November 1995

Vol 18, No 6

SIGNALLING RECORD SOCIETY OF VICTORIA INC

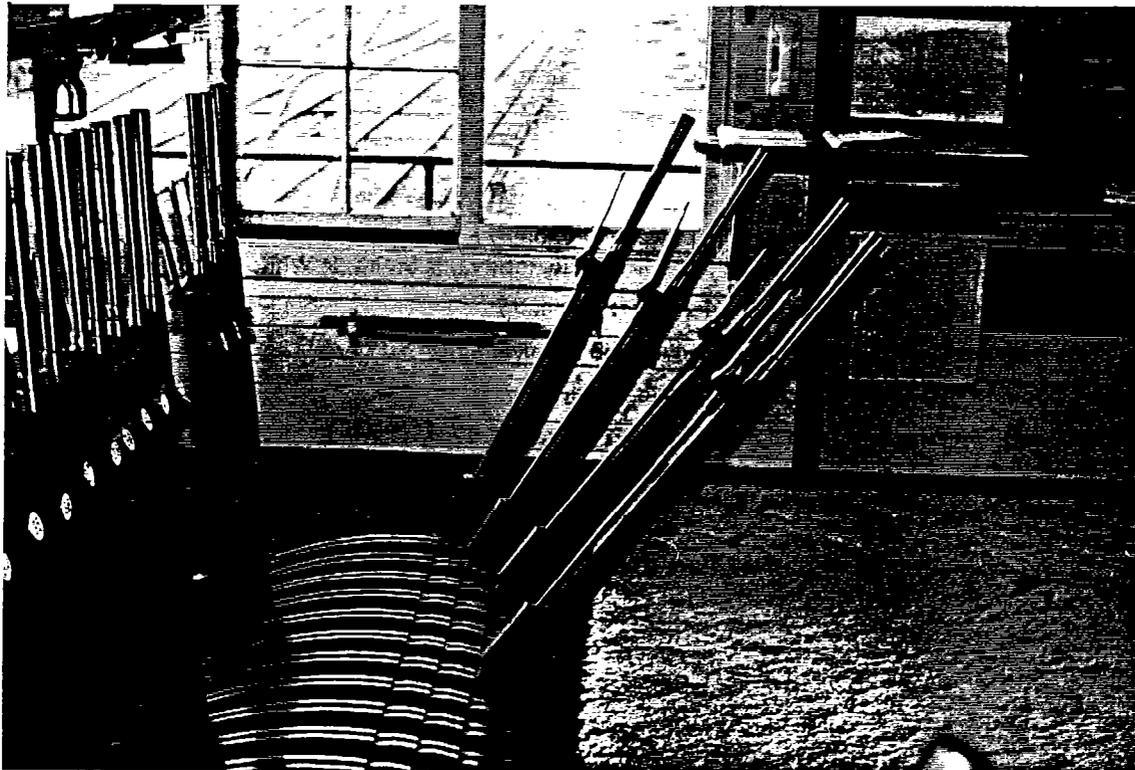
One of the clever design features of the McKenzie and Holland frames was the provision of three reverse notches for signal levers. This provides a quick and easy method for the Signaller to vary the travel of the lever tail and hence the amount of slack taken in as the lever is reversed. The lever moved 29 degrees from the normal position to the first notch which gave a travel of 13 7/8 inches at the 28 inch pin hole. The third notch gave a further 11 degrees of lever movement and 5 5/8 inches in travel. This feature was copied in the standard 'A' pattern cam and tappet frames. This photograph of the Up end of the frame at North Geelong 'B' box, a cam and tappet frame, shows the levers pulled for a Down passenger train. It just so happens that the last three levers pull to the first second and third notches. Lever 50 works the Down distant. At 1066 metres from the signalbox, the distant is motor operated as it is too far to work mechanically. The lever consequently only works to the first notch. Lever 49 is the first Down Home and is 567 metres from the signalbox. This lever works to the second notch, but draft gear beneath the floor doubles the travel and the lever effectively works to a 'fourth' notch. The use of the draft gear halves the distance the lever moves, but the laws of physics give nothing for free and the Signaller has to exert twice the effort. Lever 48, the second Down Home is 164 metres from the box and only requires a long pull to the third notch. Lever 44 works the Down Home to Geelong and is 254 metres from the box and so also works to the third notch.

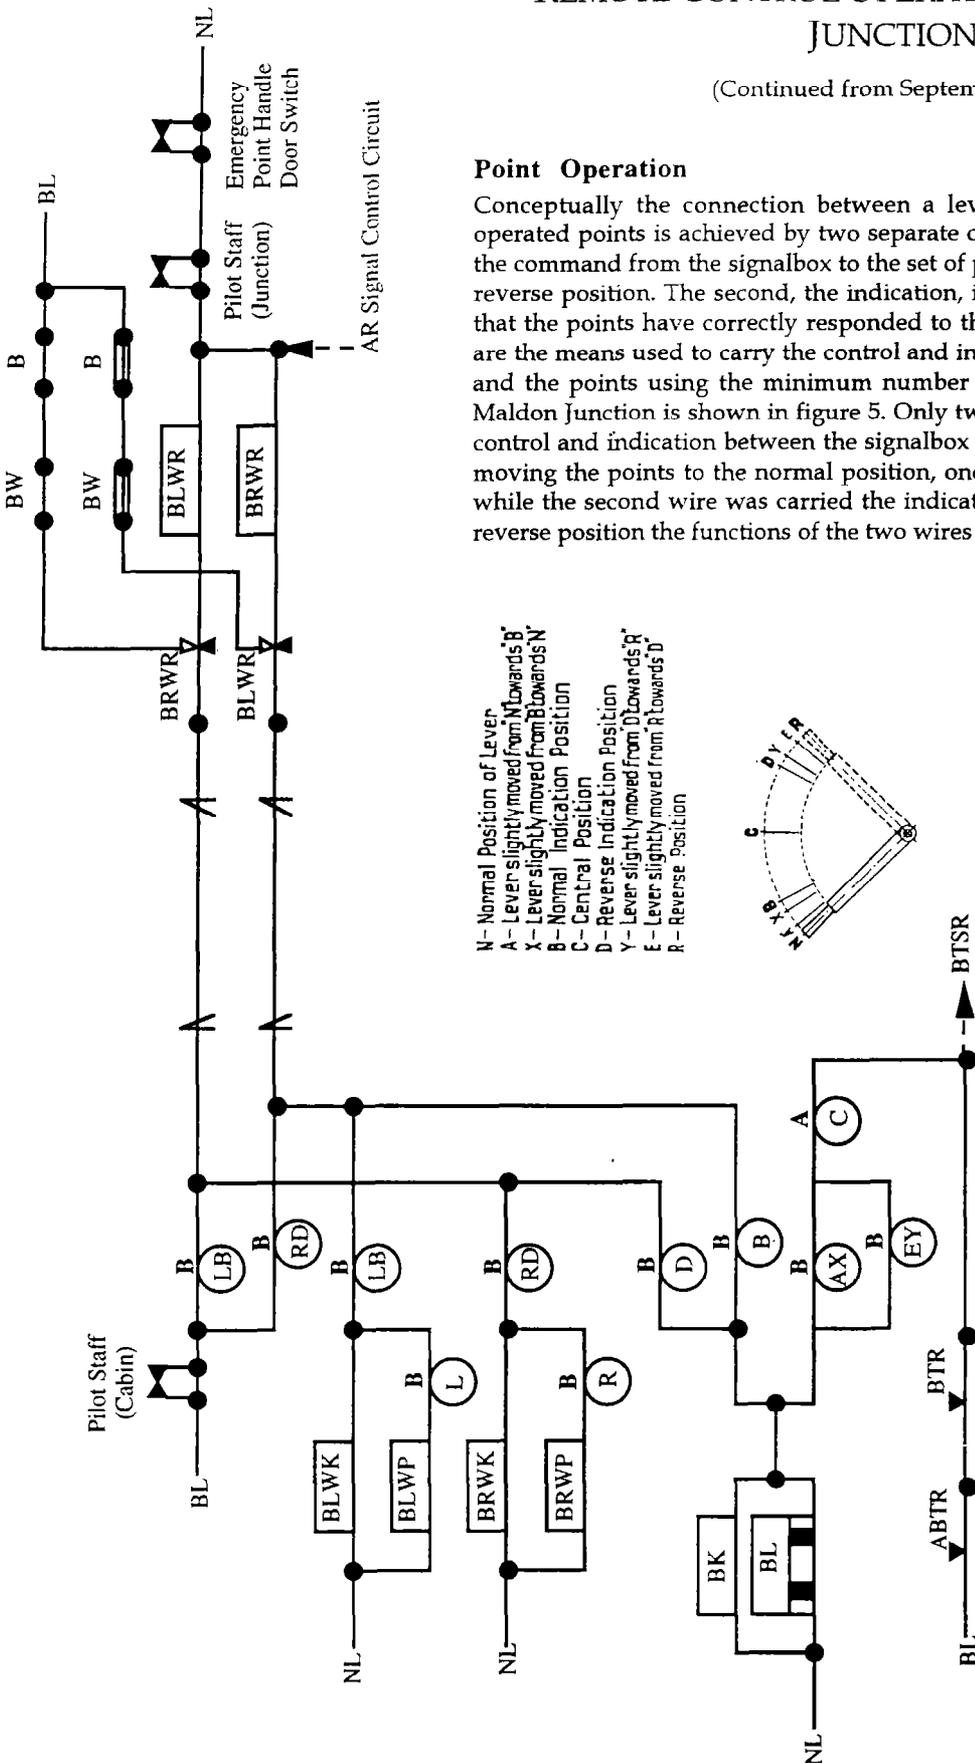
- N - Normal Position of Lever
- A - Lever slightly moved from M towards B
- X - Lever slightly moved from B towards N
- B - Normal Indication Position
- C - Central Position
- D - Reverse Indication Position
- Y - Lever slightly moved from D towards R
- E - Lever slightly moved from R towards D
- R - Reverse Position

Figure 5. The control and indication circuits for Points B at Maldon Junction. The equipment at the top of the page, including relays BLWR and BRWR was located at Maldon Junction. The equipment at the bottom of the page at Castlemaine 'A' Box, mainly in the unit interlocker. Only two line wires were required to transmit the control and indication between the signalbox and the remote location. The inset shows the positions of the point lever.

Figure 5 shows the circuits which transmitted the control and indication between the signalbox and Maldon Junction. To reverse the points for the Maldon line the Signaller moved lever B from the central position to the D position. Further movement to the full R position was prevented by the lever lock BL. However, movement to the D position was sufficient to energise relay BRWR (B Reverse Point Relay). Current flowed from the Signalbox box bus, through contacts in the Cabin Pilot Staff box, RD contacts on lever B, to the line wire. This ran to the relay cabinet at the junction, where the current passed through a back contact of relay BLWR, the coils of BRWR, contacts of the Junction Pilot Staff box, and contacts on the door of the Emergency Point Handle Box, to common.

With the points fully reversed and locked, the indication could be sent back to the Signalbox. Returning to figure 5, current flowed from BL at the Junction, through the reverse contacts B (detecting the points lock in), BW (detecting the points reverse), the front contact of BRWR, and back to the Signalbox via the second line wire. Here the current divided. One branch went through an RD contact on lever B to energise BRWK (B Reverse Point Indicator). This changed the bottom right indicator on the Table Interlocker from blank to show 'Points Reverse'. Figure 7 shows the labelling on the three indications fitted to Lever B.

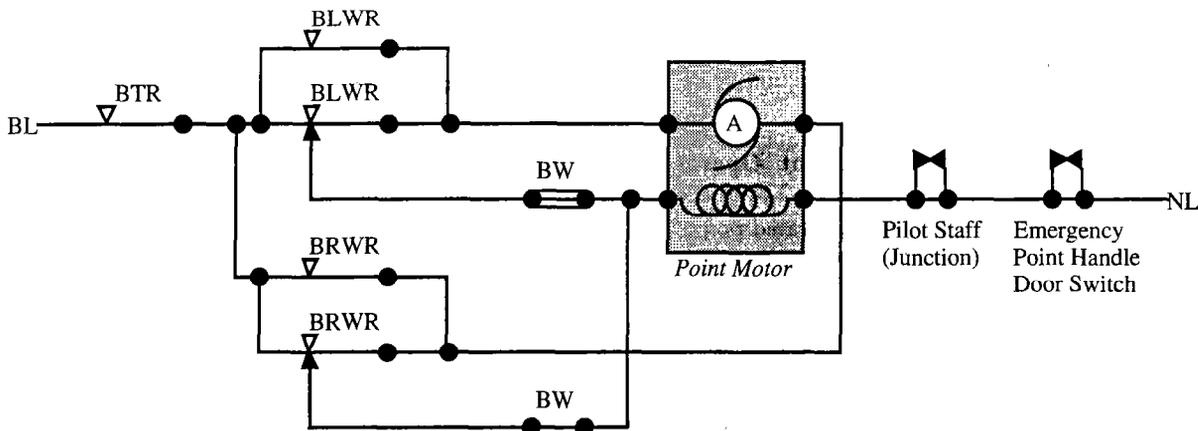
Figure 6. The point operation circuit. This circuit supplies power to operate the point motor at the junction points at Maldon Junction. The direction of the current through the field coils of the point motor determines its direction and this is controlled by the position of relays BLWR and BRWR. All this equipment was located at Maldon Junction.

Energising relay BRWR started the point motor (see figure 6). Current flowed from BL through front contact of BTR, the front contact of BRWR, the armature of the point motor, the back contact of BLWR, the point and lock detector BW, the field coils of the point motor, and finally through contacts on the Junction Pilot Staff Box

and the Emergency Point Handle Box. Contact BW remained closed until the points were fully reversed and the point lock in. It then opened and power to the motor was cut. Separation of the motor operation circuit from the control circuit meant that the heavy current required to operate the point motor did not have to travel through the light control wire.

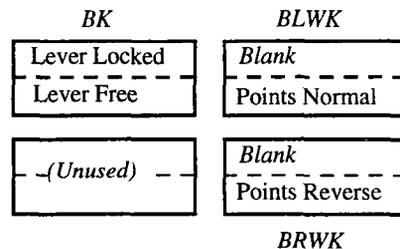
Figure 7. The lettering on the four indication screens fitted to Lever B. One screen was not used. The upper indication for each indicator was shown if the controlling relay was de-energised. The lower indication was shown if the relay was energised.

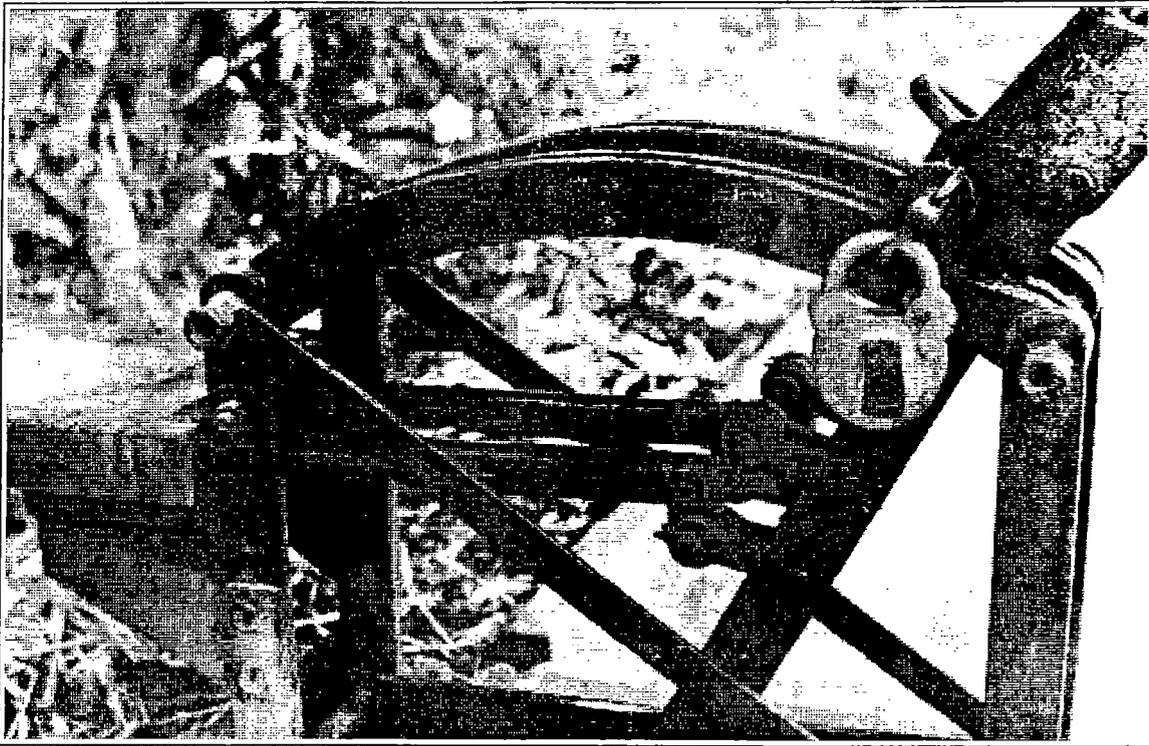
One of the problems with designing a tappet frame is the problem of the travel of the tappets. If a tappet is directly attached to the lever, it could move more than a foot as the lever moves from normal to reverse. Any notches in the tappets move the same distance and this is far greater than the distance between the locking troughs. This means that as the lever is moved, a notch in the tappet may pass several locks and leads to the possibility of the locking being incorrectly freed. The common solution to this problem was to adopt some mechanism to reduce the travel of the tappet. The "A" pattern frame used in Victoria used a cam. An alternative using two tappets was patented by J.D. Brettell in 1908. Frames using this locking were built by McKenzie and Holland and were popular in Queensland. The top photo shows the detail of Brettell Duplex Locking on a standard Queensland ground frame with two levers. As can be seen, each lever has two tappets. To quote [SSG] "Both the tappet irons are worked direct from the lever, because they are attached at

different distances from the lever fulcrum, they have different travels and the notches in both tappets coincide only when the lever is in the normal or reverse position." The two tappets, with their separate attachments to the lever, can be seen in the photograph. A set of notches for a normal lock can be seen cut in the tappets for both lever. On the nearer lever, these are just to the right and left of the diagonal bar.

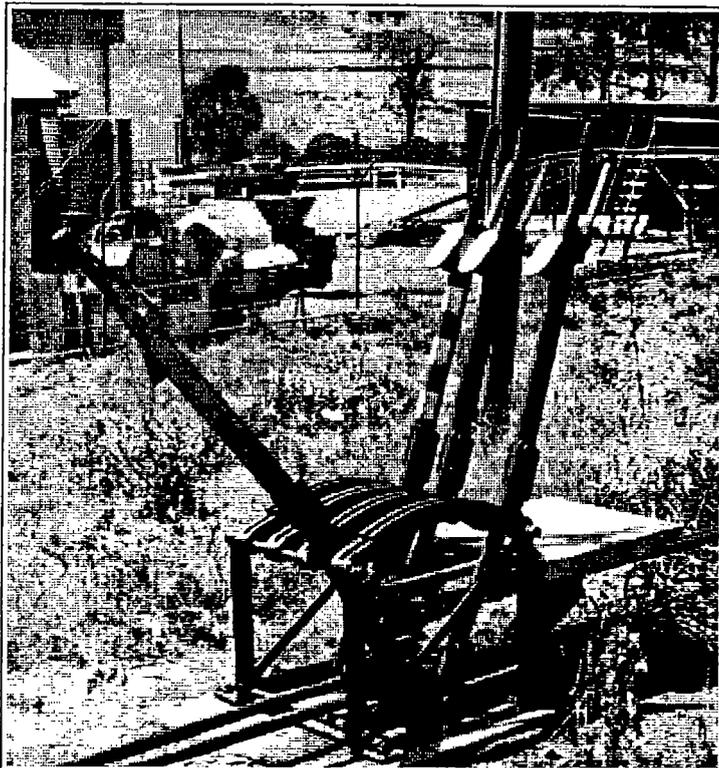
The second photo (left) is an overall view of a standard Queensland ground frame, this time of four levers. This frame is equipped with Brettell pattern locking, with the locking box at the rear. These ground frames were constructed out of steel bars and pins and consequently looked much less solid than ground frames elsewhere with their cast iron standards and floor plates. This frame worked the connections to the meat plant at Willowburn.

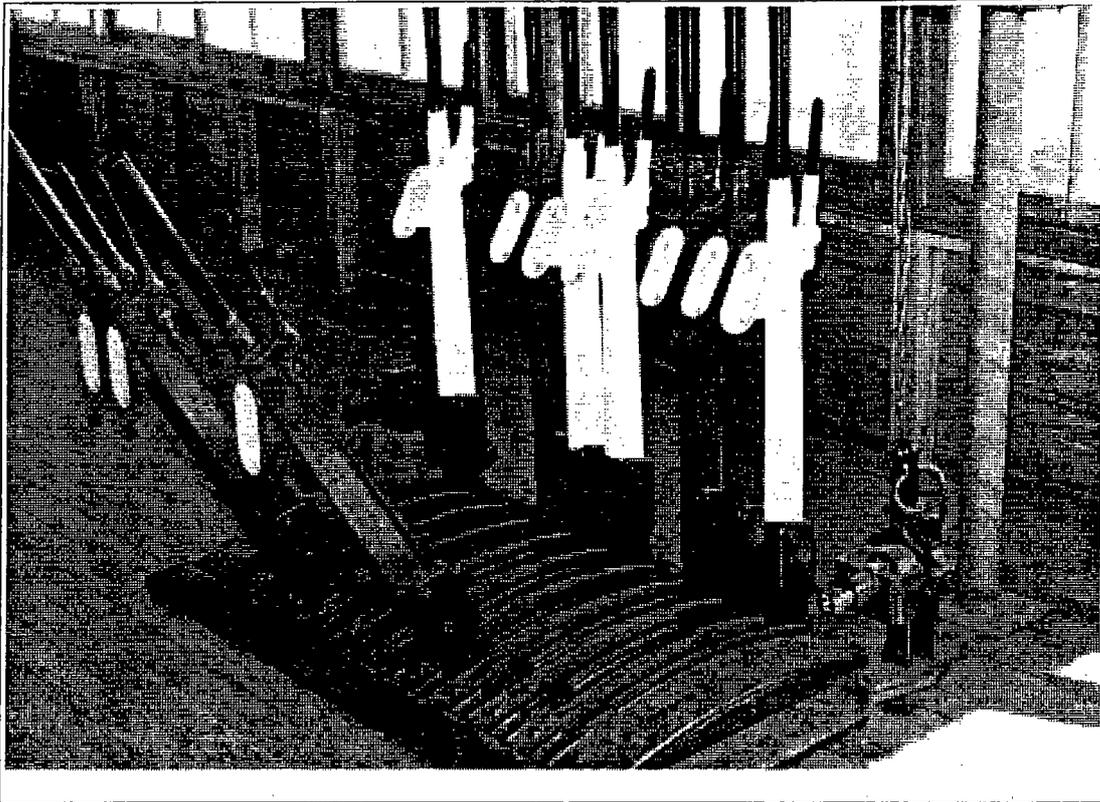
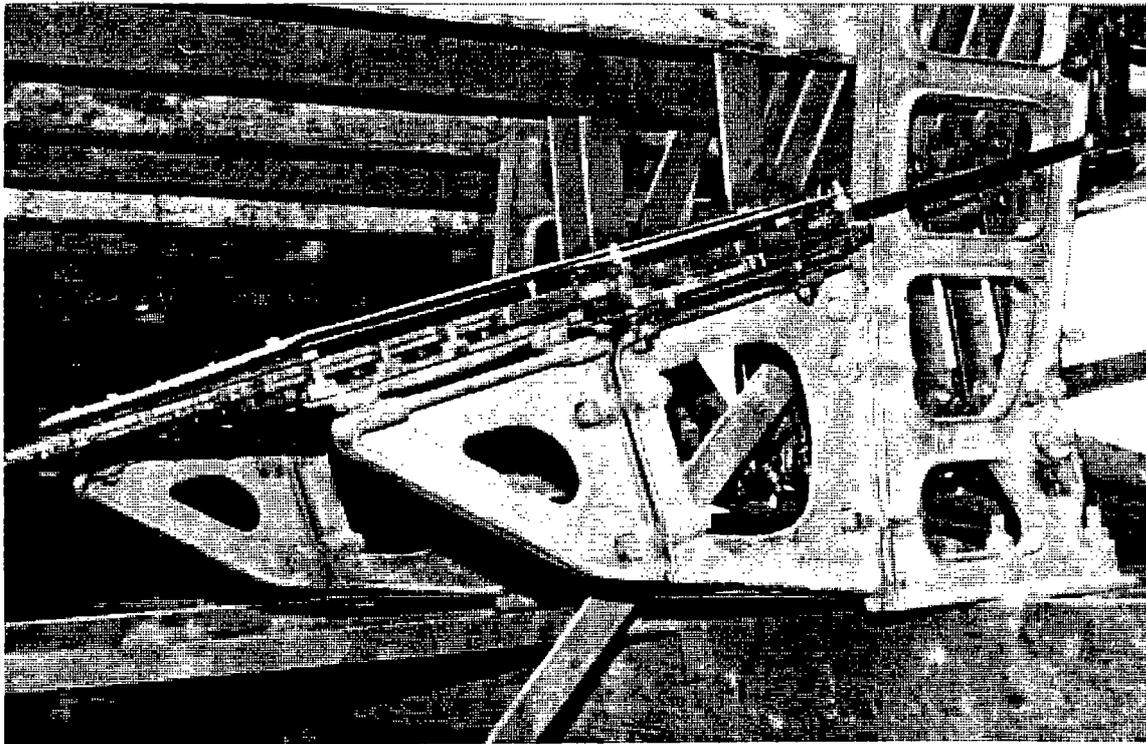
Full size frames using Brettell Duplex locking were known as McKenzie and Holland No 21 pattern frames. These two photographs show the 10 lever frame at Chinchilla (to the west of Toowoomba). This small frame only works the signals, although the much larger elevated cabin suggests that it was once planned to interlock the entire yard. The small stands at each end of the frame are the equivalent of Annett Locks; the keys operate outlying points. These are interlocked with the signal levers using the a vertical slide which can be seen, on the lower photo to operate a separate tappet via a bell crank. The connections between two tappets and Lever 10 can be seen through the hole in the standard.

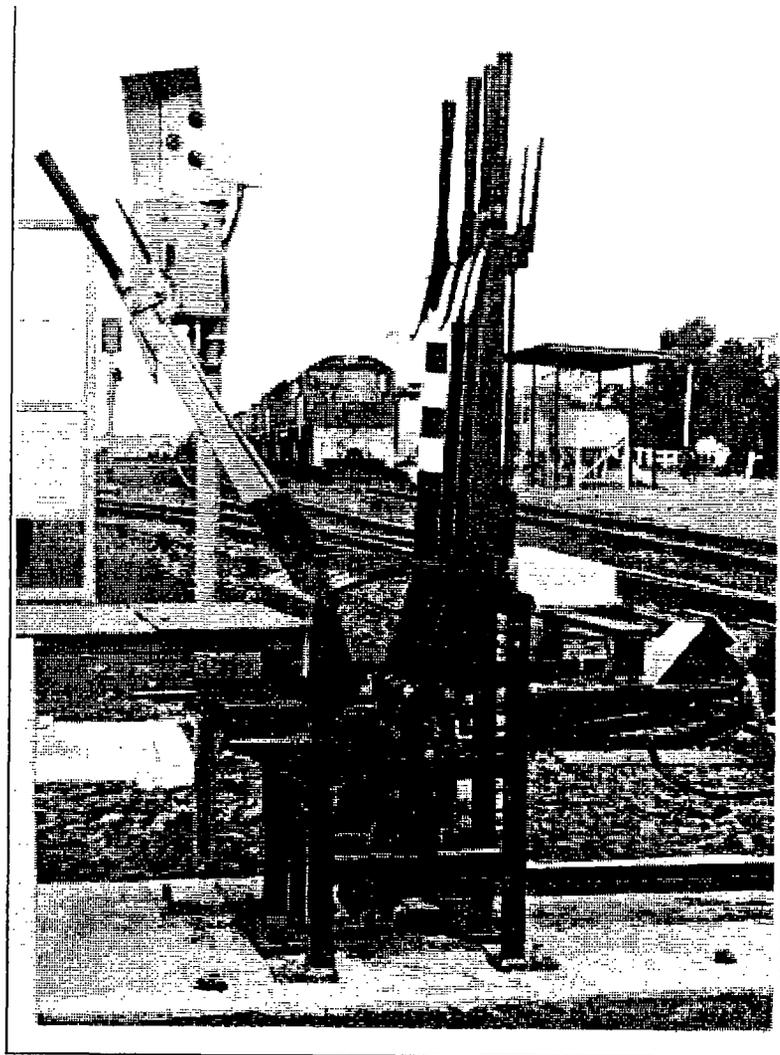
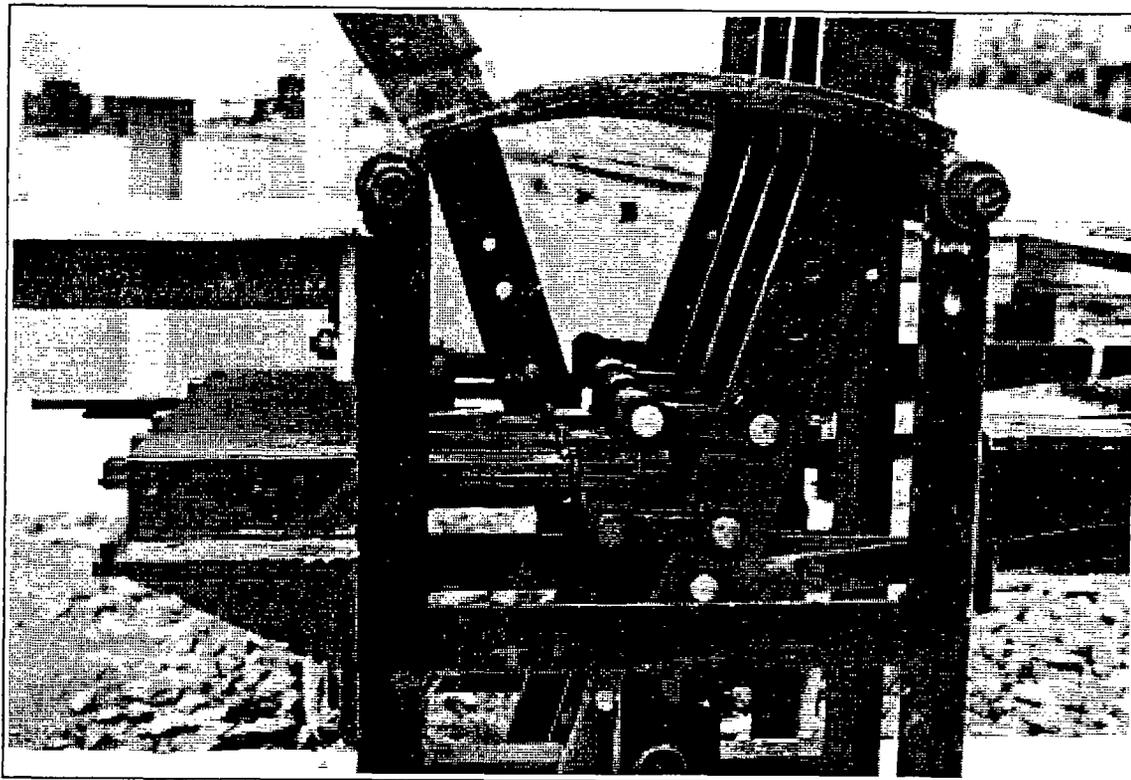
Just to show that Brettell Duplex Locking is not yet finished in Queensland, this pair of photographs shows the ground frame at Grandchester which had been installed for the then brand new CTC installation. The photo to the left shows the complete ground frame. The boxes behind the levers are circuit controllers and lever locks. The lower view shows the detail of the Brettell Duplex locking. One lever is reversed, and the difference in travel in the two tappets can be seen on the left. The train in the background is waiting for the Down Indlander
