# SOMERSAULT

SEPTEMBER 2003

SIGNALLING RECORD SOCIETY OF VICTORIA INC

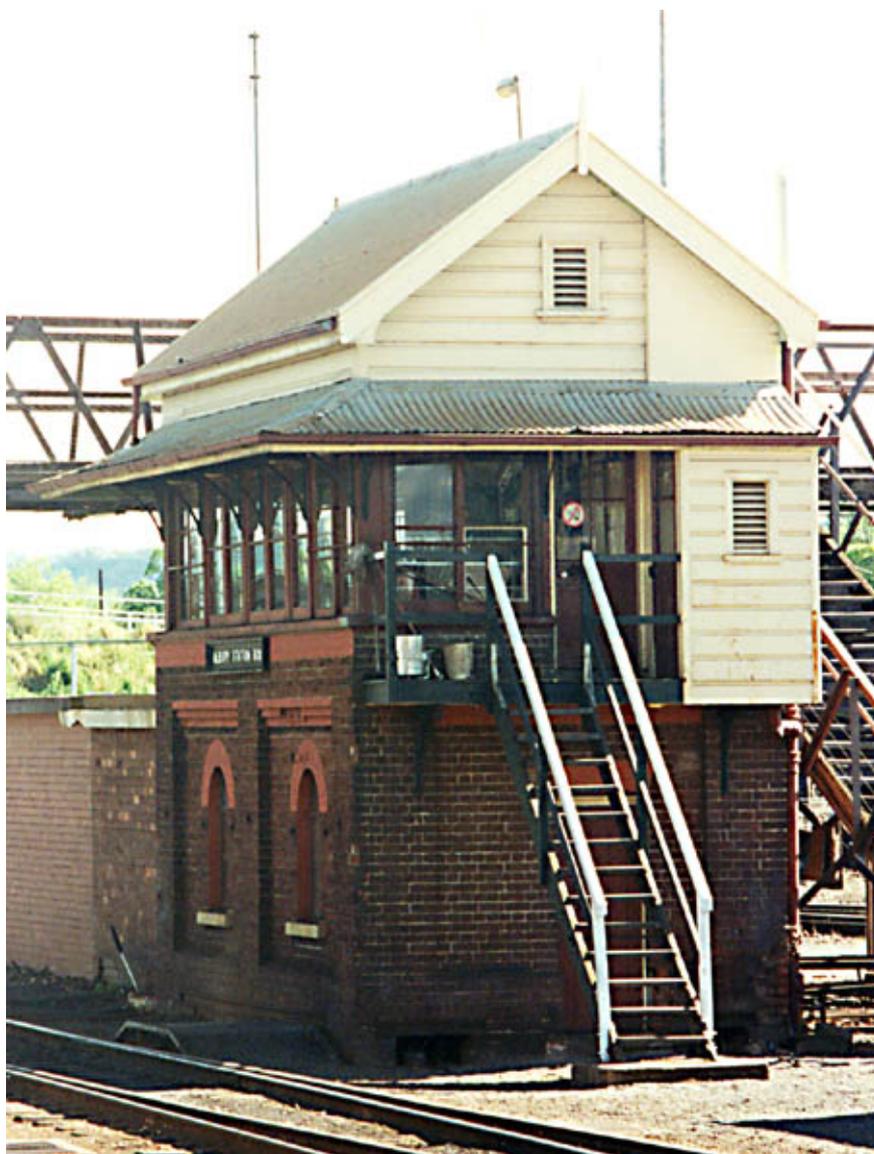
*Albury Station Box on the morning of 8 November 1995. This brick to floor box was opened on 25 March 1887 and was placed out of use at 0600 hours on Friday, 1 August 2003, at the grand old age of 116 years. During this time the box controlled the track and signals at the northern (Sydney) end of Albury platform. Originally Albury Station Box appears to have been equipped with a 36 lever frame. This was replaced by a new 44 lever frame on 14 March 1940 to work additional crossovers in the vicinity of the box to assist in shunting the expanded transshipping sidings opposite the platform. On 31 July 1945 the yard was extended northwards and 4 new car sidings and 3 new reception sidings provided. The main line connections to these sidings were worked from ground frames electrically released by Albury Station Box. An 11 lever kellogg key panel was provided to release ground frames and to operate a new upper quadrant home signal. This panel was replaced by a rotary switch panel on 10 March 1984 when the signalling was rearranged in preparation for the provision of CTC between Junee and Albury.*

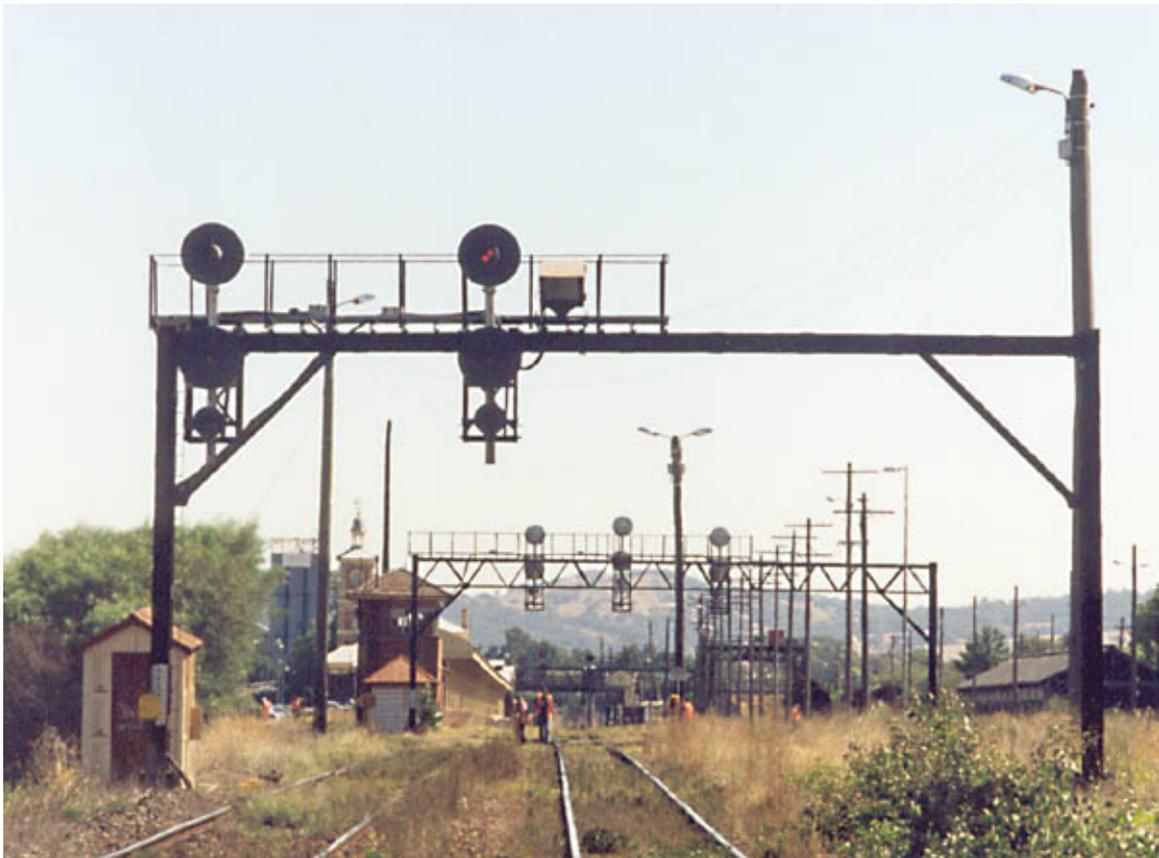
(Above) Looking north from the southern throat of the yard in February 2000 during the SRS tour. The broad gauge line is on the left and the standard gauge line on the right. Albury South box can be seen at the end of the platform on the left of the picture between the broad and standard gauge lines. All movements, including broad gauge movements, in Albury yard were controlled by NSW signals; Victorian drivers had to know enough about NSW signalling to navigate around the yard. (Below) Looking south from Albury South box in November 1995. The broad gauge line is on the extreme right. The standard gauge Platform Road, Through Road, and Run Around are in the centre and end at the three way points with the standard gauge line leading onward to Melbourne. Note that the Through Road has a set of catch points; a feature retained today even though the line is now the main line. The two tracks to the extreme left are the broad gauge goods lines with the transshipping yard out of the picture to the left. The connection from the goods lines to the broad gauge main line can be seen crossing the standard gauge line just beyond the three way points.

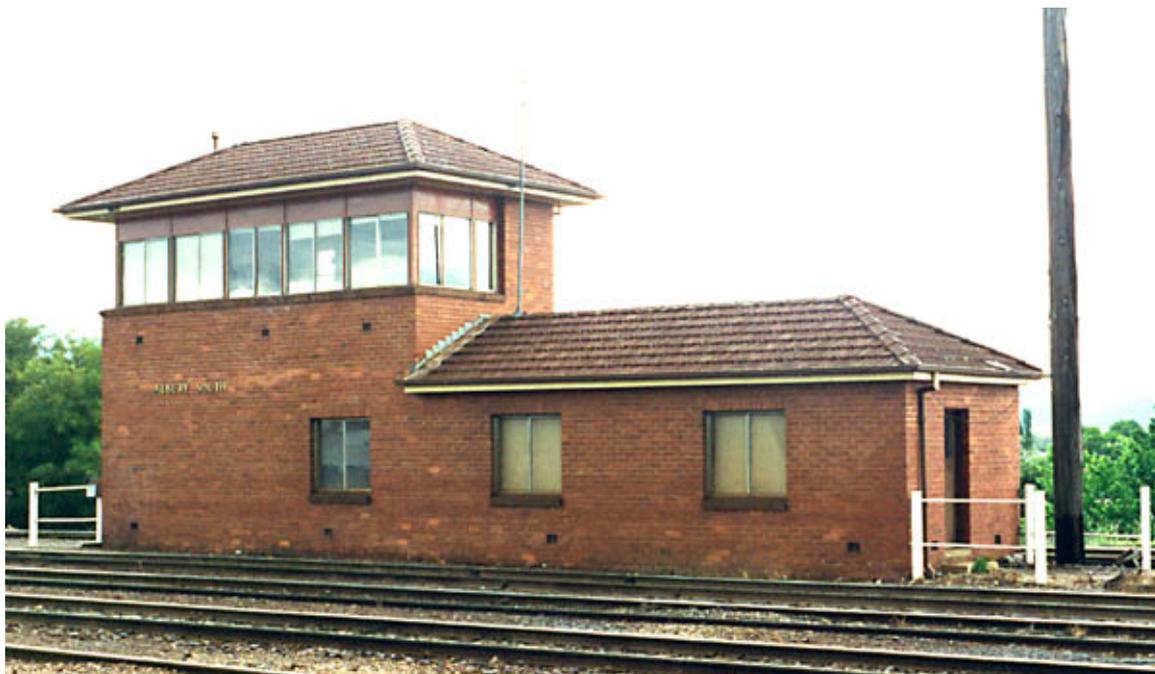
(Above) Albury South Box was situated at the southern end of the passenger platform between the broad and standard gauge tracks and was opened on 14 May 1962. The original Albury South Box was opened in 1888, and unlike the fancy brick Albury Station Box, was of utilitarian wooden construction. The box originally contained a 24 lever frame, but this was replaced by a 32 lever frame on 8 July 1913. The larger frame was required to work additional signals; the basic layout did not change. The frame was replaced (or extended?) again on 31 January 1940 when a 36 frame was provided to work additional transshipping sidings. The new brick box was provided as part of the work associated with the provision of the standard gauge line to Melbourne. It was not, however, ready for the opening of the standard gauge line to goods (2 January 1962) or to passengers (12 April 1962) and the old box had the honour of signalling these initial trains. The coming of the new box saw all the signals at the south end of Albury yard replaced by light signals, however, the basic track layout remained almost unchanged. Indeed, like Albury Station Box, the original 1888 layout could be traced in 1995. (Below) The new box was provided with a rotary switch panel manufactured by McKenzie and Holland. The switches were mounted on the desk below the diagram and were grouped into Up signals, points, and Down signals. The telephone concentrator was at the right hand end of the desk and the left hand end was used for the Train Register. Built into the front of the desk were three bell pushes (standard and broad gauge to Wodonga, and Albury Station) and two ashtrays. It seems passing strange that the opportunity was not taken in 1962 to combine the functions of Albury South Box and Albury Station Box onto one panel. But this did not occur and both boxes continued to work for over forty years.

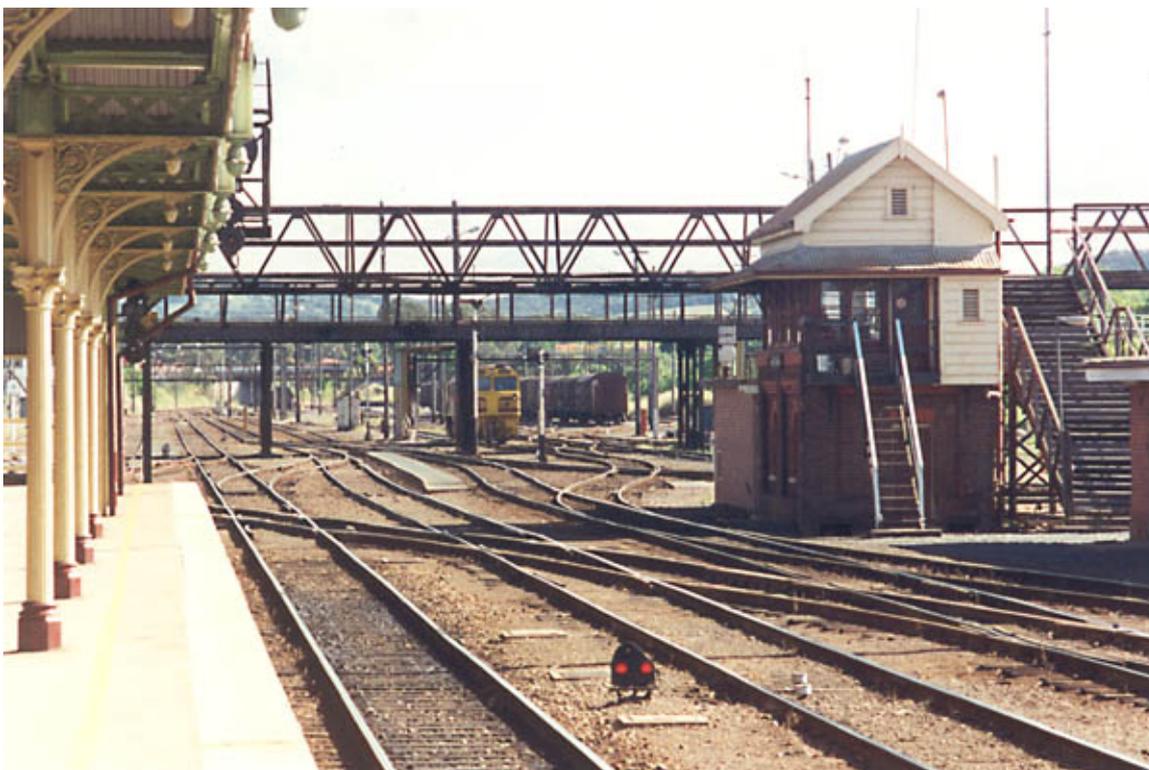
(Above) The centre portion of Albury yard looking north with Albury Station box on the left. The track crossing diagonally across the picture between the platform and the box is the broad gauge Goods Line providing access to the goods yard. The track immediately adjacent to the platform is, of course, the standard gauge Platform Road. To the right is the Through Road, and then the Run Round which continues to become the No 1 Engine Siding. The sidings seen beyond Albury Station Box were the site of the loco depot and carriage sidings. Locomotive 42220 can be seen stabled in loco just beyond the Dean St overbridge. Prior to 1984, the Platform loop ended at Crossover 22 (just beyond the broad gauge line), and the track beyond was the No 1 Goods Siding. In that year part of the No 1 Goods Siding was converted into the 'Extended Loop'. Almost none of the trackwork in this view survives; only the three standard gauge roads, as plain track, and the two sets of points immediately in front of the box. (Left). The Up 2nd Home (Signal AY 9) from the Platform Road. The main signal was above the platform verandah, and a co-acting signal was provided below the verandah. This signal had a fixed red upper light. The second target was the marker light (white) which was illuminated at all times. Underneath these 'fixed' lights the working lights which actually signalled trains can be seen. A two position route indicator is below the marker light and this shows 'M' for moves across Crossover 22 to the main line, or 'L' for moves along the extended loop. The small signal below the route indicator is a low speed signal. This shows a green light for running moves to the main line or extended loop and indicates that the driver should be prepared to stop at the next signal. The lowest signal is a shunt signal and shows a yellow light for shunting moves to the main line or extended loop. Note that no route indicator is provided on the co-acting signal. The route indicator was added in 1984 when the Extended Loop was provided, and perhaps it was too difficult (expensive) to add to the co-acting signal.

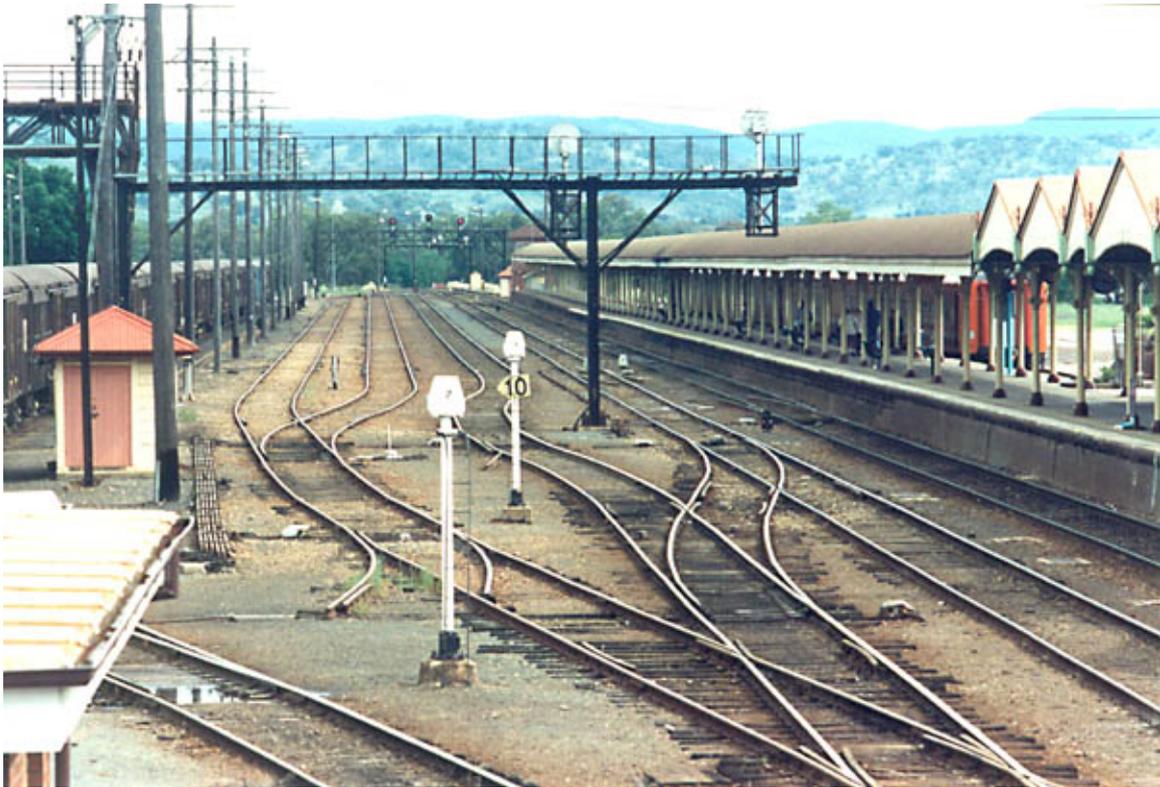
*(Above) Looking towards Melbourne from Albury Station Box in November 1995. From the platform the first three tracks are the standard gauge Platform Road, Through Road, and Run Round. The next two roads are the broad gauge Goods Line and Goods Loop. The start of the diagonal broad gauge crossing to the goods yard can be seen. The broad gauge crossing had ceased to be used when the former goods yard was cleared, and by November 1995 the broad gauge tracks ended just beyond the catch point on the western side. The transshipping sidings can be seen to the left of the broad gauge Goods Loop. By this date these sidings were effectively out of use as transshipping at Albury had ceased. All the point work and signals in this view have been removed. (Below) Looking towards Sydney from the footbridge adjacent to Station Signal Box in November 1995 showing most of the remaining mechanical signals. During 1995 the loco depot had been closed, the track in the shed area lifted and the shed demolished. However, locomotive 42220 was stabled in No 1 Loco Siding when this photo was taken.*

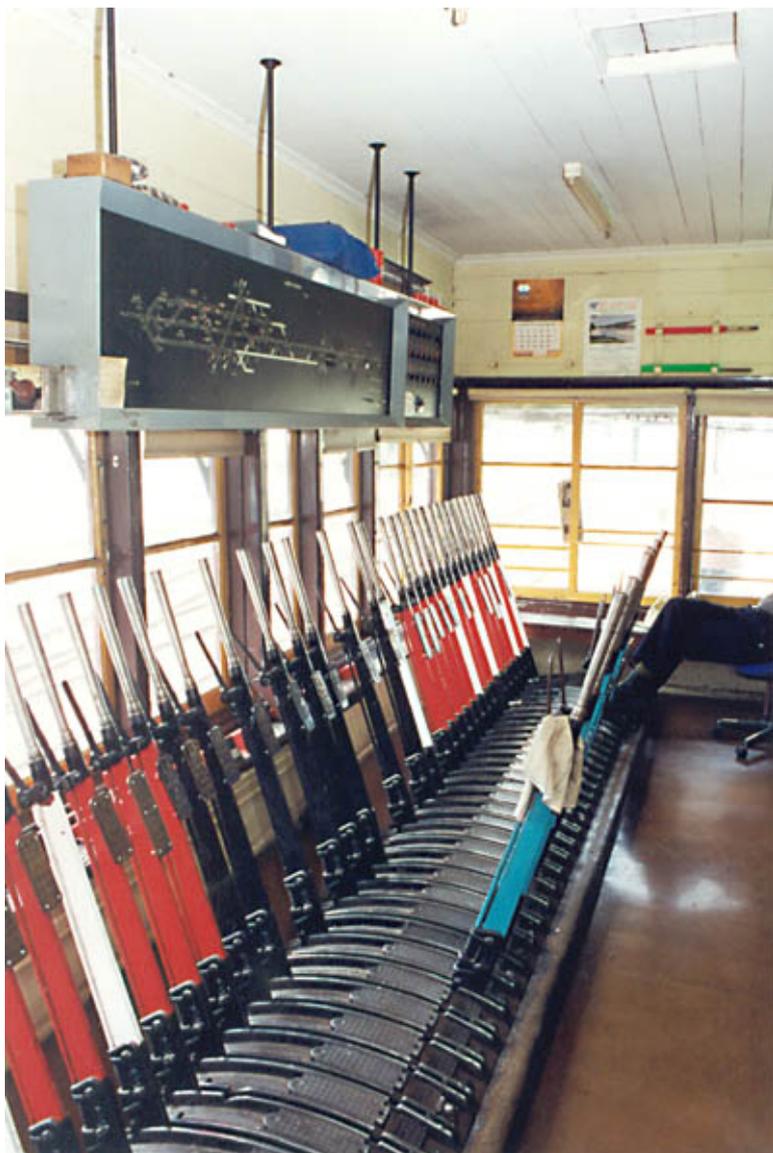
(Left) The interior of Albury Station Box in November 1995 showing a very well kept and highly polished box. The 44 lever Standard NSW Cam and Tappet frame was provided on 14 March 1940 as part of the expansion of Albury to handle the war time transshipping traffic. In 1995 most of the levers were still in use, but a few white levers can be identified; these were made redundant in 1984 when a portion of No 1 Goods Siding was converted into the Extended Loop. The illuminated diagram above the frame was provided at the same time. A small rotary switch (what Victoria calls a 'unilever') panel is located at the far end of the illuminated diagram to work the points, signals, and ground frame releases at the Sydney end of the yard. The standard NSW Cam and Tappet frame is similar in design to the Victorian A Pattern cam and tappet frame, but, of course, almost all the details differ. (Below) Looking south from the Guinea Street at the northern end of Albury yard. From the right the tracks are the Up Shunting Neck, Main Line, No 1 Engine Siding. To the left of the Engine Siding are a collection of sidings added during 1945 to ease congestion in the yard. Access to these sidings was by two ground frames (F and G) released by Albury Station Box. Ground Frame G was almost underneath the Guinea Street bridge (the points that can be seen in the Up Shunting Neck were worked from the frame). The Down 4th Home, controlling movements into the main line or Extended Loop can be seen in the middle of the picture, just before the Wilson Street footbridge. On the extreme right can be seen the massive wall of Dalgety's woolstore.

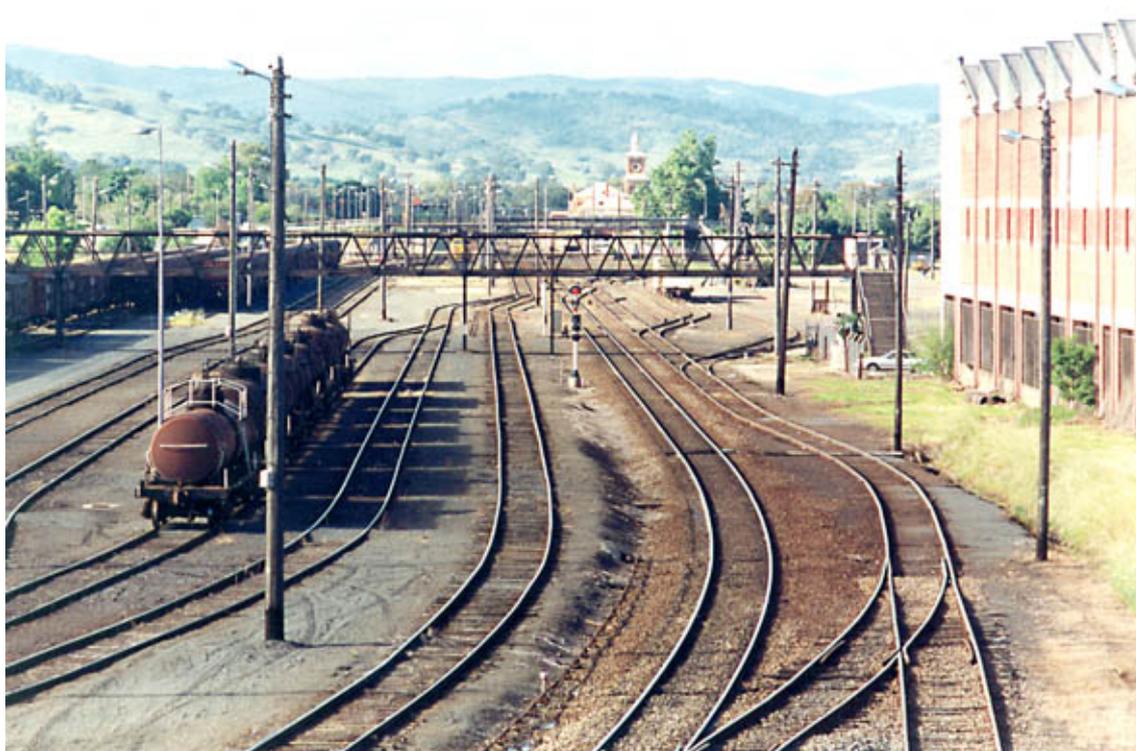
A short freight arriving at Albury from the north on the afternoon of the 7 November 1995 behind 8169. The photo is taken from the Dean Street bridge. The train is on the main line with the Extended Loop to the left. The tail of the train is passing over Points 59 at the end of this extended loop and the signals for the end of the loop can be seen on the signal bridge above the train. Beyond the end of the Extended Loop, the line continues as the Up Shunting Neck. To the right of the main line is 'No 1 Engine Siding' and beyond them the Car Sidings and Reception Sidings provided in 1945 to assist in handling the massive transshipping task undertaken during the Second World War. (Below) The points at the Sydney end of the yard were worked from three ground frames which were electrically released from Albury Station Box. This is Frame G which worked connections between the Main Line and the Up and Down Shunting Necks. The electric release can be seen to the left of the frame on the short post. The electric release releases an Annett key which can be used to unlock the facing point lock lever (2) and allow the point levers to be reversed. This frame was provided in 1940 with the extension of the goods yard. Close examination of the left hand running rail shows that a lock bar is provided to prevent the points from being unlocked while a train is passing over them; even though the operating frame is adjacent to the points. The points worked by Frame H at Albury were similarly equipped.

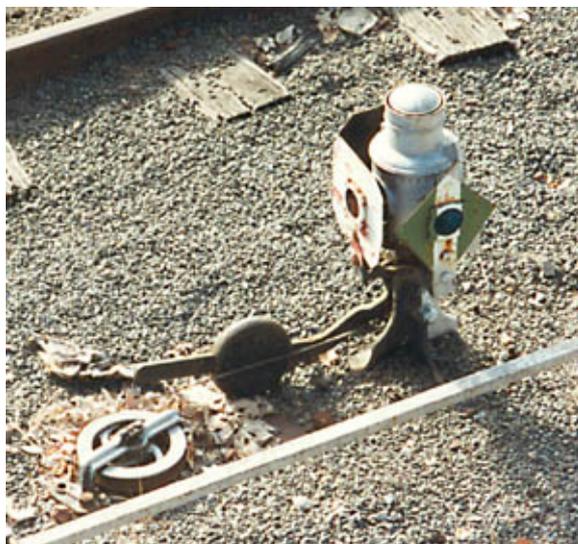
*(Right) Possibly the most interesting signal at Albury was this 'mechanical revolving disc signal'. Albury Station Box signal 32 applied from No 2 Goods Siding to the Car Dock. Mechanically, it is almost identical to a Victorian ground disc. It shows a red square disc with horizontal white stripe when at Stop (red light at night) and a green diamond with vertical white stripe when at Caution (green light at night). Both the red and green faces can be seen in this view. This was probably the oldest remaining signal in Albury yard. It was in existence in 1929, and probably from 1909 when the 'discs were altered to new standard'.*
