SOMERSAULT

MAY 2008
Vol 31, No 3

SIGNALLING RECORD SOCIETY OF VICTORIA INC

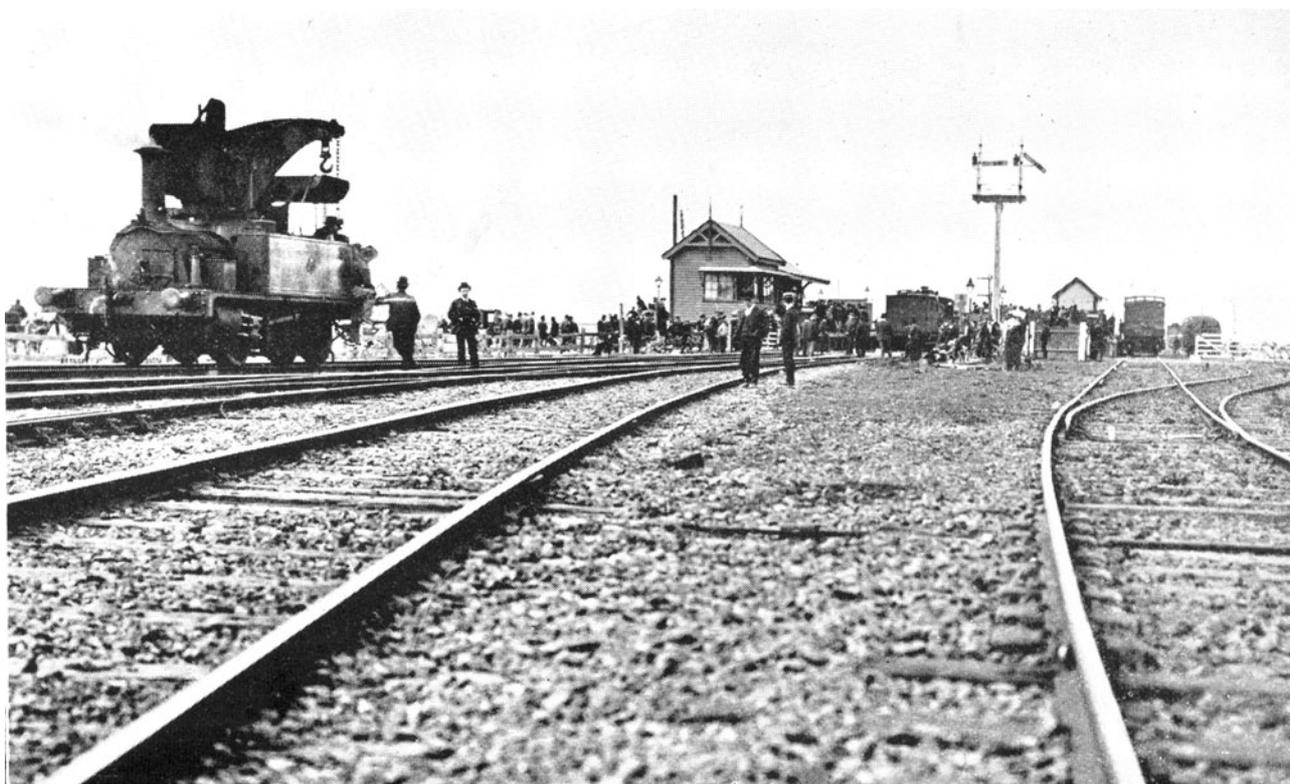
On Easter Monday, 20 April 1908, the 6.50 pm Up Bendigo passenger train overran the home signal and crashed into the rear of an Up special train from the Ballarat line. Forty four people lost their lives in this accident and over 400 were injured. This photograph was taken on the following day and shows the 'big crane' from Newport Workshops standing on the Up Bendigo line at the north end of Sunshine yard during clearing operations. The Up and Down Ballarat lines can be seen passing the camera on the left (the single line commenced behind the camera). On the right is the Newport line, with a siding leading from it. The signalbox visible here was brought into service on 20 January 1896 when a 'combined booking office and signalbay' was brought into service on the Up platform. In practice, as can be seen here, the new facility was really a signalbox erected adjacent to the station building and connected by a doorway. None-the-less, it allowed a useful reduction in staff. Previously, the station had been staffed by an SM, porter, and two classified signalmen. Afterwards it was staffed by an SM and two operating porters. The box contained a 33 lever Rocker frame which was constructed on 9 February 1890 and so was, presumably, relocated from the older box. The Sunshine accident was probably caused by the Driver approaching the home signal at too high a speed and braking too late, but there were contributing causes. The first was the Bendigo train was not accepted under the Warning arrangement, even though the SM intended to bring the Ballarat train into the platform while the Bendigo train was approaching. The second was that the starting signal, at clear for the Ballarat train, was visible for a far longer distance than the Bendigo home or distant signals. This resulted in the Driver thinking the signals were off for his train, although the Driver was emphatic that he had seen both the distant and home at danger and correctly responded to them. The final cause was the extremely poor maintenance of the Westinghouse brakes on the Bendigo train which would have significantly extended the stopping distance of the train. This photograph is taken from W.O. Bagley's "The Sunshine Railway Disaster".

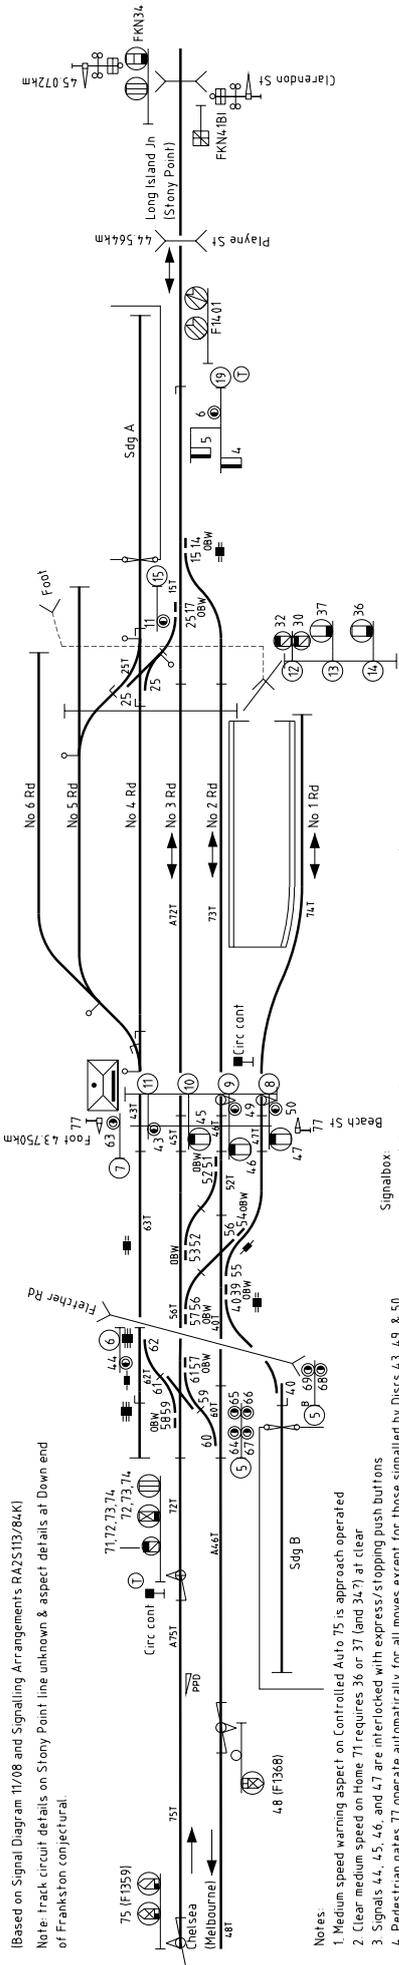
(Based on Signal Diagram 11/08 and Signalling Arrangements RAZS113/84K1)

Note: track circuit details on Stony Point line unknown & aspect details at Down end of Frankston conjectural.

1. Medium speed warning aspect on Controlled Auto 75 is approach operated
2. Clear medium speed on Home 71 requires 36 or 37 (and 34-7) at clear
3. Signals 44, 45, 46, and 47 are interlocked with express/stopping push buttons
4. Pedestrian gates 77 operate automatically for all moves except for those signalled by Discs 43, 49, & 50
5. Crossover 56 and Points 60 air assisted
6. Beach St pedestrian gates. Up approach starts at 72T (304m, 30s@40km/h), Down Holding A75T (150m, 10s), Up control A72T, 73T or 74T (255m, 22s@40km/h)

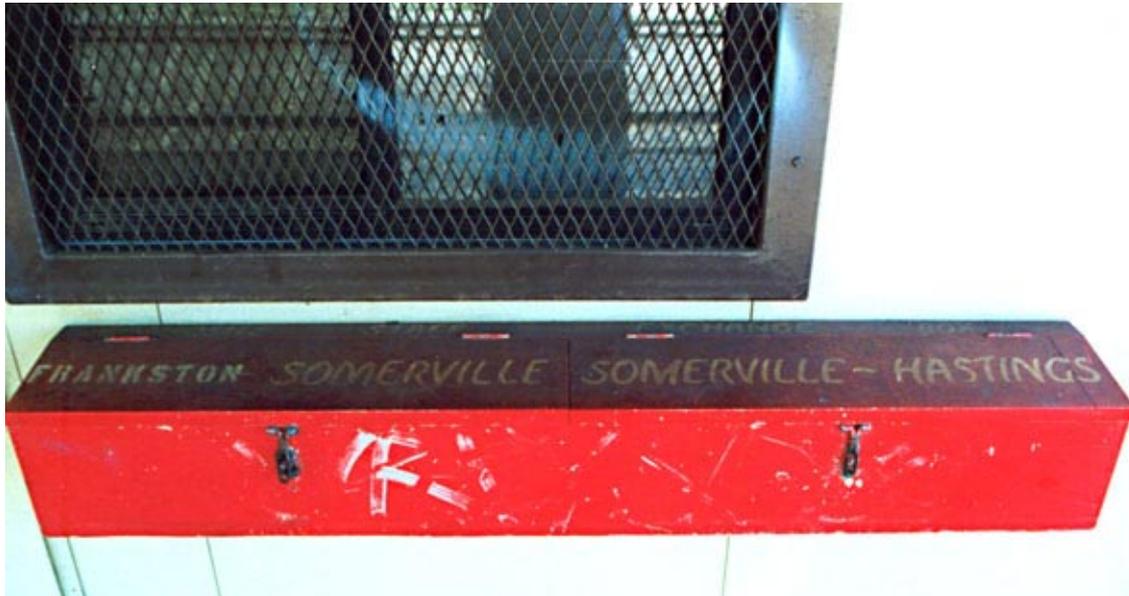
The staff exchange box at Somerville was fixed to the platform wall of the station building and was an example of an F2922 Composite Staff Exchange Box. This type of exchange box was a simple wooden box roughly 4' 9" long, by 9" tall and 8" deep. Internally, the box was divided into two compartments, each of which was accessed by a hinged lid. These lids could be secured by means of a padlock.

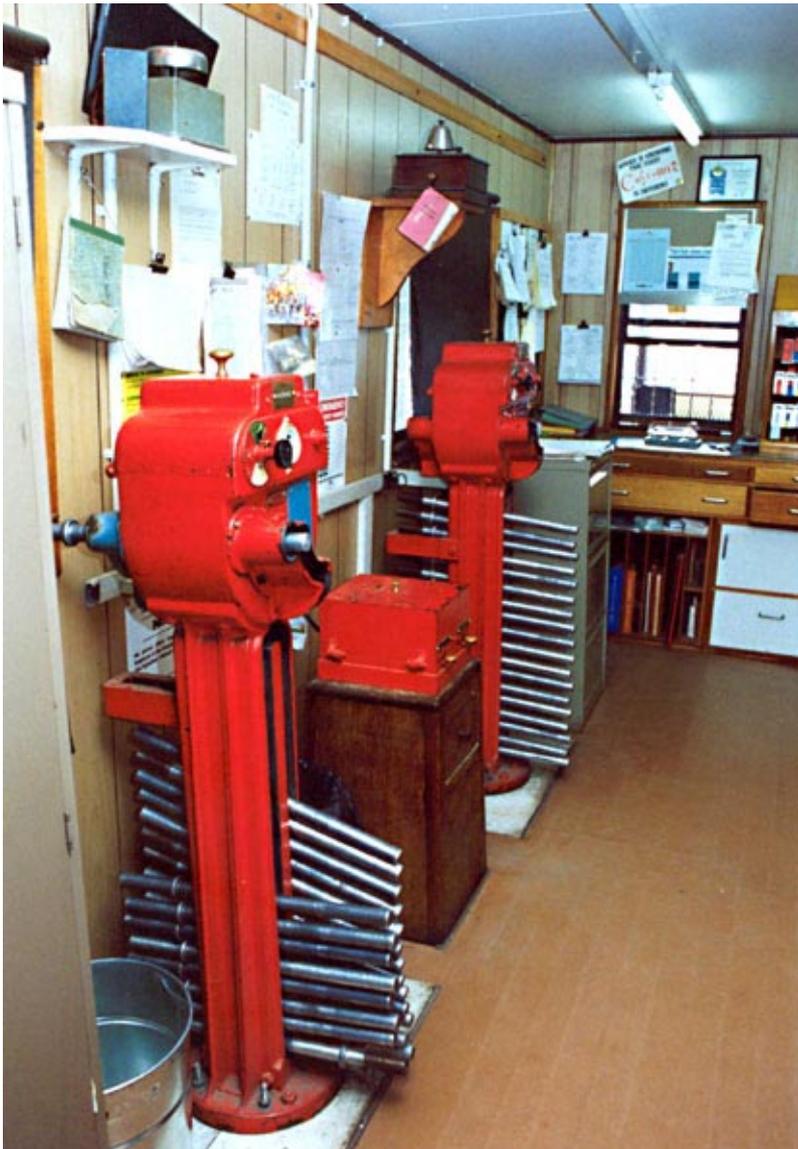
The large staff instruments at Somerville on 12 March 1993. The instrument closest to the camera is the blue instrument to Hastings. A staff has been extracted for a Down train and can be seen in the throat of the instrument. The further instrument is the red instrument for the Frankston section. Between the two instruments can be seen the magneto generator which is used to send bell signals and current to the other ends of the section. On the wall above the two instruments can be seen the gongs to receive the bell signals. The gong for the Frankston section is in a traditional wooden case. That for the Hastings section is in a metal case. Next to the Hastings gong, and side-on to the camera, is a galvanometer which shows whether a staff is in or out of the Somerville - Hastings instruments. The three drawer filing cabinet beyond the Frankston instrument makes a convenient desk for the train register book.

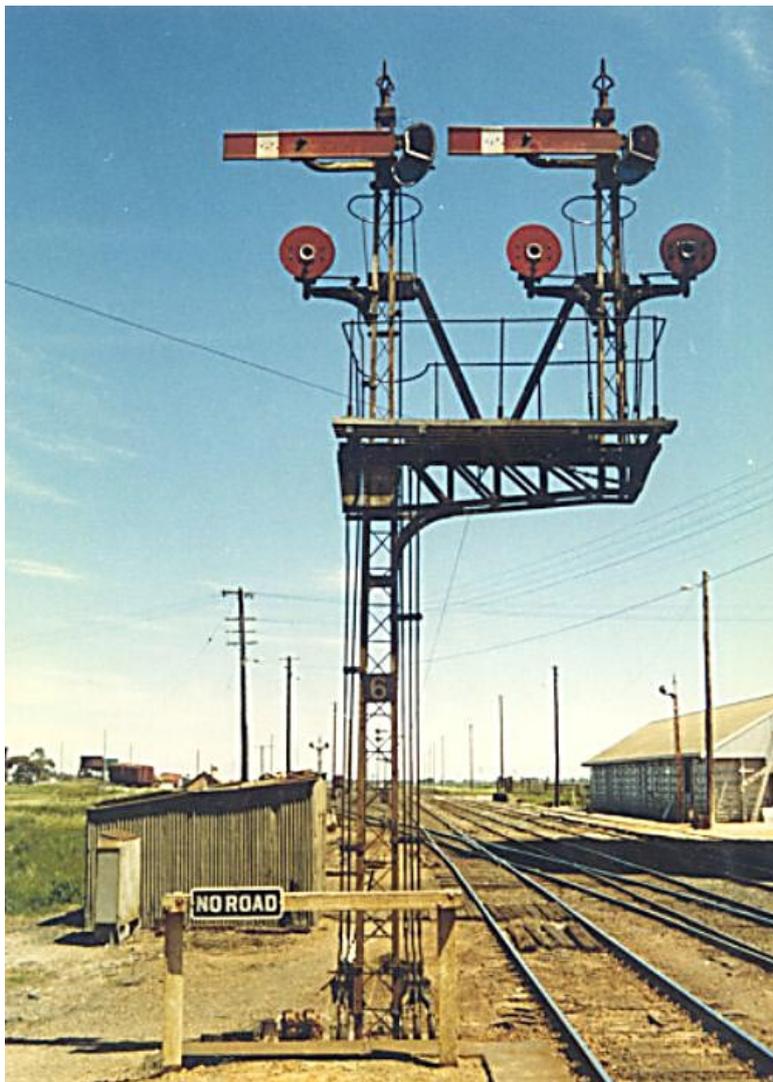
Serviceton was interlocked on 15 May 1890 with the provision of two signalboxes. Serviceton East contained a 40 lever rocker frame and was situated opposite the platform. Serviceton West contained a 30 lever rocker frame and worked the mixed gauge connections at the extreme Adelaide end of the yard. The West box only lasted until 12 June 1894 when the connections at that end of the yard were simplified and secured by staff locks. Serviceton East then became simply 'Serviceton' and survived until CTC was provided between Nhill and Wolsley on 1 May 1984. In May 1934 the original frame was extended by 6 levers (three at each end) when the yard was track locked and calling-on arms provided. The photograph below was taken towards the end of the box's life. The photo to the right shows Post 6 which stood at the Down end of the platform and controlled moves from No 1 Road (left hand doll) and the Loop (right hand doll). The arms are for moves towards Adelaide. The left hand discs are for moves to Sidings B and the Engine Roads, while the righthand disc on the right hand doll is for moves from the Loop straight ahead to No 2 Road. Photos by Ray Gomerski.
