SOMERSAULT

MAY 2010
Vol 33, No 3

SIGNALLING RECORD SOCIETY OF VICTORIA INC

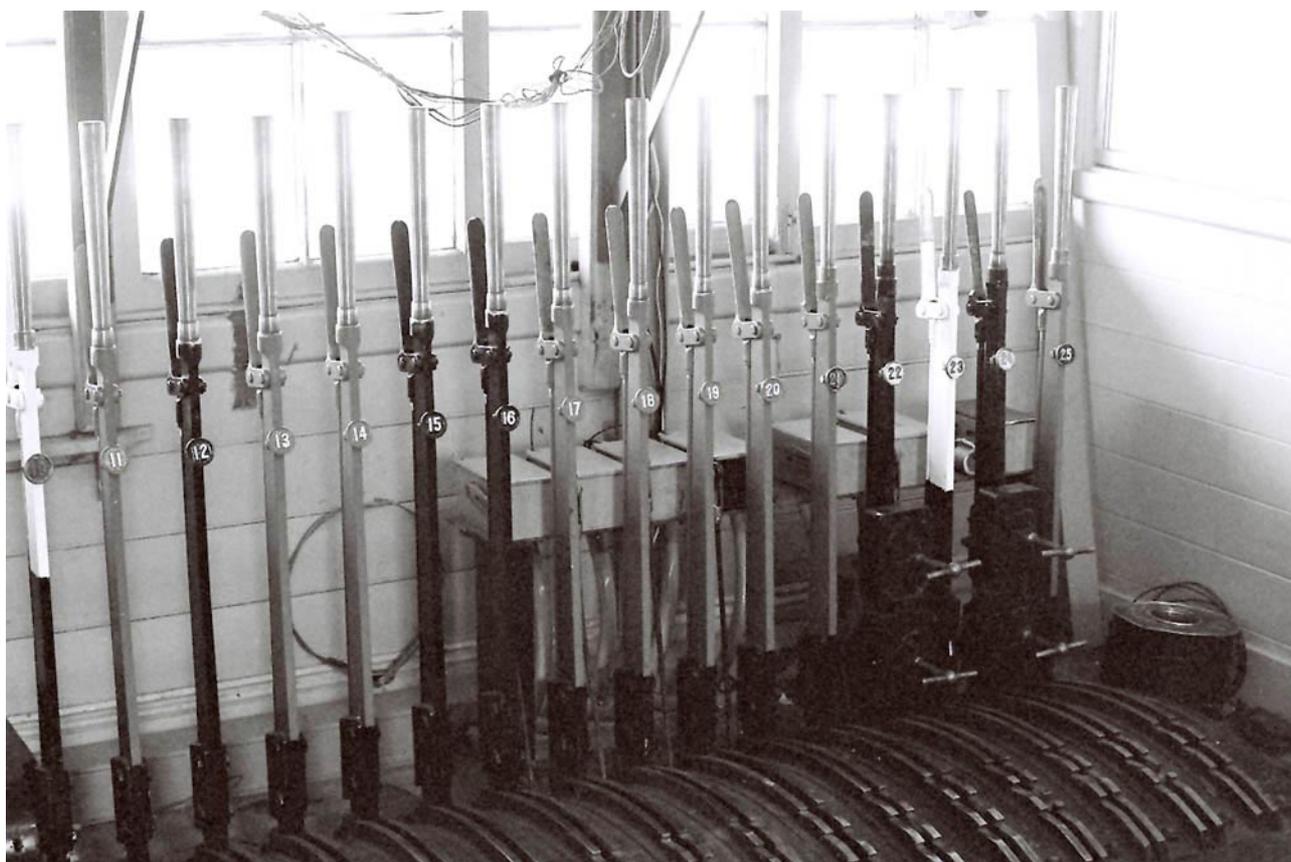
A mystery shot by David Langley: where is this, when (roughly) and why are there four Annett locks on two levers? It would appear to be a Victorian frame, but multiple Annett locks were more typically associated with New South Wales. In case the reproduction is not sufficiently clear, it should be noted that the frame has 25 levers, though this was not its original size. Answers on the metaphorical postcard to the editor (or by email) and the best answers will be published in the next issue.

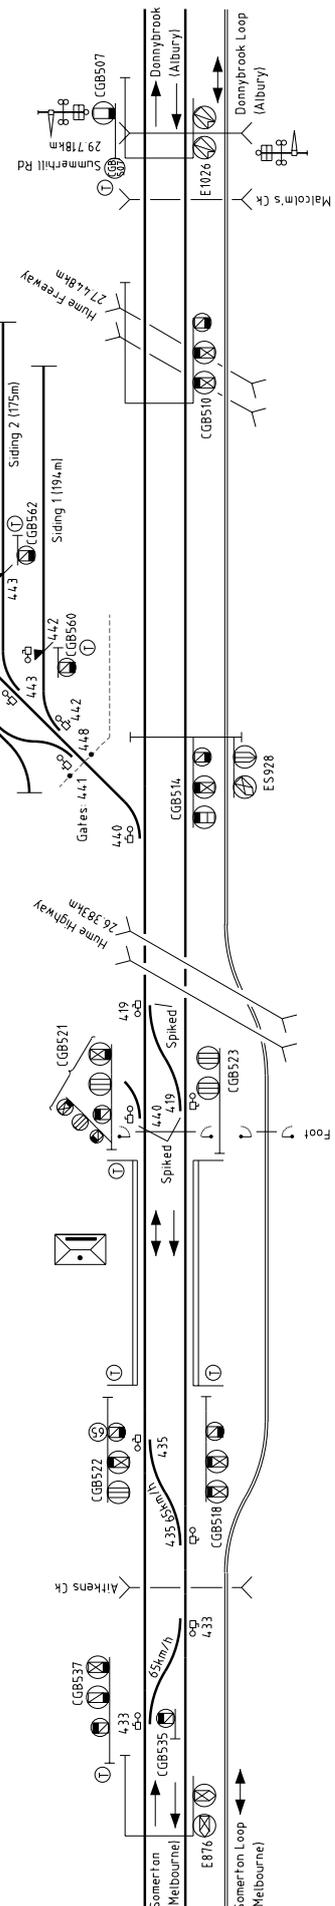
Craigieburn

Based on Diagram 3109 & WN 21/09

09 (Glenbervie - Somerton) and 51/09 (Craigieburn) replaced 33/09 and 31/09.

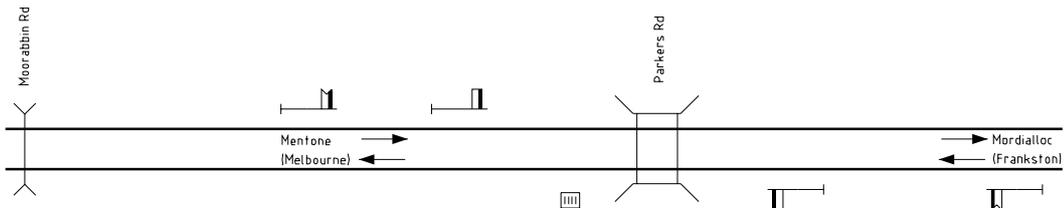
Parker's Road 1911

Probable layout

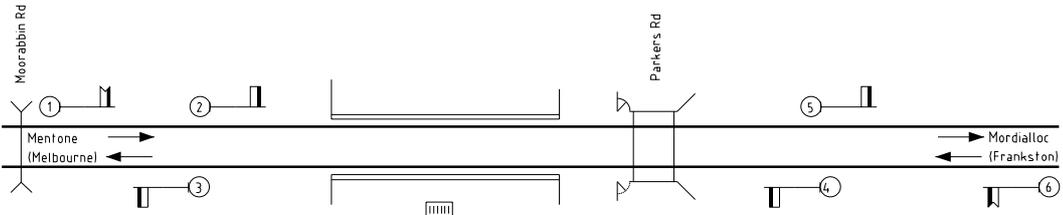
Parkdale 1919

Probable layout

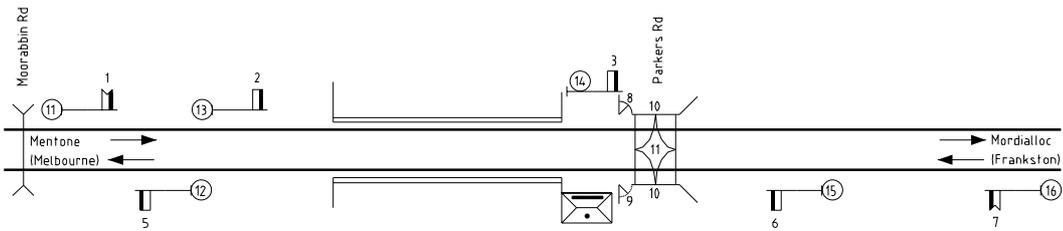
Parkdale 1924

Based on Interlocking Sketch A360 amended to 27.7.83

Signalbay 12'10.25"x7'
11 Lever A Pattern Frame
Spare: 4

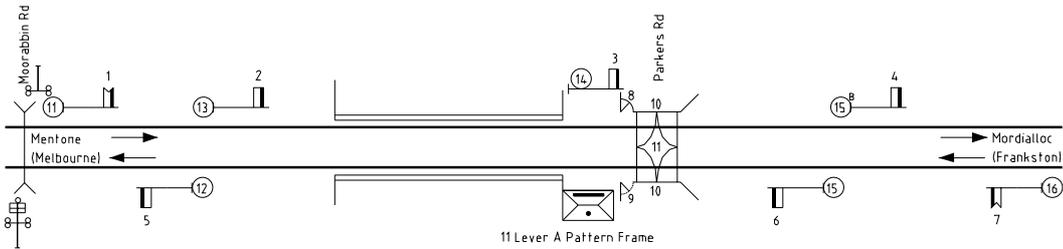
Parkdale 1943

Based on Interlocking Sketch A360 amended to 27.7.83

11 Lever A Pattern Frame
Spare: None

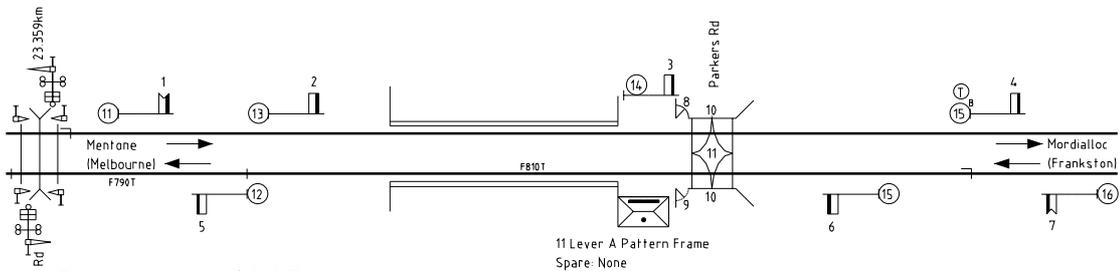
Parkdale 1983

Based on Interlocking Sketch A360 amended to 27.7.83

Warrigal Road

Up Control F790T down (28s, 510m), Up Express Holding F810T down (27s, 600m), Up Stopping Holding 33s after F810T down

On 27 July 1983 boom barriers and pedestrian wickets replaced the flashing lights at Warrigal Road (the former Moorabbin Rd). A lever lock was provided on lever 5 working the Up starting signal to prevent the signaller from clearing the starting signal until the conditions were correct.

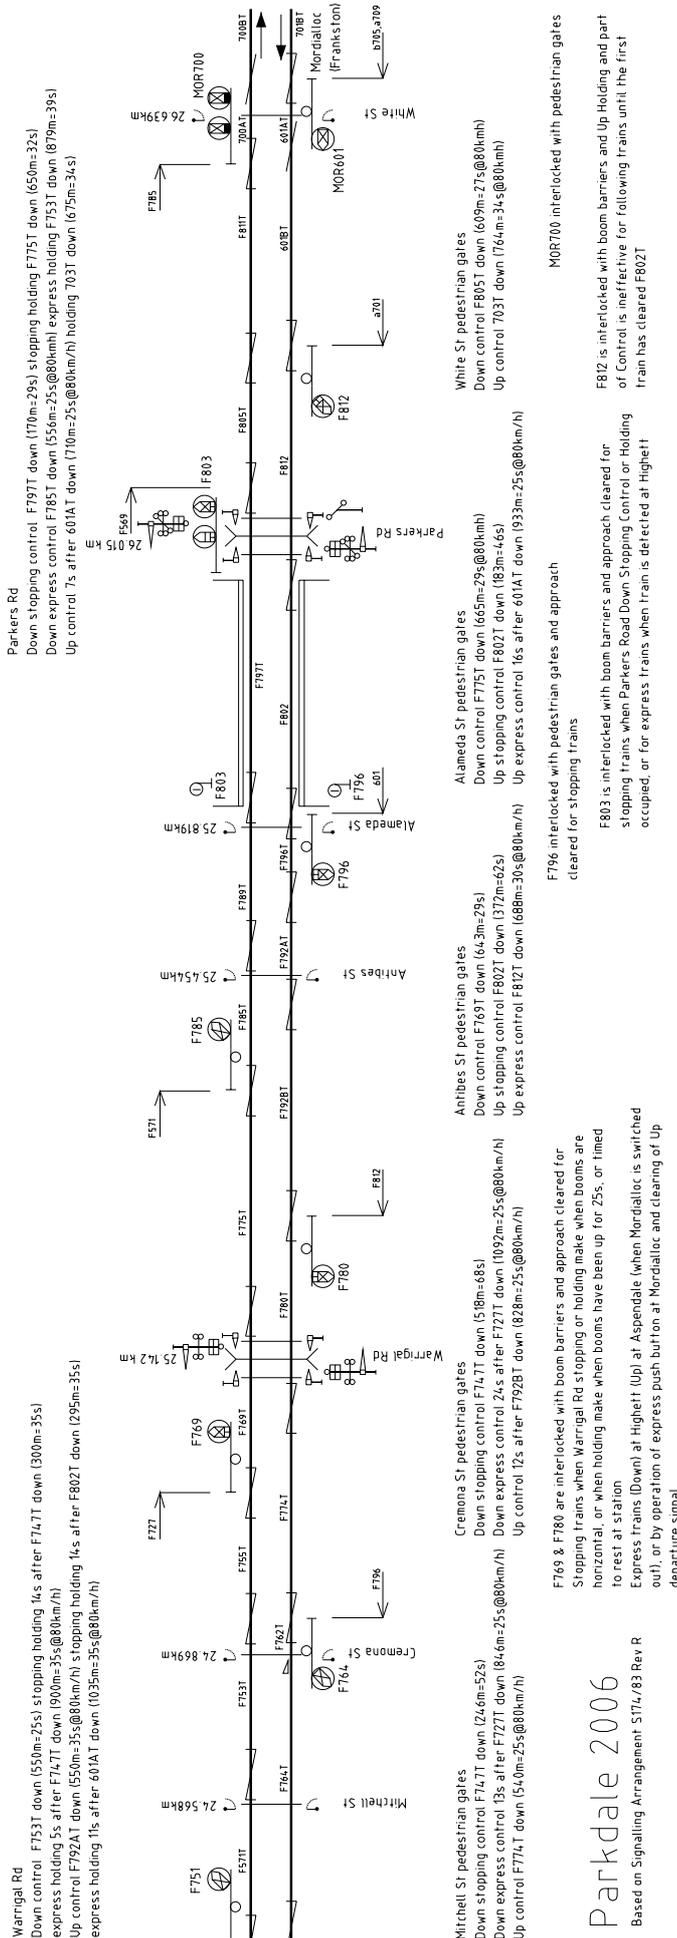
Parkdale 2006

Based on Signalling Arrangement S174/83 Rev R
