# SOMERSAULT

JULY 2011  
Vol 34, No 4

SIGNALLING RECORD SOCIETY OF VICTORIA INC

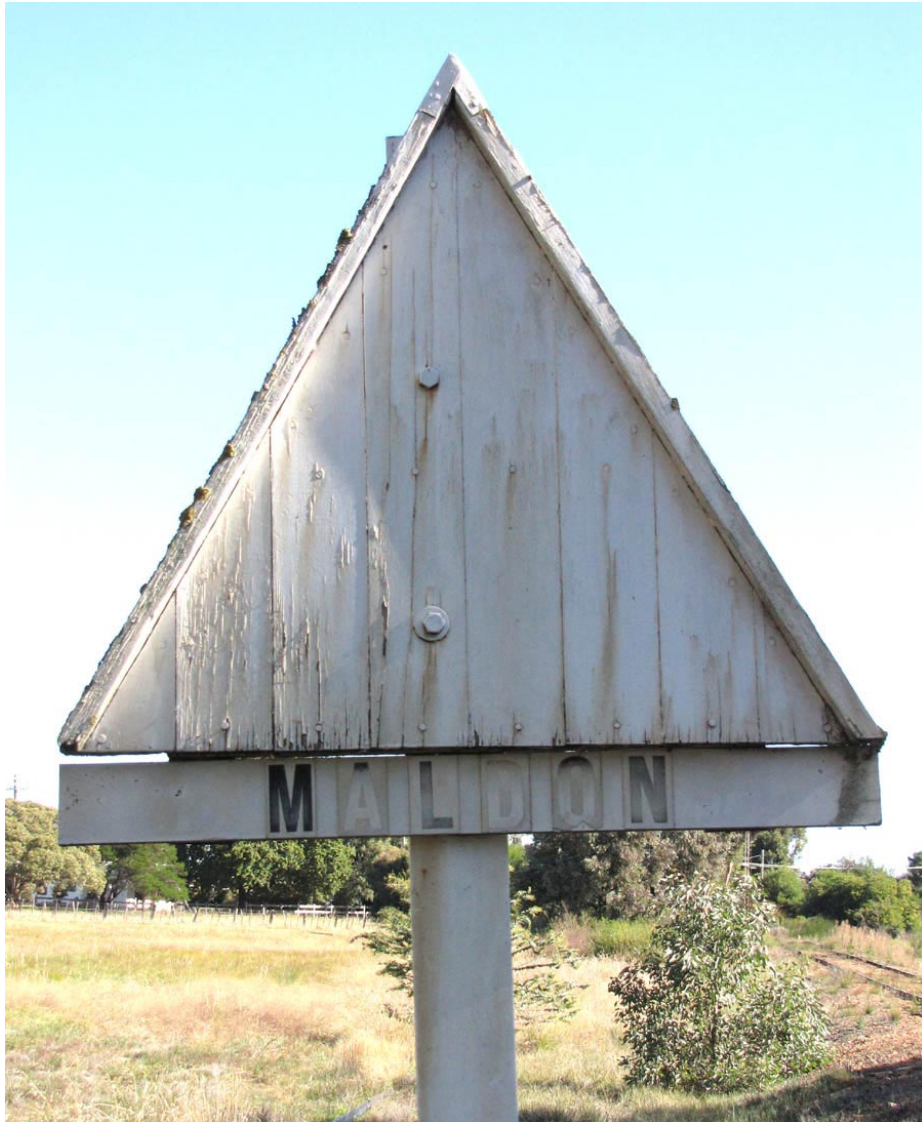
*The Down Location Board at Maldon on the Victorian Goldfields Railway is to drawing F4060. This drawing was dated 19 September 1947 and consisted of a white painted triangle three feet on a side. The triangle is constructed from timber boards. Beneath the triangle is a detachable name board 4 inches high. The name board has the location in 3 inch letters painted upon it, although how much use that was to the loco crew approaching the station is highly questionable. The bottom of the name board was to be 6 feet above rail level. The location board at Maldon was provided on 22 May 1962 when the home signal and plunger locking was taken out of use. This was as part of a policy on the VR at this time to remove plunger locking from branch line termini where it was unlikely that two trains would be there at once. Plunger locking has been re-instated at Maldon since the VGR reopened the line, but the location board still exists.*

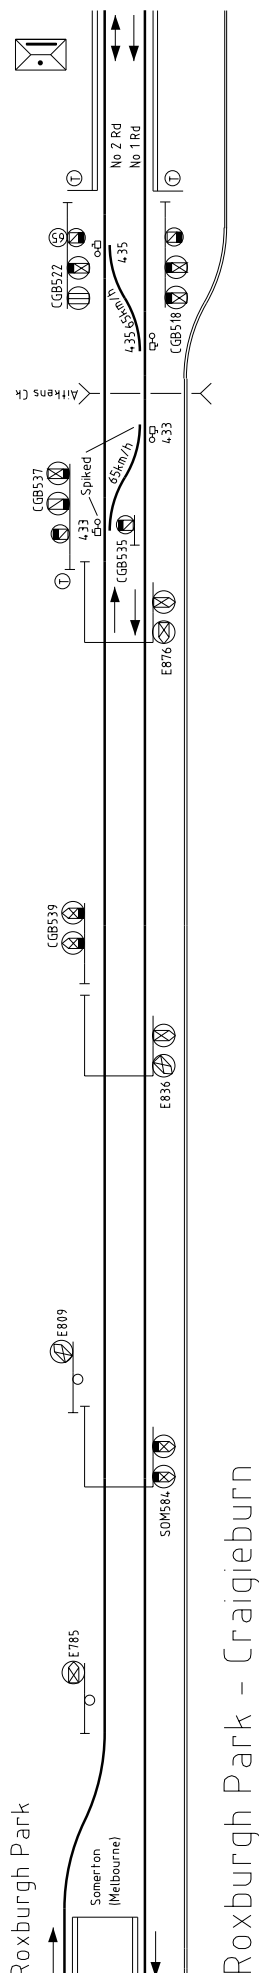
After being tripped to a stop at E785, the train was accelerated under full power until it reached a speed of 63 km/h. It then coasted for about 5 seconds before braking commenced for Auto E809, which was also at stop. The operation of the train on the approach to E809 was similar

to that for E785. The train passed E809 travelling at about 4 km/h with the brake controller still in notches 1 or 2. It was again tripped to a stand. The train continued its journey after a stop of about 34 seconds, and again the train accelerated under full power for 41 seconds achieving a speed of 69 km/h. Power was then shut off and the train coasted for 13 seconds with the speed falling to 66 km/h on the rising grade.

Departure of the suburban train from Roxburgh Park was about a minute late. The master controller was then stepped up to notch 4 (maximum power) until the train reached 34 km/h when power was cut off. Braking was then engaged, ranging from notch 1 to 5, as the train approached Auto E785 which was at stop as the freight train was still occupying the track ahead of E809. When the speed had been reduced to about 9 km/h the brakes were released and the train coasted to E785. It rolled past E785 at about 3 km/h and was tripped to a stop. The brakes were then released and the train continued on its journey after a stop of about 38s.

With the train now approximately 116m from the rear of the freight train, the brake controller was moved to the emergency position. Six seconds later the EMU collided with the rear of the freight train at 47 km/h. The suburban passenger train came to rest approximately 16m beyond the point of impact.

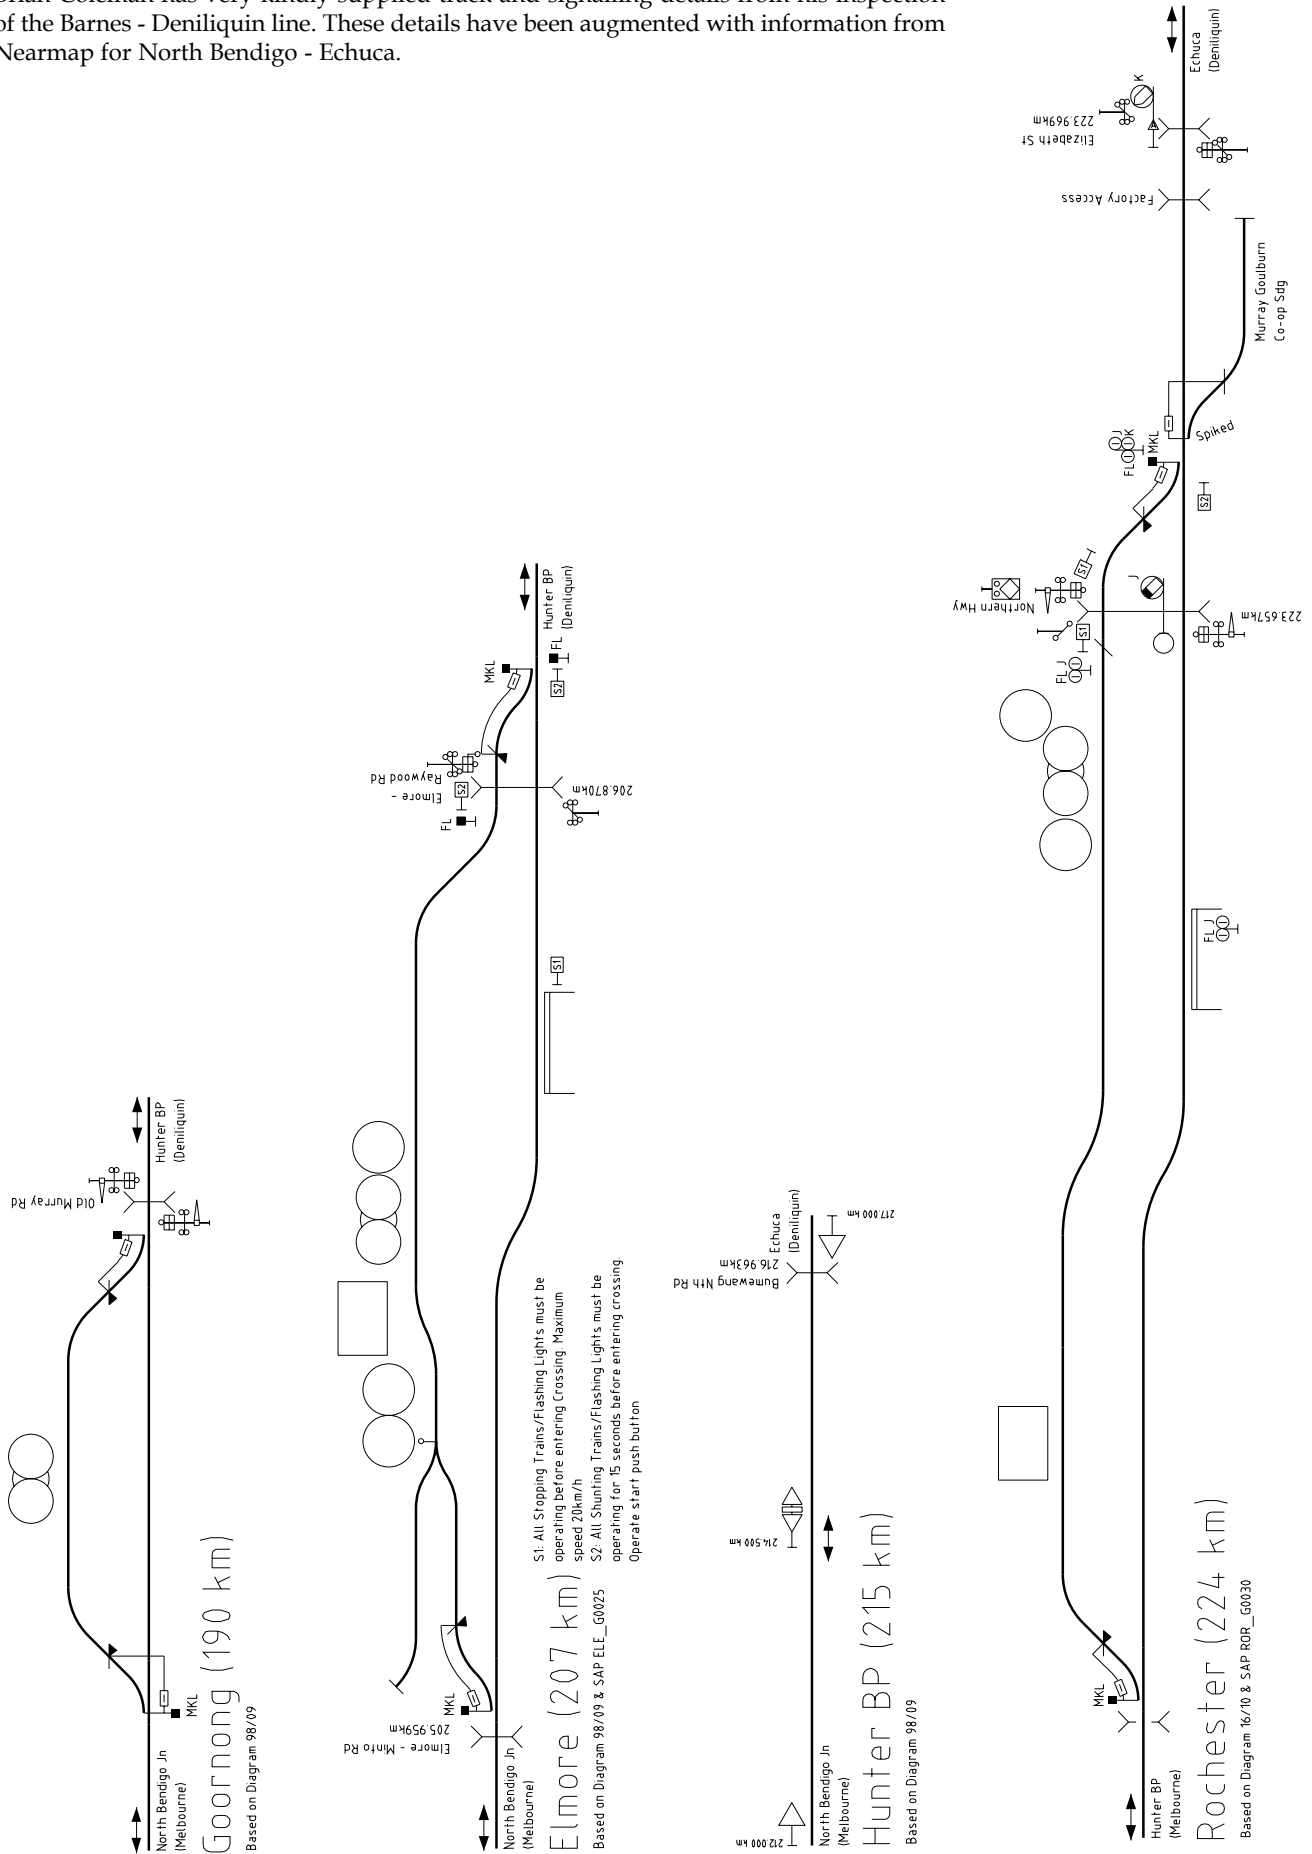
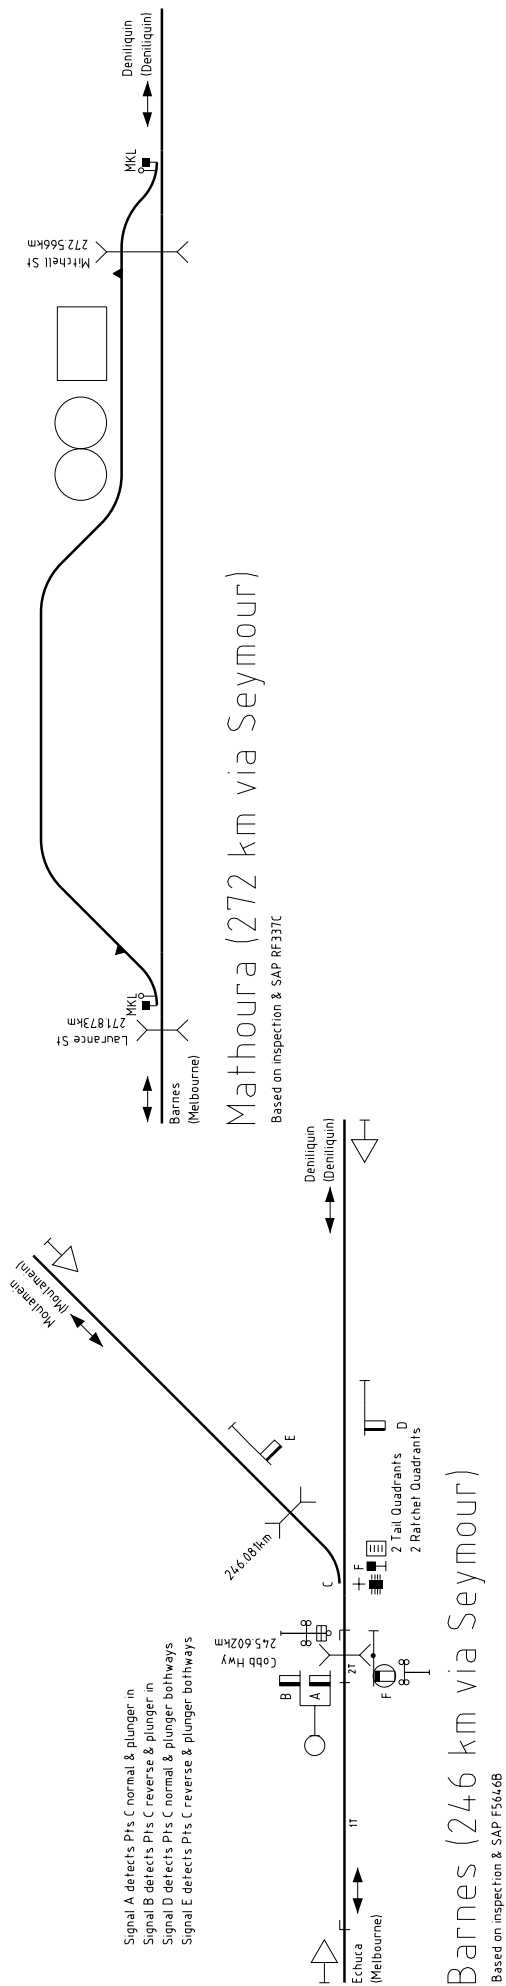
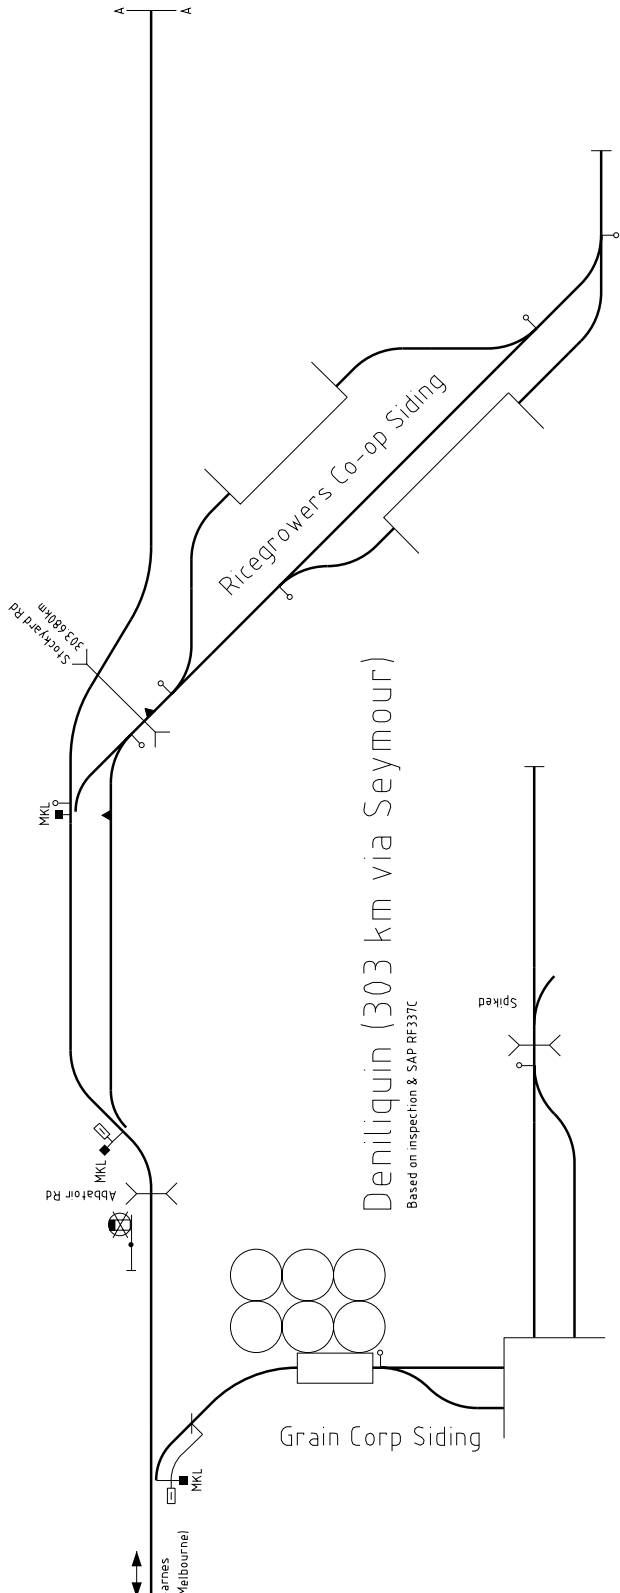
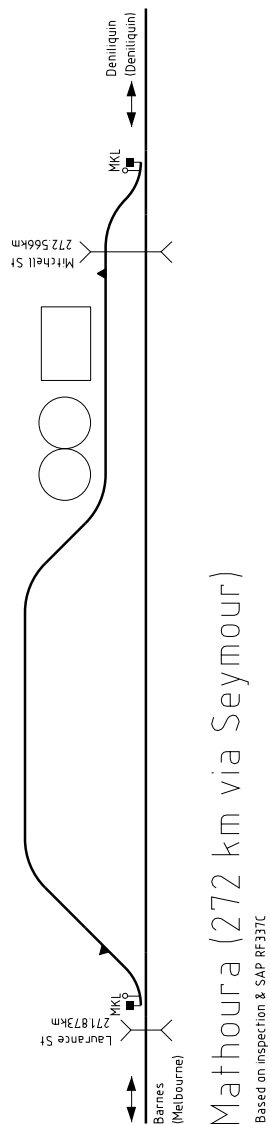
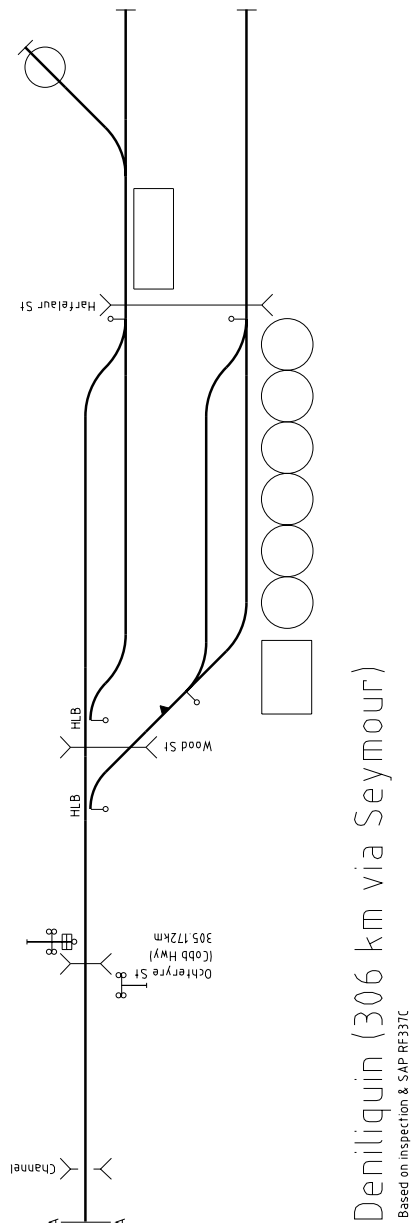
## BENDIGO - DENILQUIN 2011

Brian Coleman has very kindly supplied track and signalling details from his inspection of the Barnes - Deniliquin line. These details have been augmented with information from Nearmap for North Bendigo - Echuca.
