SOMERSAULT

SEPTEMBER 2012

SIGNALLING RECORD SOCIETY OF VICTORIA INC

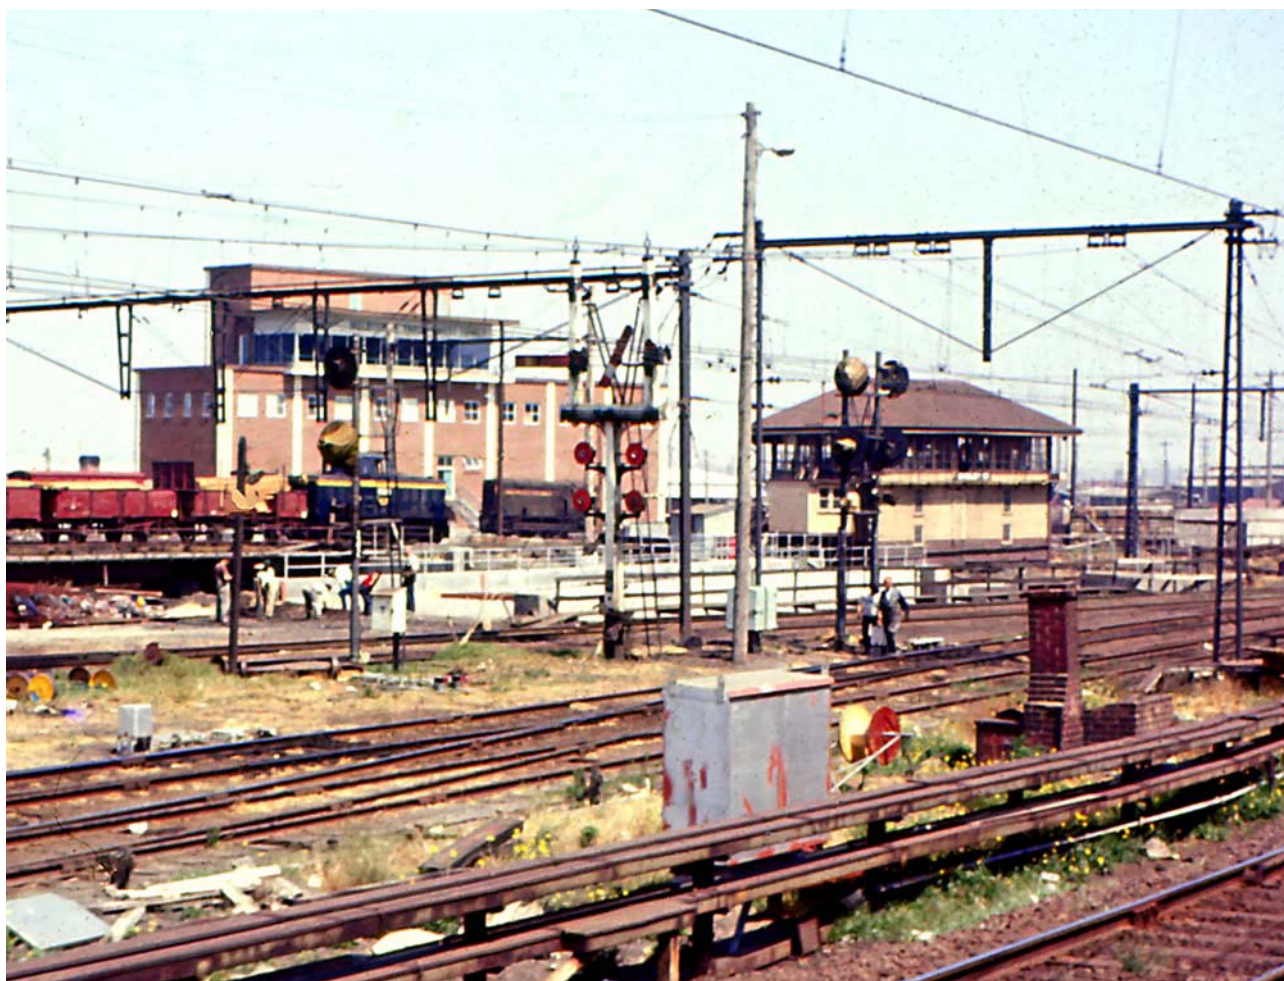
West Tower was closed as a signalbox at the end of July, albeit the name lives on describing a room in Centrol which houses the replacement VDU. This photo dates from August 1968 and shows the then uncommissioned West Tower looming over its predecessor, Dudley St. West Tower was commissioned on 1 December 1968 with a route setting panel on the top floor, and for a while shared operation of Melbourne Yard until Dudley St was closed on 29 December 1968. It is a sobering thought that almost nothing in this picture survives today. Dudley St signalbox and the mechanical signals were removed quick smart, of course, to make way for the hump. The W class and F class diesels and the four wheeled wagons are gone. The, then brand new, concrete bridge was removed when Melbourne Goods Yard was removed for the Docklands redevelopment. Even the goods lines in the foreground have now been removed, to be replaced by the new RRL track. Photo: David Langley

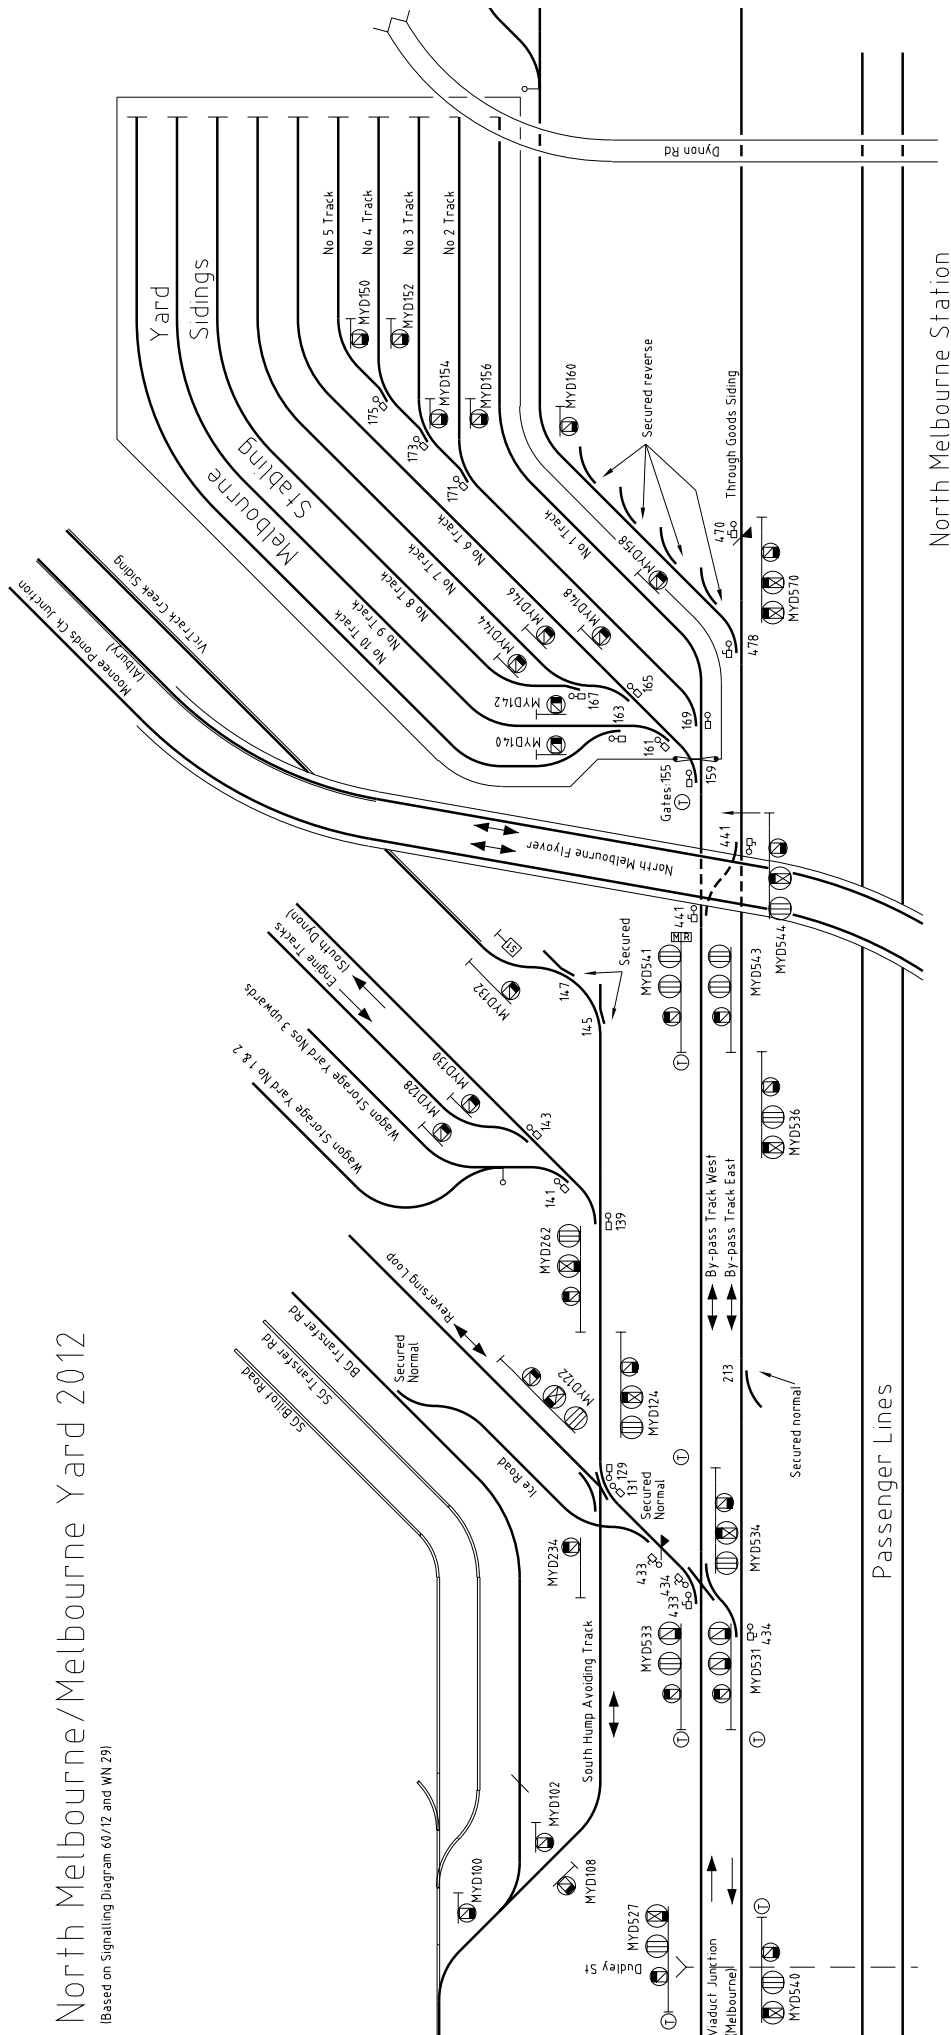
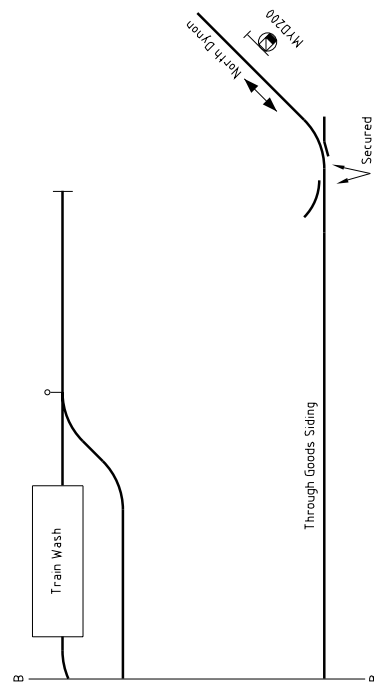
North Melbourne/Melbourne Yard 2012

(Based on Signalling Diagram 60/12 and WN 29)

Homes 124 & 262 and Dwarf 122 were converted to LED and renumbered with a 'MYD' prefix. The prefix 'MYD' was added to Dwarfs 100, 102, 104, 106, 108, 128, 130, 132, 140, 142, 144, 146, 148, 150, 152, 154, 156, 158, 160, 184, 186, 190, 194, 234, 280, 284, & 286. Dwarfs WST230 & WST232 were renumbered with the MYD prefix. Note that Dwarf 200 was not renumbered.

New East and West Bypass tracks were provided between Viaduct Junction and West Tower. These are located immediately on the western side of the former Goods Lines. The North Hump Avoiding Track was restored to use to form a connection between the Bypass tracks and the South Hump Avoiding Track and the Reversing Loop.

Diagrams 45/12 (Southern Cross - MTM Passenger Lines), 60/12 (West Tower), 72/12 (South Kensington), and 67/12 (Moonee Ponds Creek) replaced 21/12, 57/12, 55/12, and 3/11 respectively.

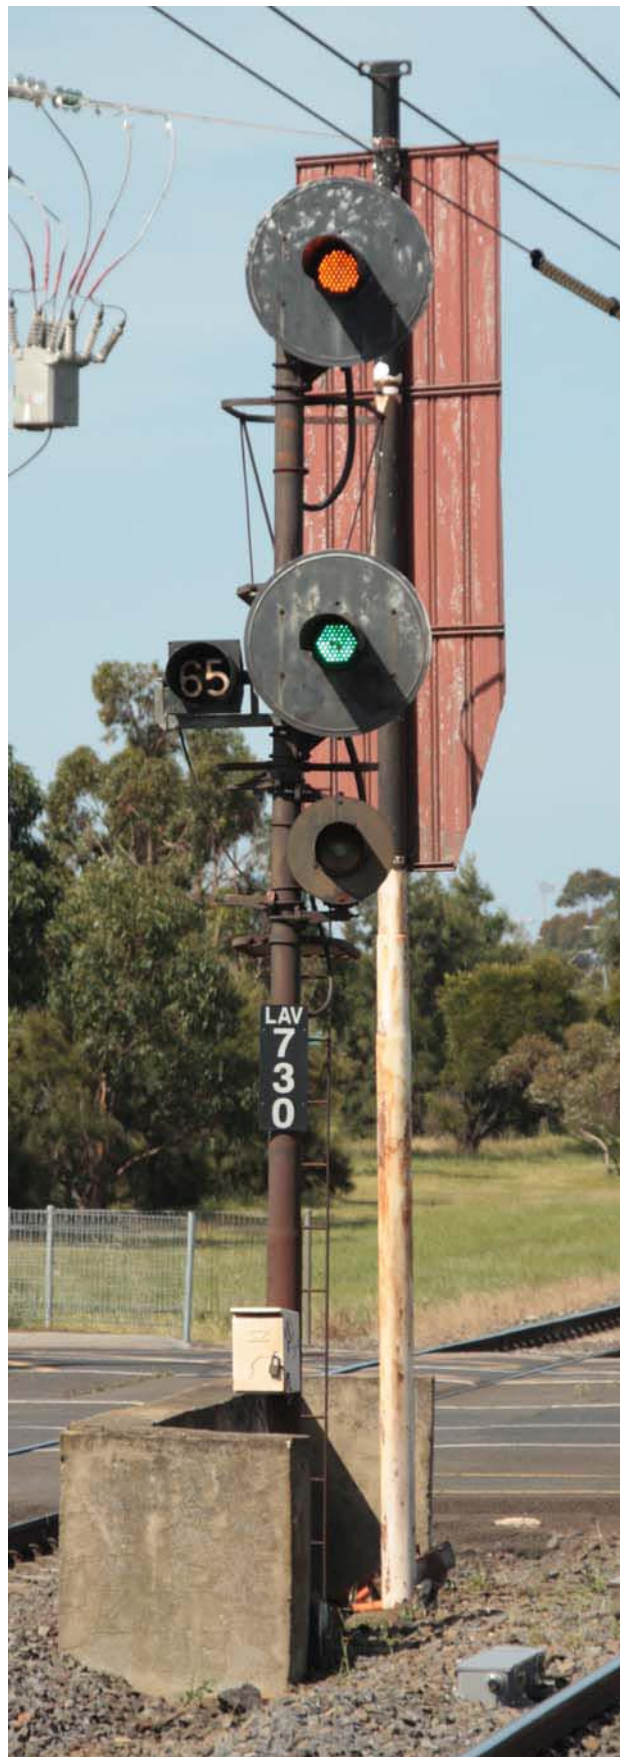
Home 20 is now Home LAV730 and in this photo displays a Reduce to Medium Speed aspect for an Up Sparc to proceed to the Altona Loop at Laverton. The back board was provided after the accident to reduce the chance of misreading the signal. Since the accident, the crossover at Laverton has been replaced by a high speed (65 km/h) crossover, hence the provision of a '65' indicator on this signal.

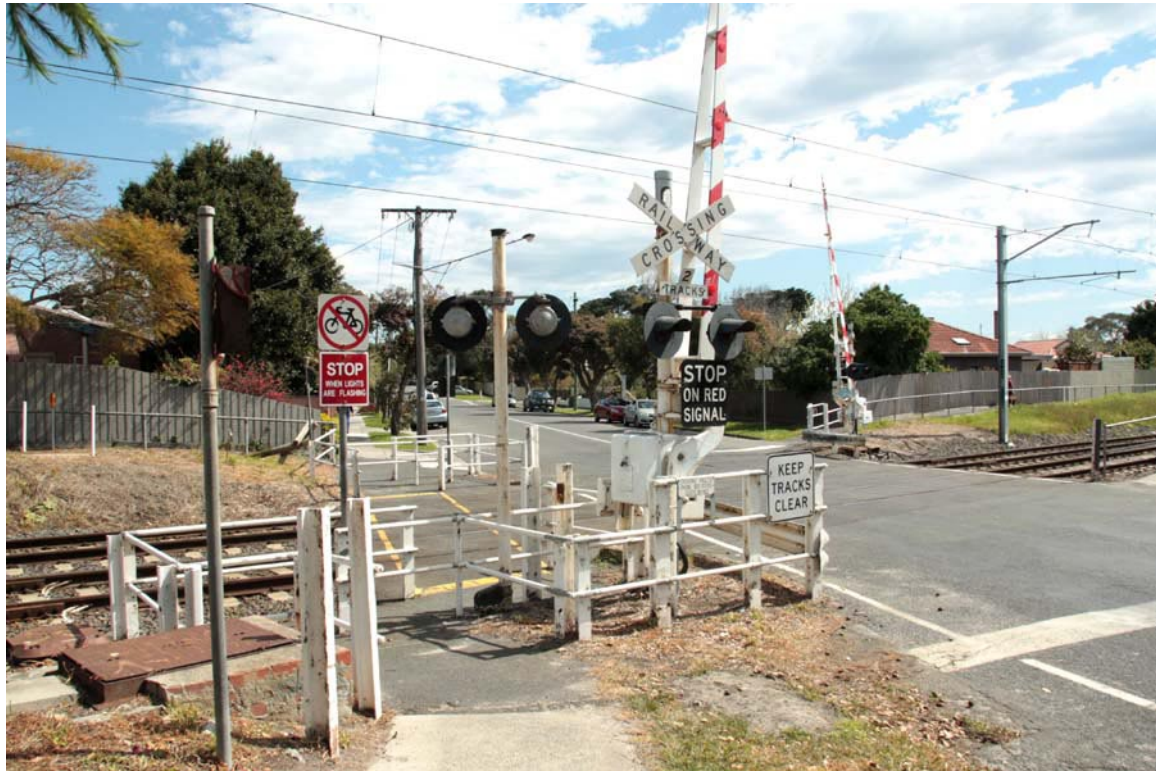
Linacre Rd (18.293 km) on the Sandringham line is a now rare example of a crib crossing in the electrified area. The boom barriers here replaced hand gates on 19 December 1956, and little has changed since (it is interesting to try and spot the changes). Only one pedestrian crossing is provided, on the Down side of the road. Pedestrians on the northern side of the road, presumably, were expected to cross over to the southern side of the line. In practice they simply walk along the road. The crib crossing itself is constructed of lengths of condemned rail forming the uprights and painted tubular steel. Notice how the crib crossings are laid out so that the pedestrian approaches the actual crossing facing trains approaching on the nearest track - a subtle design feature to encourage the pedestrian to notice the trains.

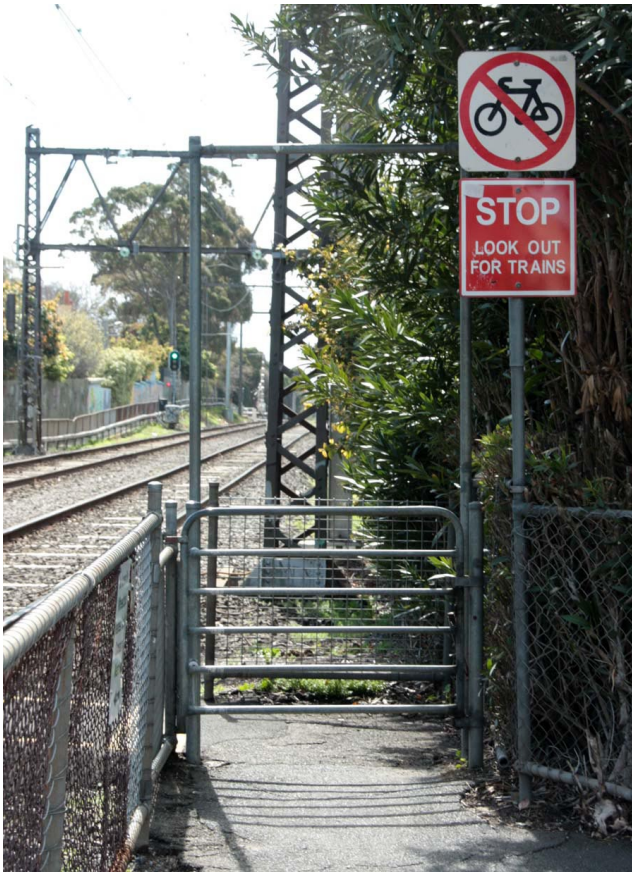
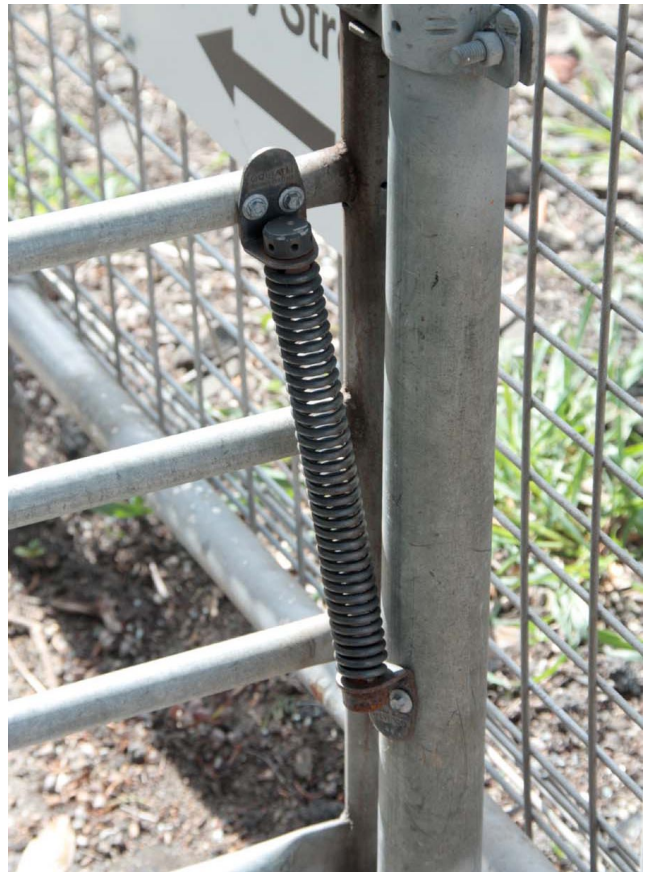
This pedestrian only crossing at Kinane St (15.391 km), also on the Sandringham line and just south of Dendy St, is a puzzle. Although the Addenda states that this is an open crossing, in fact it is provided with hand operated wickets on both sides of the line. Neither wicket is controlled in any way and can be opened at any time by pedestrians. The gates open away from the track, and a spring is provided to close the wickets behind pedestrians. This is, in fact, a 'modern' implementation of a very old approach to pedestrian wickets in Victoria. However, this is the only known example of this type of crossing. On both sides, the pedestrians approach the actual crossing facing the trains approaching on the nearest track. However, the above picture shows that visibility of trains on the Down side is dubious at best. The pedestrian crossing is also completely unusable by anyone in a wheel chair or motorised scooter.
