SOMERSAULT

SEPTEMBER 2013

SIGNALLING RECORD SOCIETY OF VICTORIA INC

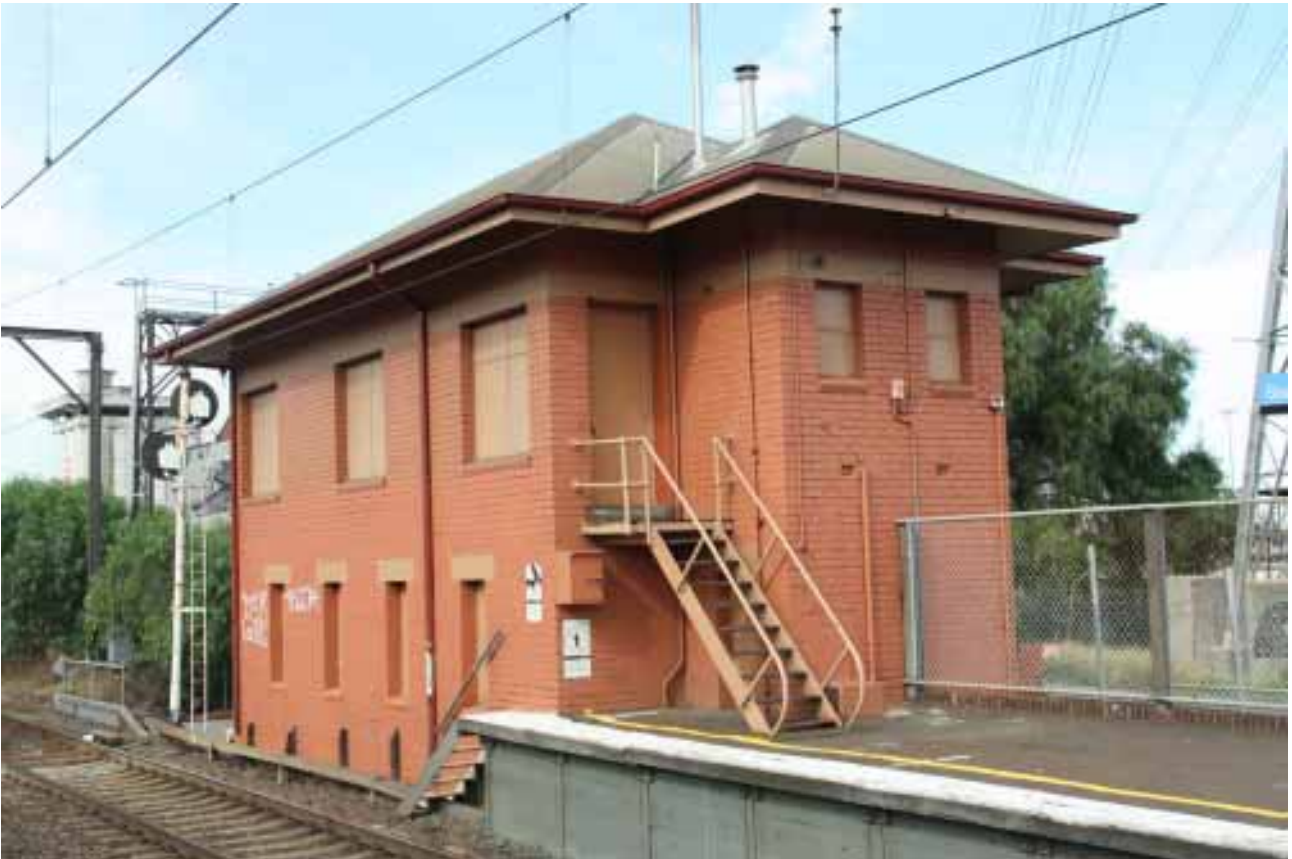
One of the surprise losses this year was South Kensington signal box which was unceremoniously demolished on the weekend of 20/21 July, apparently because it was foul of the new RRL lines. This box was brought into use on 21 October 1928 in connection with the provision of the goods lines to West Footscray. It contained a 68 lever McKenzie and Holland Style A power frame. On 18 December 1960 a control panel was provided opposite the frame to control the points and signals in the South Dynon area in connection with the provision of the new standard gauge lines. The power frame was replaced by a control panel on 13 July 1992 which worked the same layout. At the time it was reported that there was some urgency about the replacement due to the deteriorated condition of the insulation of the wires in the relay room. In late June 1992 control of the Dynon/South Dynon area was transferred to a new panel in West Tower. Like Franklin St and North Melbourne, South Kensington simply faded away. At some date control of the points and signals was transferred to Metrol, however the panel apparently remained available for use in an emergency.

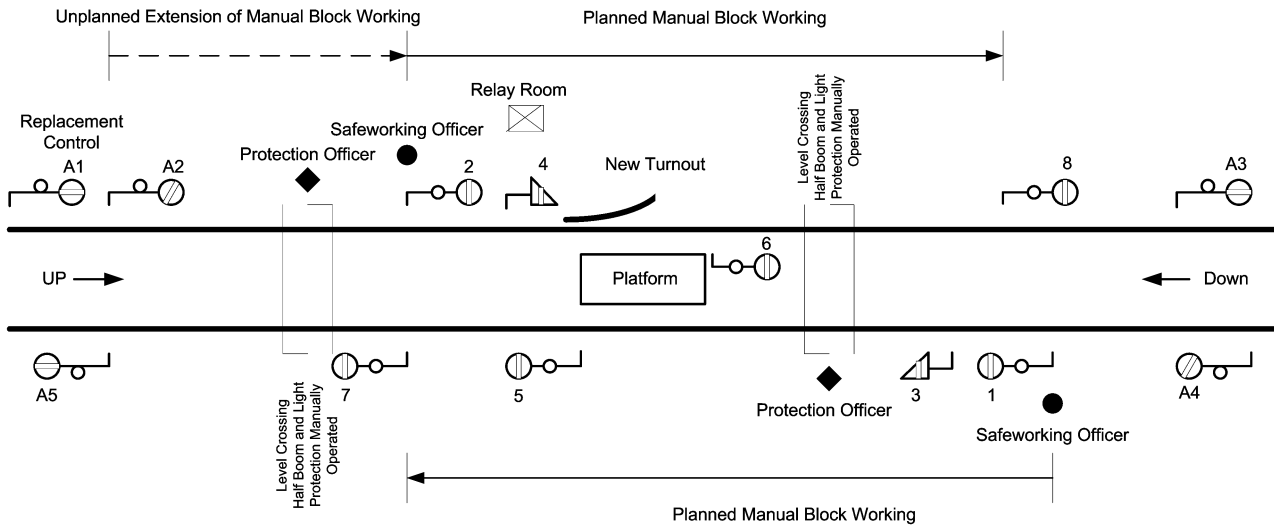
Location Track and Signalling Diagram

Layout Simplified for Clarity
(Normal Signal Aspects Shown)

Planned Arrangements for Manual Block Working

1. Signals 1, 2, 3, 4, 5 & 6 to be Fixed at Stop
2. Signals 7 & 8 to be Converted to Automatic Operation (Signal 7 to Display Red & Yellow Only)

1. Signal A1 False Fed to Overcome Replacement Control Function
2. Signal A2 Maintained at Stop (On Account of Level Crossing Controls)
3. Signal 8 Alterations Attempted to Entice Automatic Operation

Signal electricians were then sent to check on the aspects of all signals and to ensure that things were as planned. This exercise confirmed that signal A2 was still at red when it should have been displaying yellow and had apparently found that other signals were without any temporary measures being in place.

It was becoming evident that temporary signalling arrangements had not been considered or carried out on the Up line in preparation for rail traffic. For example, signal A1 had a replacement control fed from the interlocking and was therefore showing a red aspect. Signal 8 had not been configured to work automatically and was also sitting at red. With signal A2 still at red, this meant that the six consecutive Up signals would require special authorisation to pass for each train.

Between 05:30 and 05:50, signal A1 received a false feed to pick up a control relay remedying the effect of the replacement control and allowing normal automatic operation. This signal was of no further consideration in the incident.

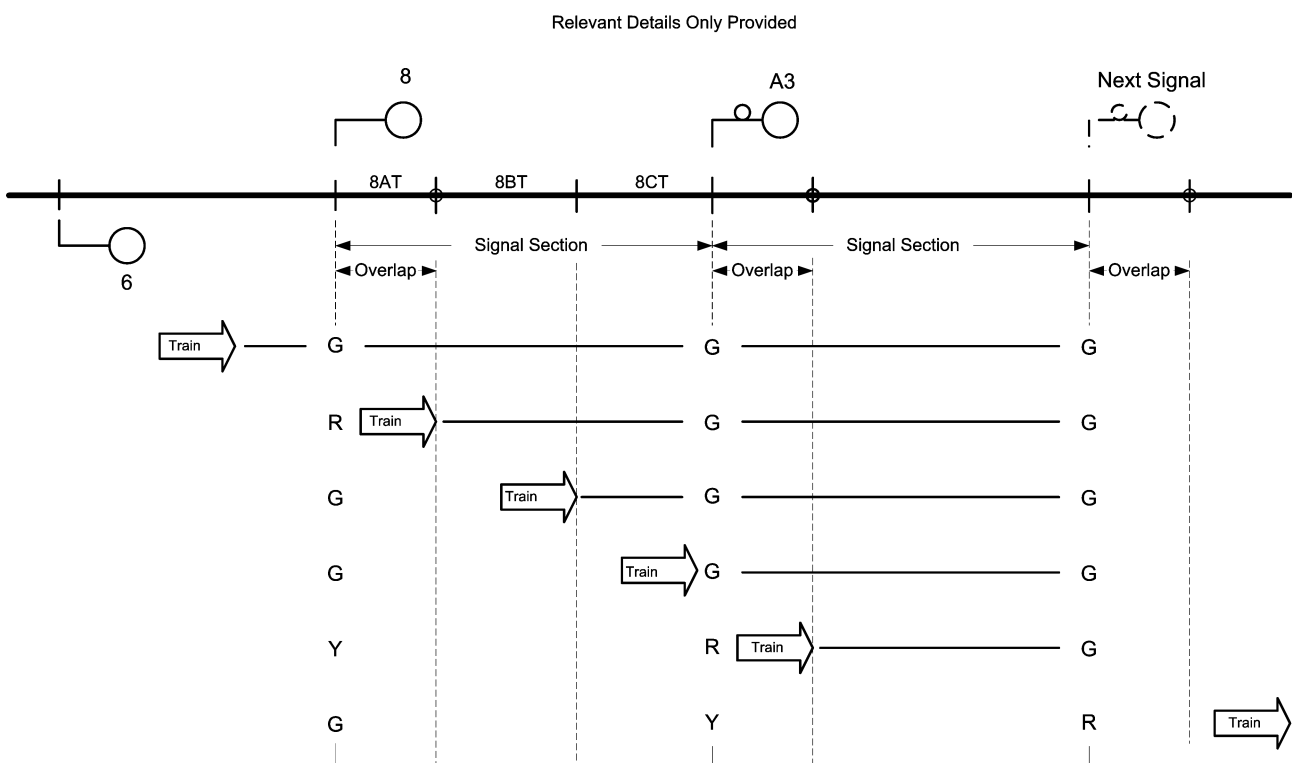
Signal 8 Aspect Sequencing During Wrong-Side Failure

Diagram 2. The operation of signal 8 is shown in each phase as a train progresses from the area of manual block operation and from signal 8. Signal 8 displayed a stop aspect only for the time a train occupied the 8AT overlap and otherwise aspect sequenced with signal A3 (Diagram by author).

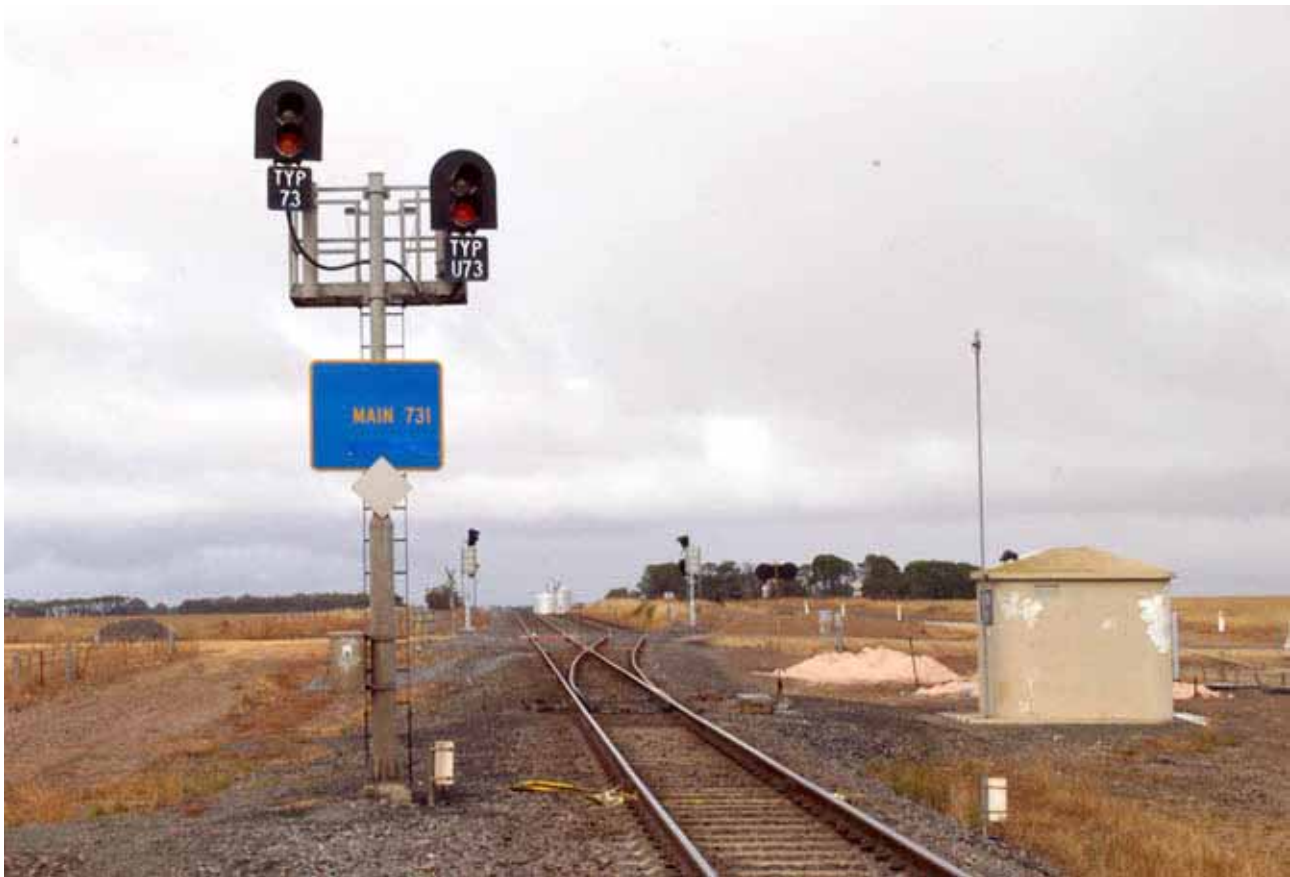
The Down end of Tatyoon Loop on 2 April 2013 showing the DICE operated equipment. The loop points are fitted with a TD84M point machine equipped with a point indicator. Trains arriving into the Tatyoon are governed by the two position Up Arrival Homes TYP73 and TYP U73 - note the lights are properly staggered. An arriving train calls the route into Tatyoon using DICE. A 3000 metre track circuit is provided on the approach to the Home signals, and when the train is on the track circuit the driver can call the route. Two codes are used - one to call the route into No 1 Rd, and a second to call the route into No 2 Rd. (For some reason, when these photos were taken the code for entering the loop at the Down end had been disabled.) If the points are free and the selected road is unoccupied, the points at each end of the loop are called for the movement. When detected

in the correct position the appropriate Home signal will clear and the train can arrive into Tatyoon. When the train has cleared the points, an arrival message will be broadcast over the radio. The instructions warned that this did not signify that the train was complete, and the drivers had to use ETAS to check that the train was complete. At the same time, the points will self normalise if they had been reversed for a move into the loop. No departure homes are provided (those that can be seen in the photo are for the impending provision of CTC and were not yet in service). Trains may depart if they are in possession of an authority for section - a reversion to a very old practice. The position of the points was indicated by the switch stand, and the route could be called, if necessary, using DICE. (Photo: Glenn Cumming)
